**DESCRIPTIVE REPORT**

Type of Survey: Navigable Area

Registry Number: H13762

Sub-locality: Alligator River

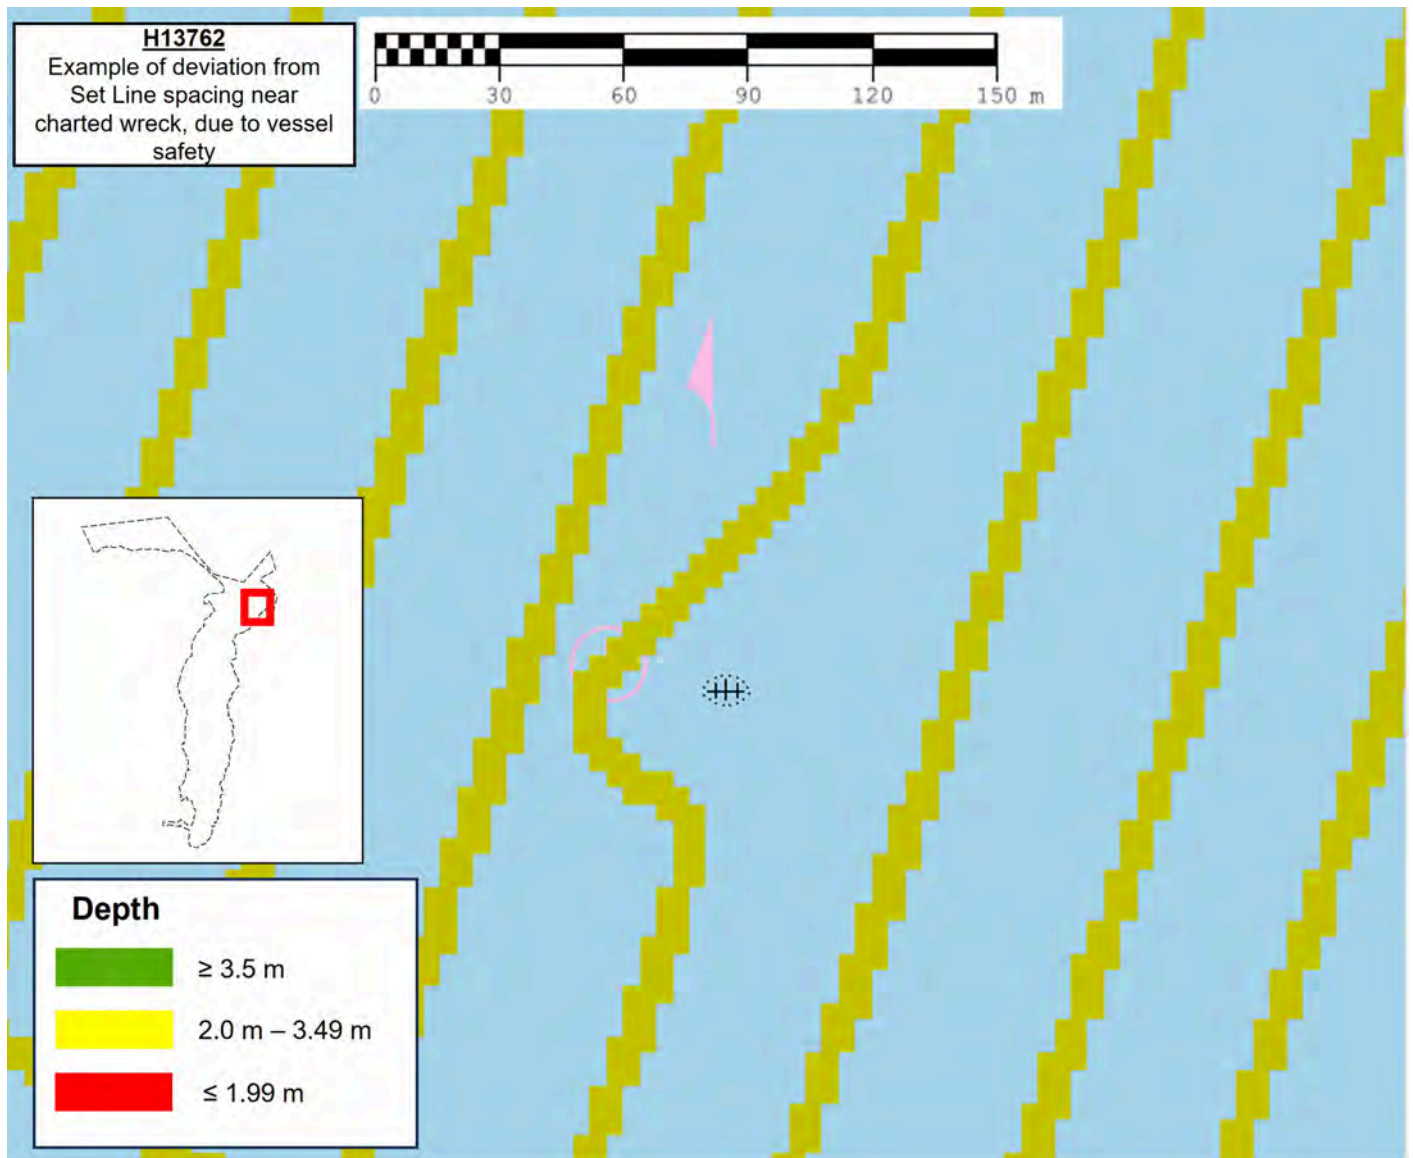
*Figure 5: Several features within SBES set line coverage areas were deemed unsafe to transit directly transit over, and deviations around several charted features were made.*

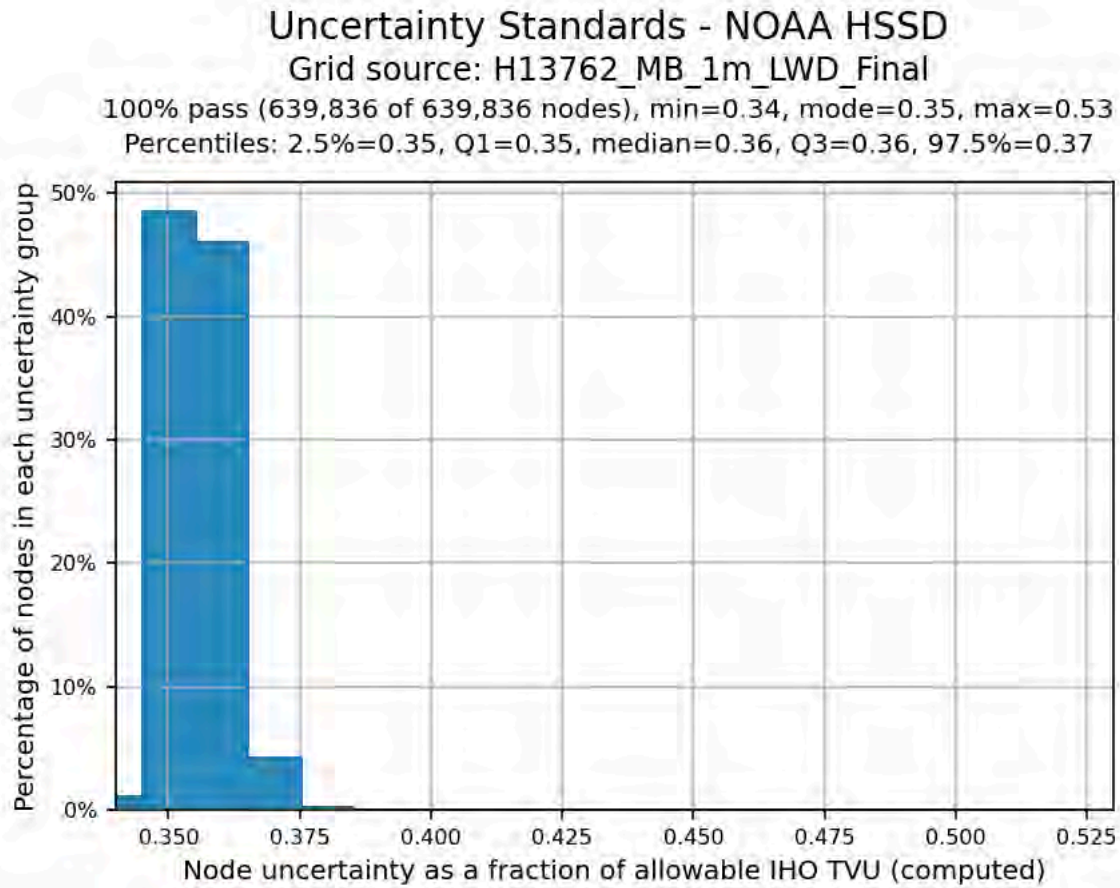
Figure 12: Finalized MBES 1m CUBE surface TVU statistics for H13762

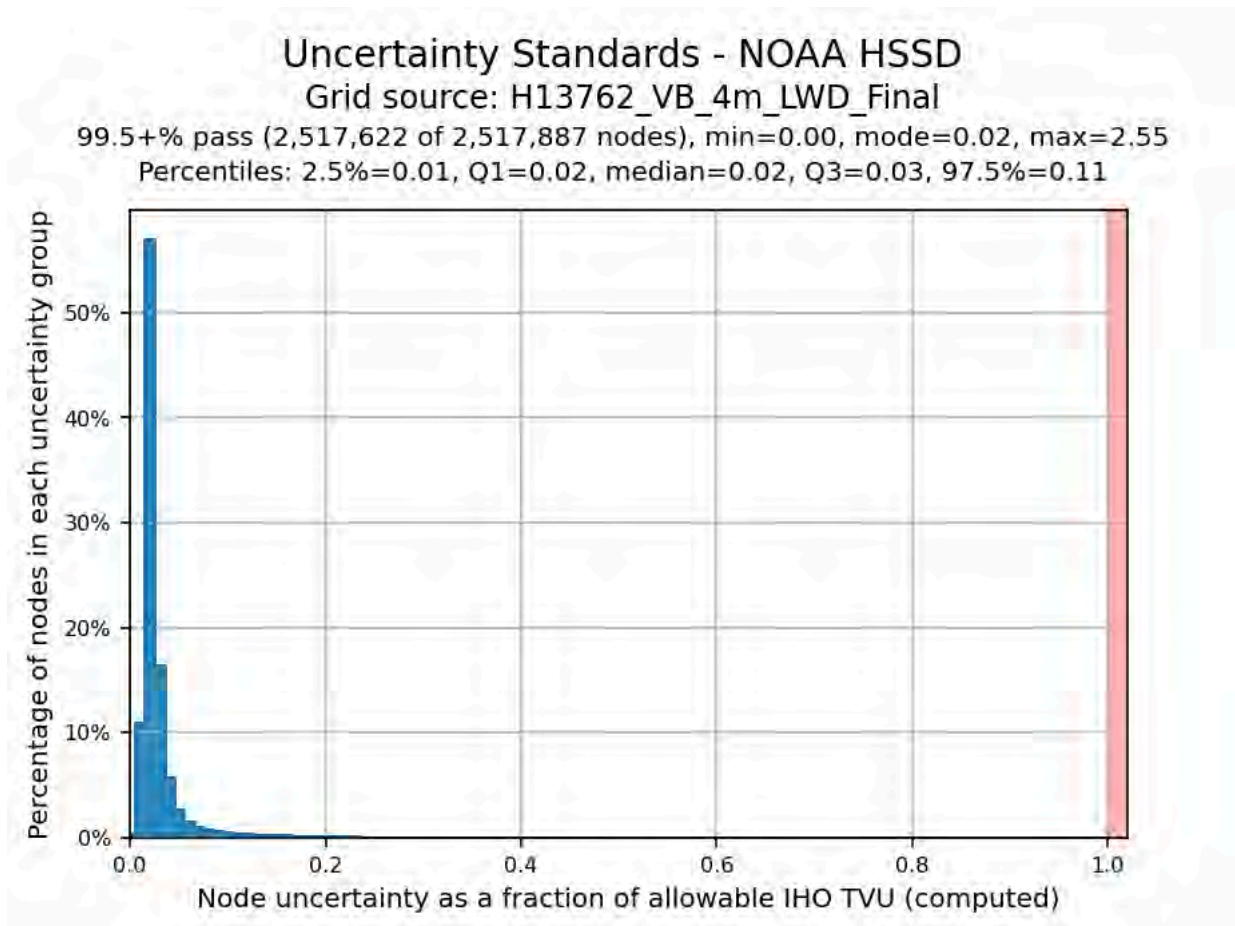
*Figure 13: Finalized SBES 4m Uncertainty surface TVU statistics for H13762*

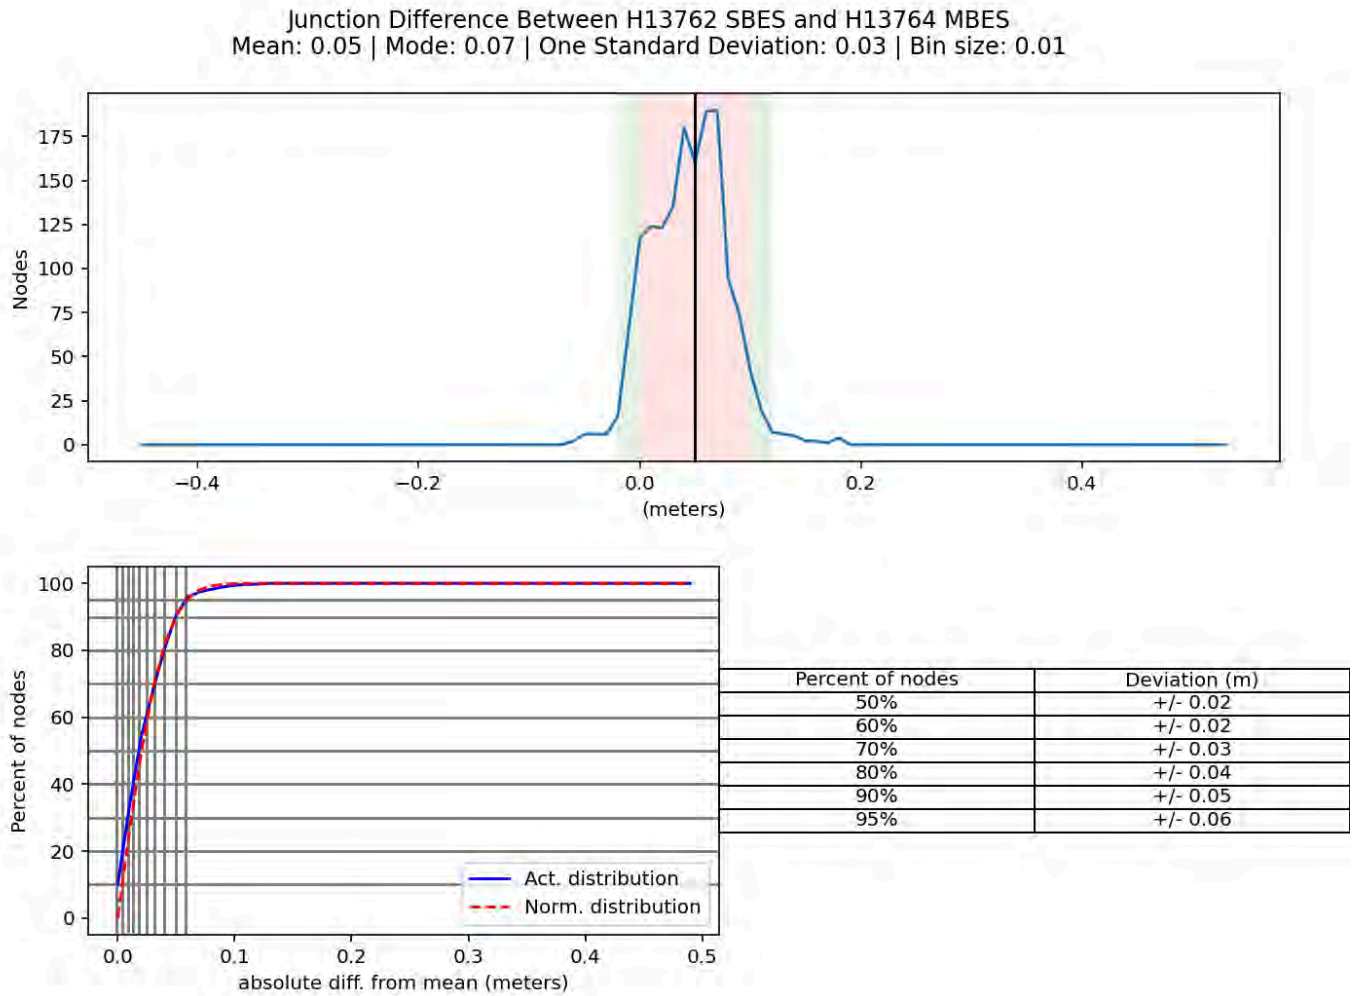
For H13762 SBES to H13764 MBES, the statistical results of the difference comparison shows 95% of nodes falling within +/- 0.06 m, with a mean difference of 0.05 m (Figure 16). Additionally, at least 95% of surface nodes met or exceed TVU specifications, as described in section 5.1.3 of the HSSD.

Figure 16: Junction analysis between H13762 SBES and H13764 MBES

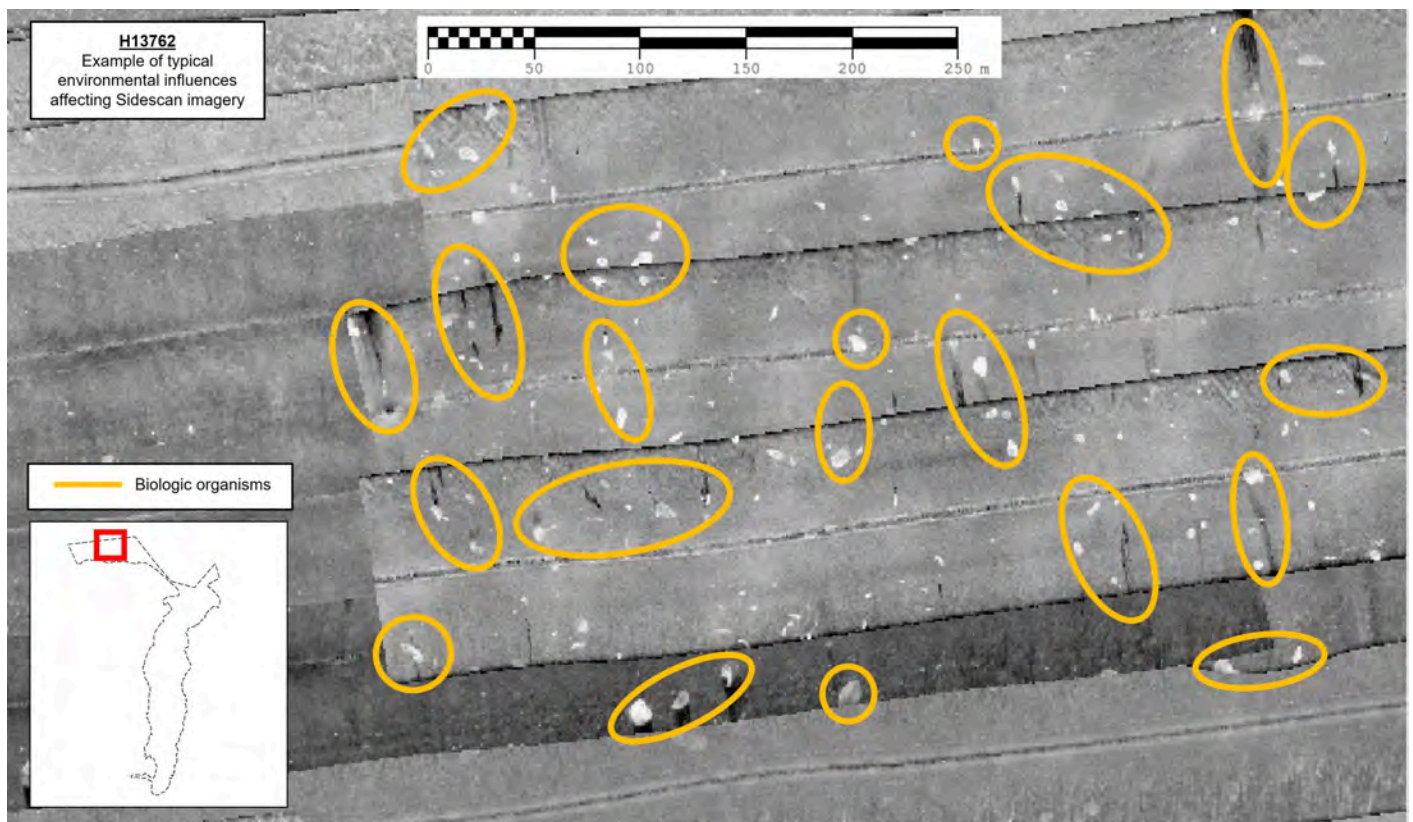
Throughout the duration of the survey, side scan acquisition frequently encountered environmental conditions which affected portions of the swath which would hinder the selection of contacts in the affected

regions. The persistent challenging environmental influences were communicated with NOAA HSD OPS in the field and was additionally discussed with AHB prior to sheet submission (see project correspondence). These environmental conditions included numerous bait balls (biologic organisms suspended within the water column), vessel prop wash, and effects from water column stratification.

*Figure 17: Example of environmental influences affecting SSS imagery which were persistent throughout the survey area, present within the final delivered mosaic.*

The affected portions of side scan imagery which would be considered a holiday due to environmental effects were identified and reacquired with either side scan or multibeam bathymetry to meet the complete coverage requirements. The SSS lines that were reacquired frequently encountered similar environmental influences, and the final mosaic has been layered as best as possible to minimize the portrayal of artifacts. The side scan sonar mosaics are not free from environmental influences, but multiple methods were taken to ensure complete coverage was achieved and side scan sonar imagery was sufficient to identify a 1m x 1m x 1m target.

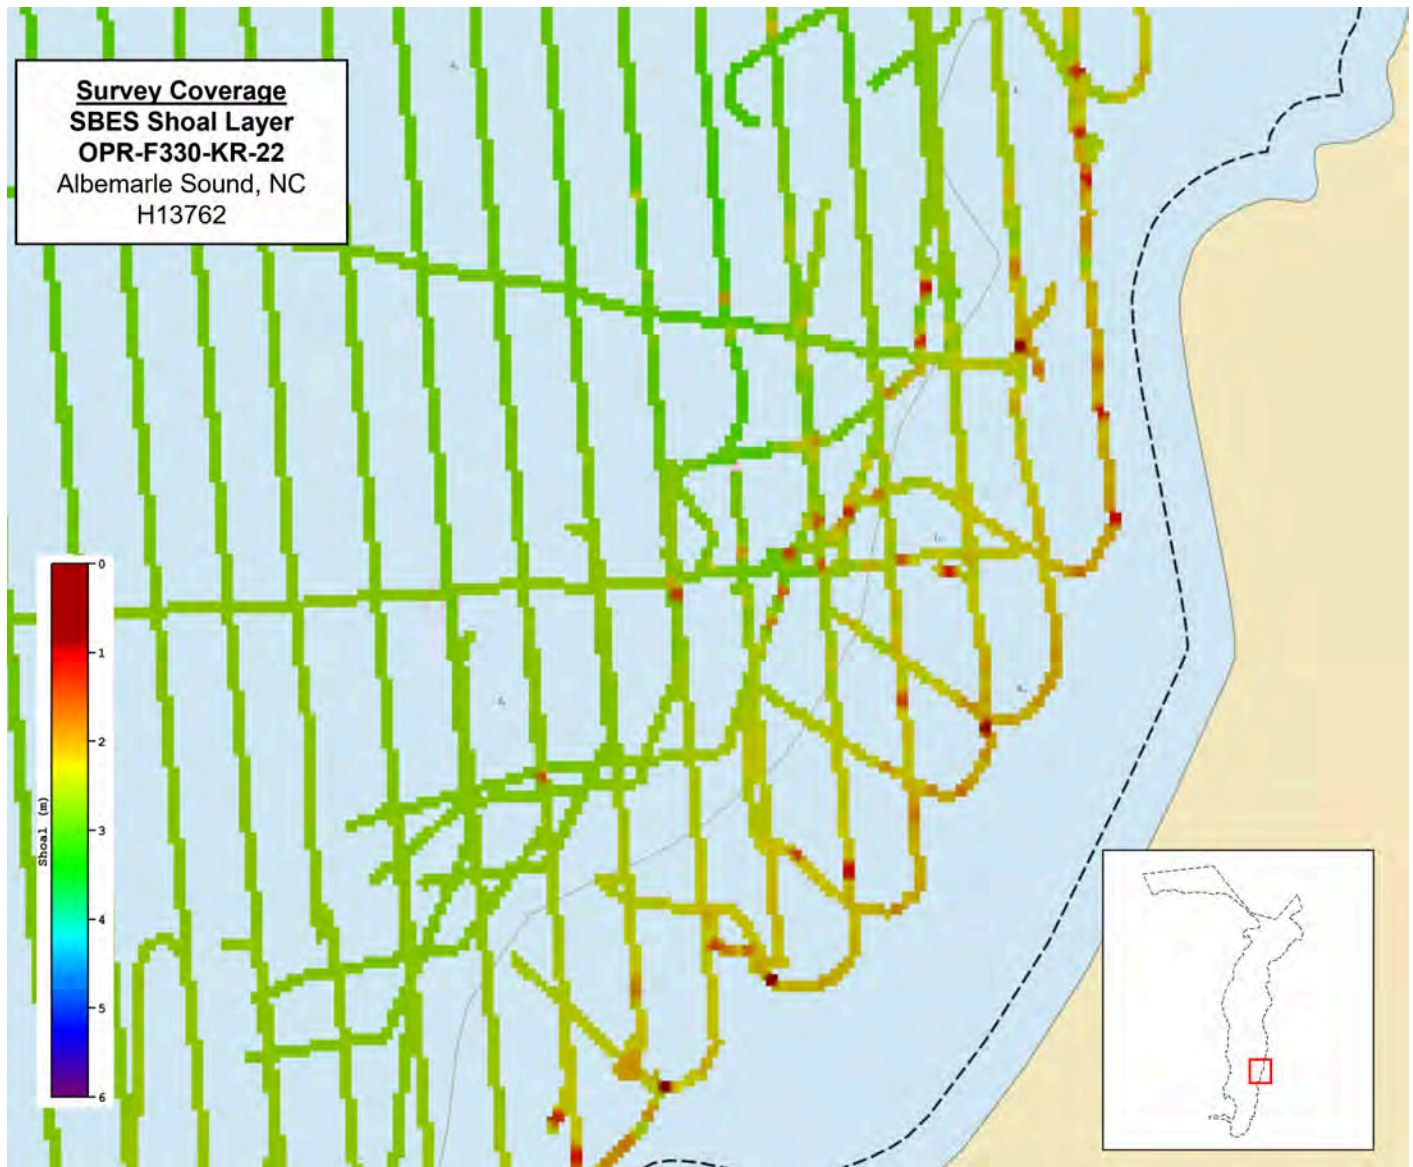
It should be noted that SBES data were cleaned with an emphasis to best represent objects extending from the seafloor. The shoal layer within the Uncertainty surface best represents these objects in the grid. These objects were not investigated further because of safety limitations. See Figure 22 for an example of bottom objects within the 4 m Uncertainty surface shoal layer.

Figure 22: Image with significant bottom objects in SBES surface seen in shoal layer

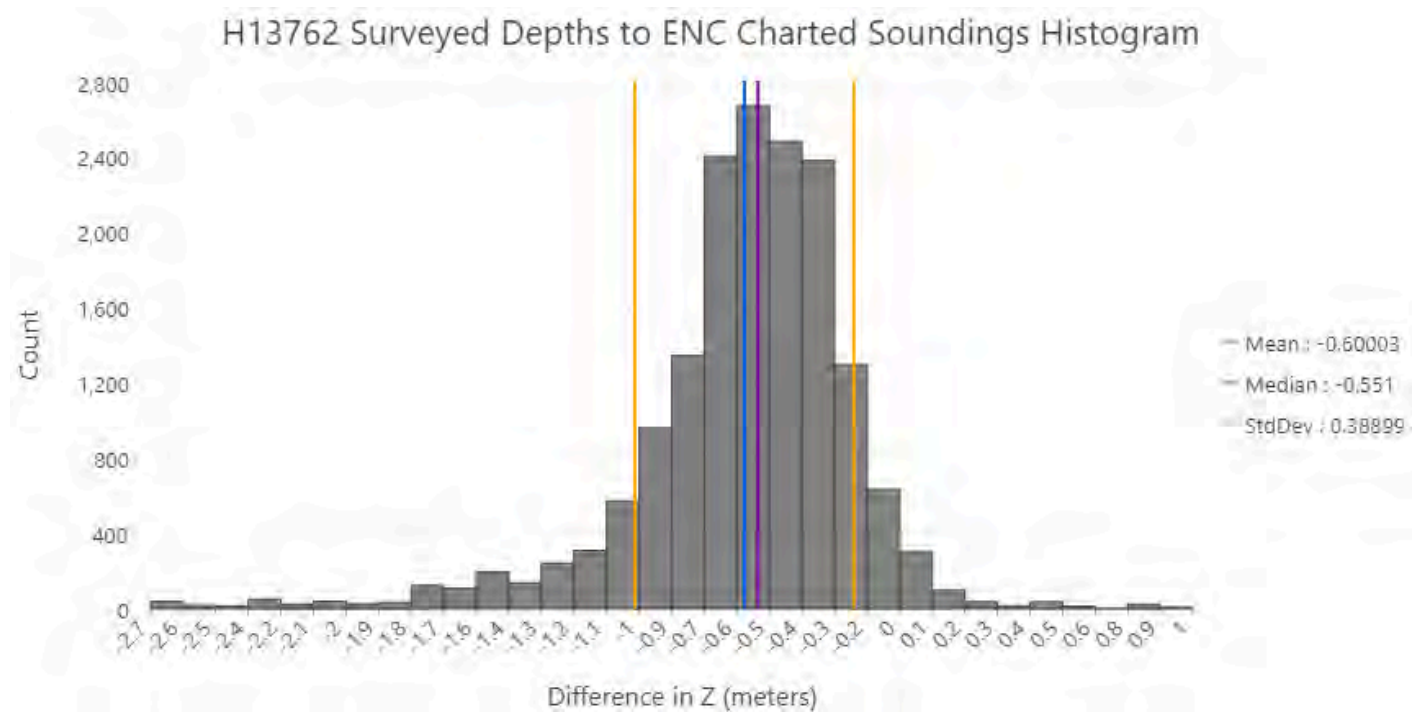
In addition to a detailed visual inspection in CARIS HIPS, all soundings from the chart were downloaded as a shapefile from NOAA's ENC Direct to GIS application and differenced with the surveyed depths from the 4 m surface in ESRI ArcPro. A statistical analysis of the difference comparison is shown in Figure 23. The surveyed depths from H13762 generally agree with the charted soundings from the largest scale ENC's within the survey area, with a mean difference of -0.60 m (ENC soundings shoaler on average).

Figure 23: H13762 statistical analysis of surveyed soundings to charted soundings
