H13807

DESCRIPTIVE REPORT

Type of Survey:	Navigable Area	
Registry Number:	H13807	
	LOCALITY	
State(s):	Minnesota	
General Locality:	Western Lake Superior	
Sub-locality:	Duluth, MN and Superior, WI	
	2023	
	CHIEF OF PARTY Dan Jacobs	
LI	BRARY & ARCHIVES	
Date:

Project Number: S-Z934-NRTST-23

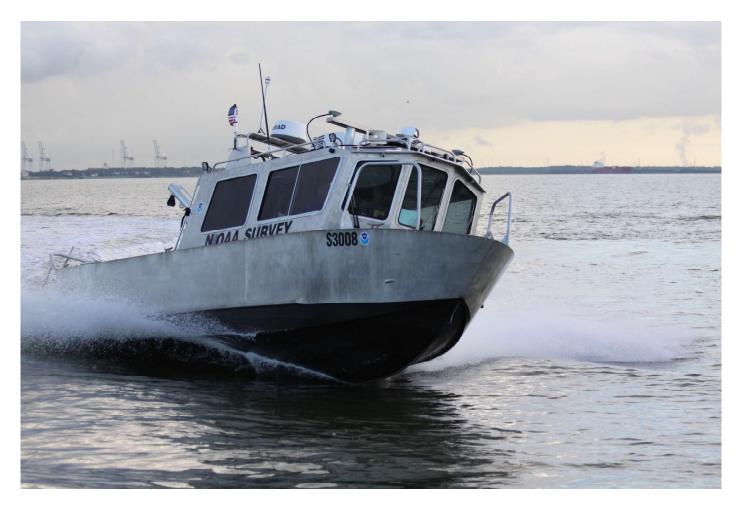
Figure 5: NRT Vessel

NRT Vessels are 30 foot, aluminum hulled fire boats modified for NOAA hydrographic survey operations. S3005 and S3008 are powered by dual 225 horsepower Honda outboard engines. A Honda 3000 watt generator supplies AC power for two workstations, 5 monitors, one POS system, one multibeam echosounder system, and one side scan sonar system.

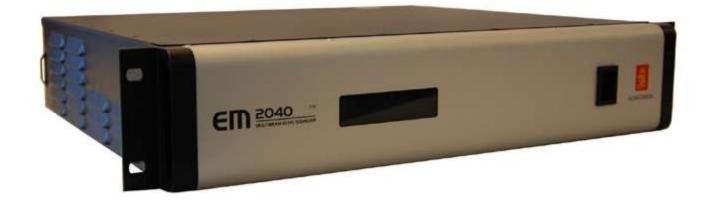
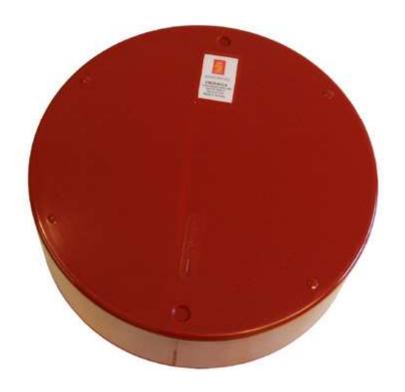
Figure 6: Kongsberg EM2040C MBES used aboard S3008

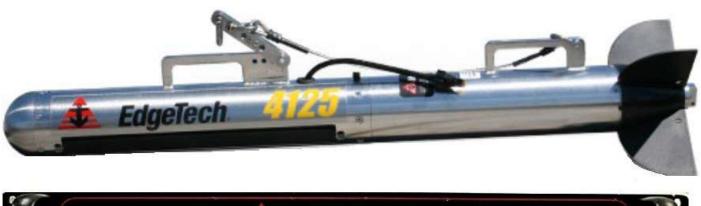
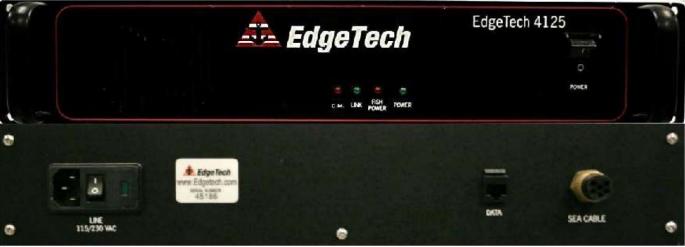
Figure 7: Edgetech 4125 Side Scan used aboard S3008

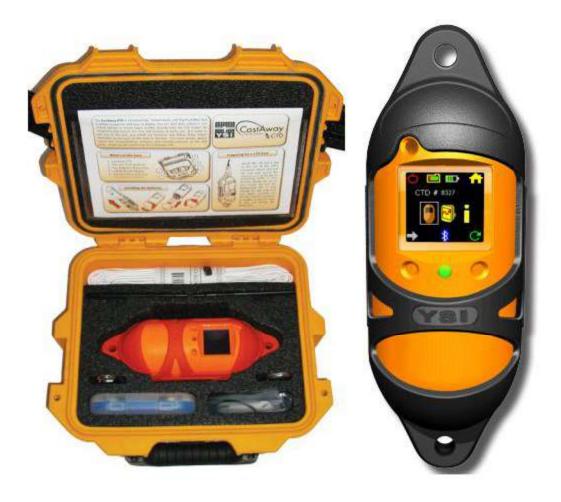
Figure 8: Castaway Sound Speed Sensor used aboard S3008
