DESCRIPTIVE REPORT

Type of Survey **Hydrographic**

Field No. **PC-13-04**

Sublocality **From Savannah, GA, to Port Canaveral, FL,
up to 62 NM offshore**

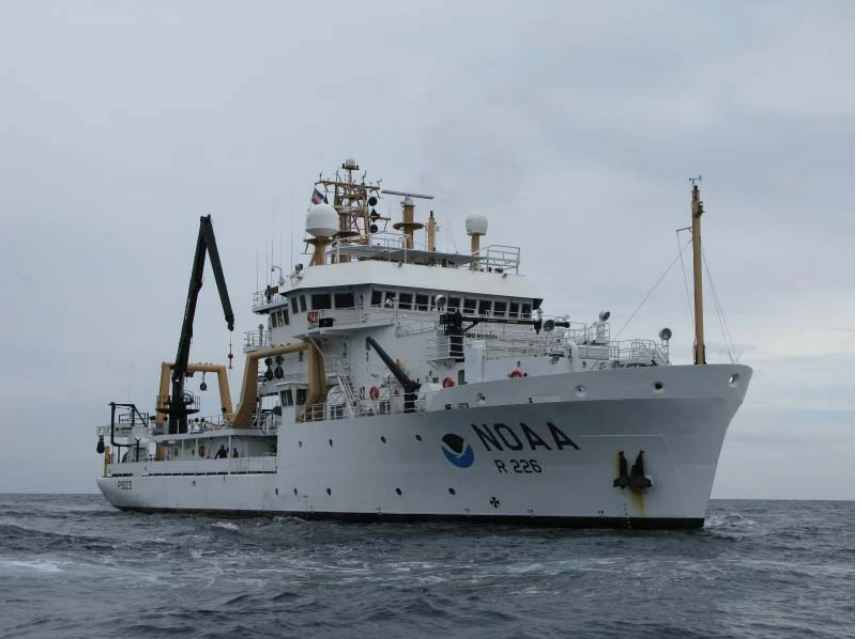
Table 1. Vessel and equipment

<p>NOAA Ship <i>Pisces</i></p>
Hull Number	R226
Builder	VT Halter Marine, Inc., Moss Point, MS
Length	63.8 m (209 ft)
Beam	15.0 m (49.2 ft)
Draft (centerboard retracted)	6.0 m (19.4 ft) Full load
Draft (centerboard extended)	9.05 m (29.7 ft)
Cruising Speed	14.5 knots (16.0 knots max)
Survey Speed	0 – 11 knots
Primary Echosounder	Simrad ME70
Sound Speed Equipment	Seabird CTD, Sippican XBT, SBE45, SBE21
Attitude and Positioning Equipment	Applanix POS MV V3, Leica MX420 DGPS

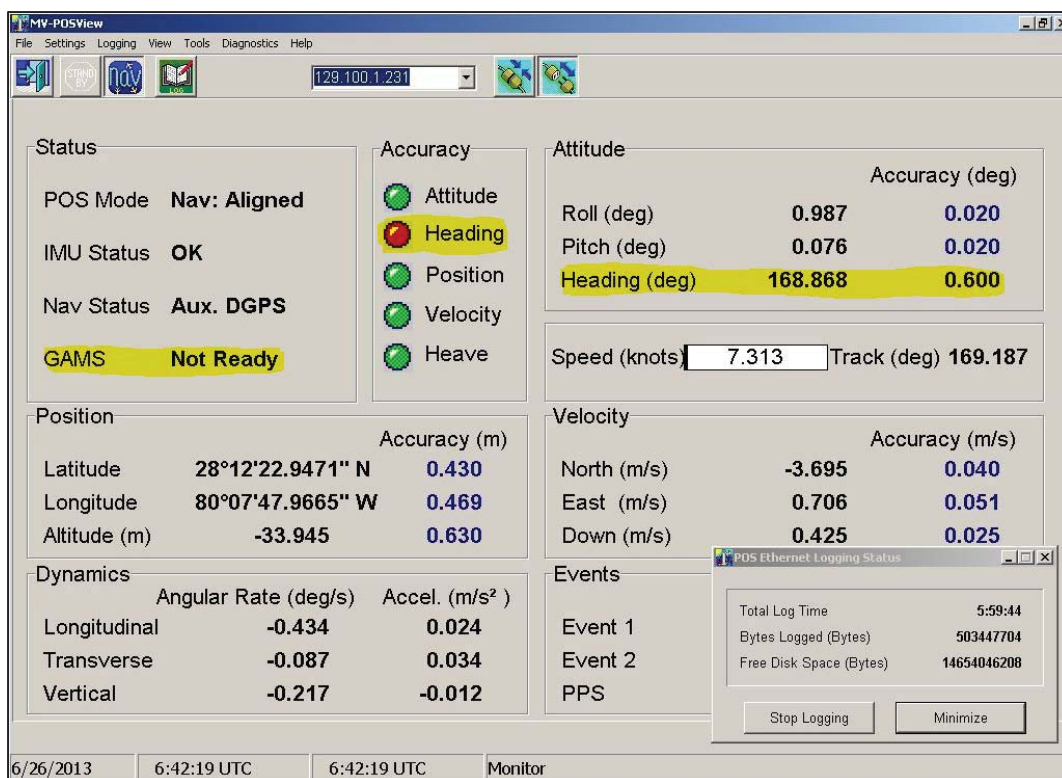
Figure 2. Degraded Heading Accuracy observed during survey data acquisition (highlighted)

The POS MV GPS Azimuth Measurement Subsystem (GAMS) provides heading aiding to the system. A successful GAMS calibration was not achieved during W00269. In addition, the heading accuracy was routinely degraded during survey operations (Figure 2).

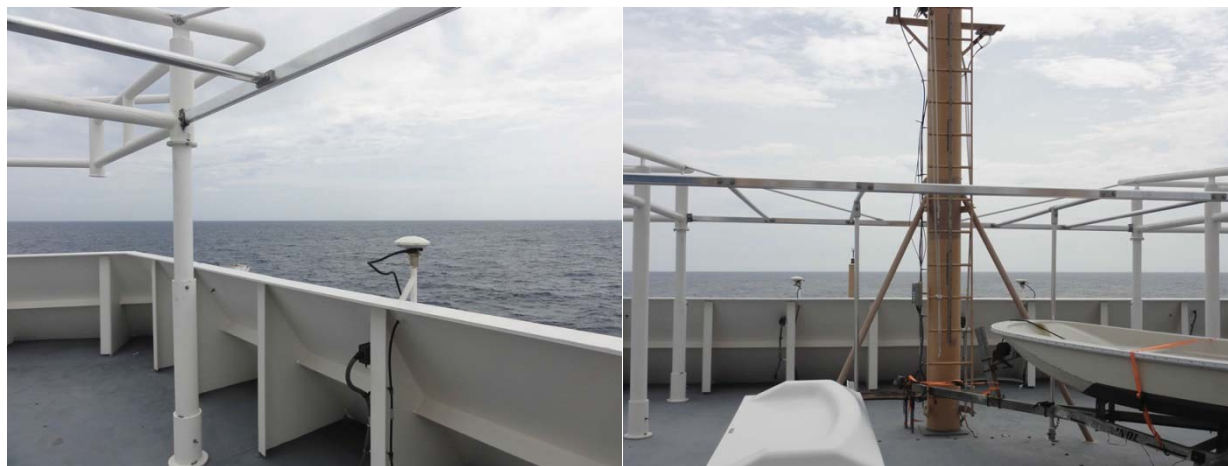
Figure 3. POS MV antenna position relative to ship superstructures.

The POS MV user's manual specifies that it is necessary for the antennas to have clear view of the sky from horizon to horizon, which currently is not the case on NOAA Ship *Pisces*. Interference from superstructures (see Figure 3) on the flying bridge of the ship could be the cause of the intermittent degraded heading accuracy as well as the inability for the system to

calibrate the GAMS. It was strongly recommended to the ship to have the POS MV antennas moved higher and away from other structures such that the requirements listed in the POS MV user manual are adhered to.

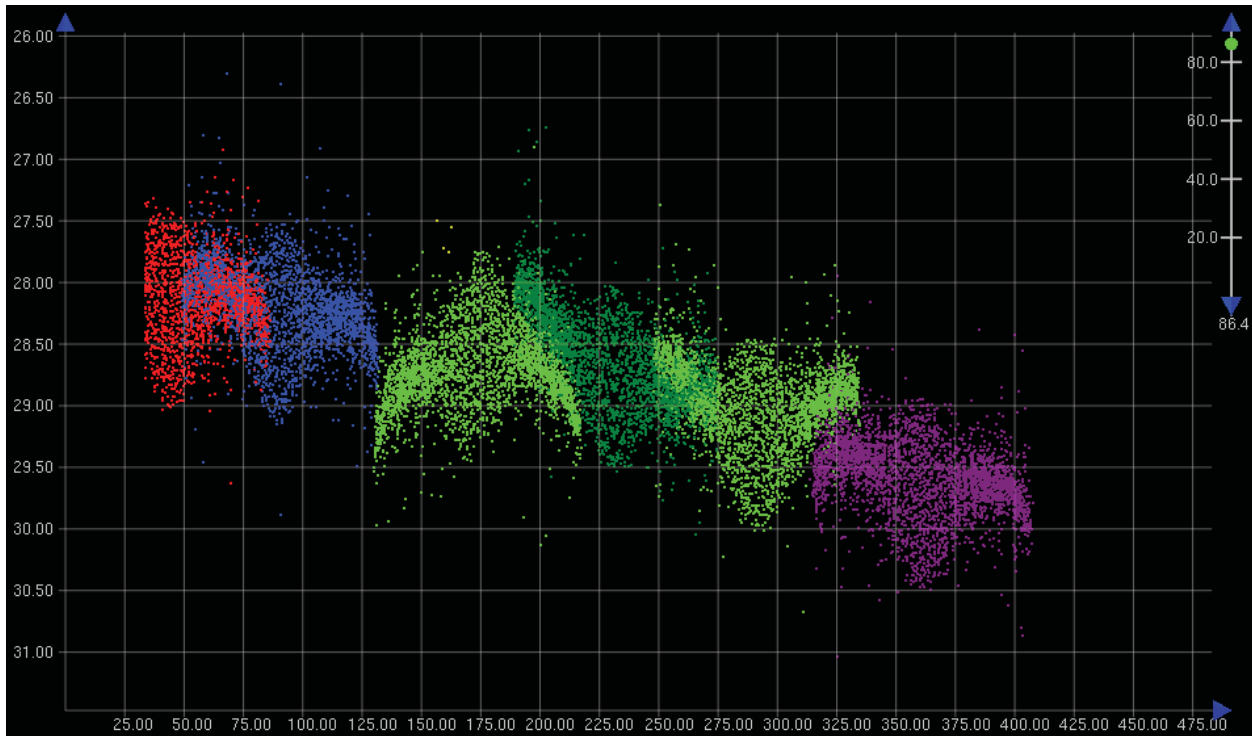
Figure 6. Lines of across-track vertically-exaggerated multibeam swaths, acquired while varying the “manual” transducer face environment sound speed value: red, blue, and purple lines used 1530 m/s, light green (left) used 1540 m/s; dark green and light green (right) used 1519 m/s. The significant effect to the multibeam swaths observed above served as confirmation to the users that the real-time sound speed was not being applied, and instead the ME70 was defaulting to that manual value.

Adjusting the static value significantly affected data quality, as shown in Figure 6, even though the real-time value was observed streaming into the system. There was speculation that the ME70 onboard NOAA Ship *Pisces* has never been utilizing a real-time sound speed for beamforming, and has always unintentionally defaulted to this static value.

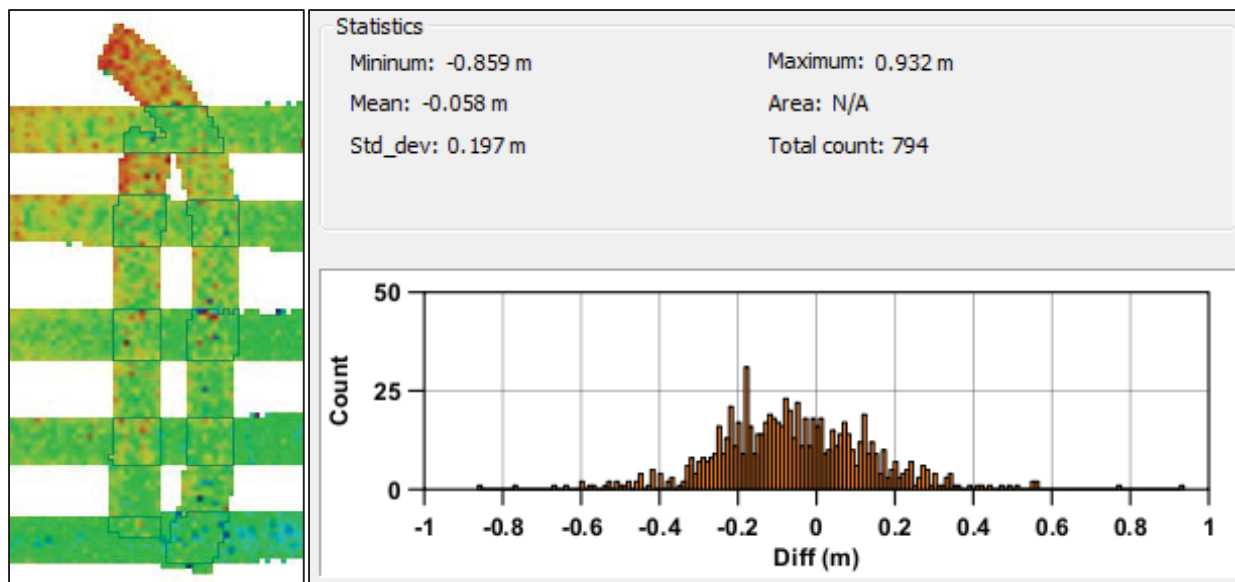
Figure 10. Bathymetric grid depicting the intersection of mainscheme and crossline bathymetry used in this analysis (left), and the resulting statistics of the comparison (right).

Crosslines were not a requirement for the support to SEFIS, and a greater overall coverage was of higher priority than data redundancy checks. However, there was one instance in which ship logistics allowed for acquisition of two short crosslines over mainscheme acquired 9-13 hours earlier (see Figure 10, left side). Two bathymetric grids were created, one to encompass the mainscheme, and another the crosslines. Prior to their creation, the sounding data were filtered to retain data 30° to either side of nadir, such that the effect of refraction in the crossline analysis was removed, and any remaining system biases might be revealed. The filtered grids were differenced, and the mean difference found to be $0.058\text{m} \pm 0.197$, as shown on the right side of Figure 10.

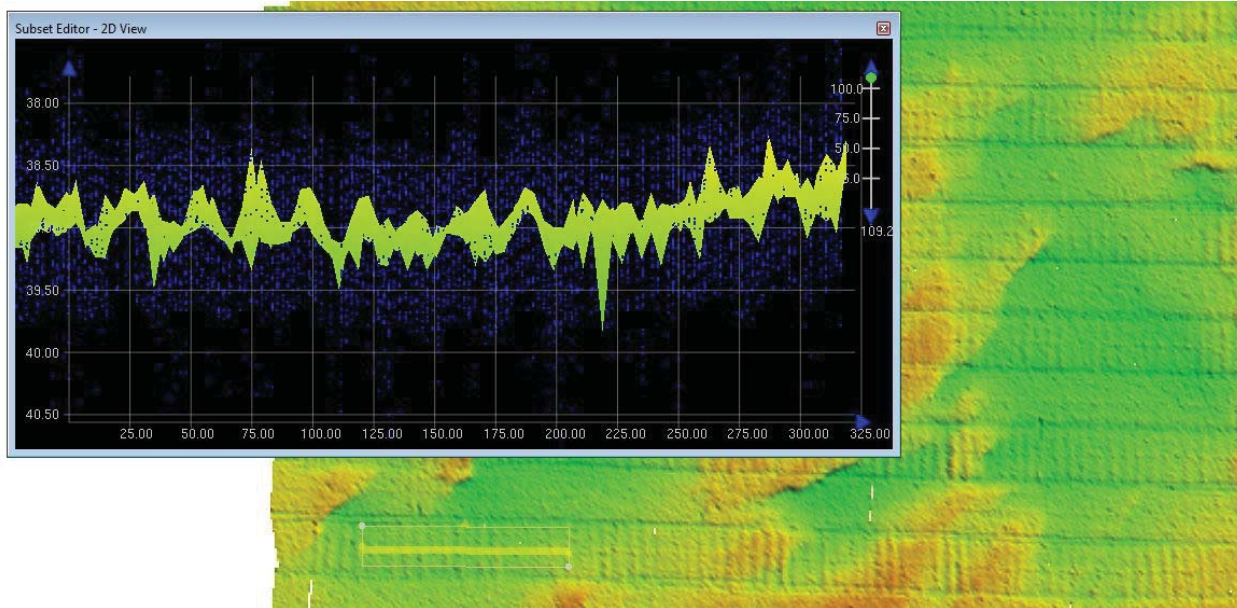
Figure 15. The heave artifact observed in Box 49 is up to 0.5m in magnitude and only evident in the 91° heading.

ship's heading, which is why the artifact is generally only observed on every other line in the grids. Application of True Heave in post-processing did not alleviate the artifact.

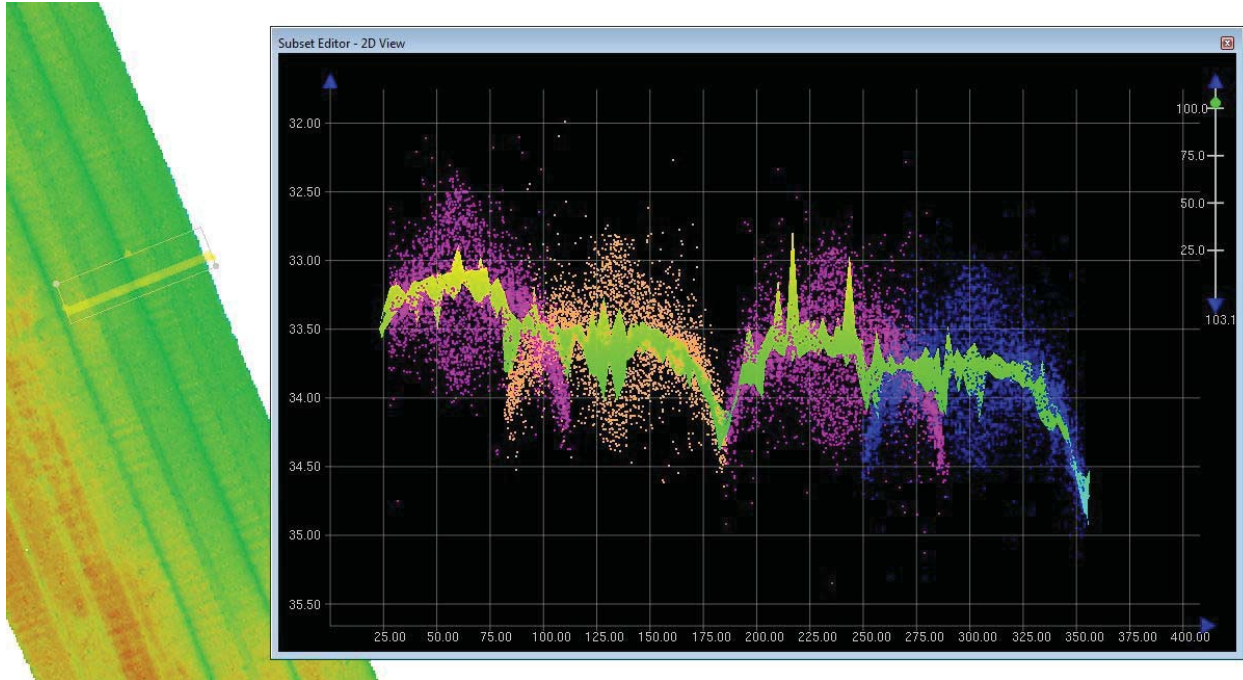
Figure 16. An example of refraction observed during the first leg of W00269 (prior to fixing the real-time sound speed input), and the resulting gridded bathymetry. Note that when the outer beams have sufficient overlap, the effect to the grid is minimized; however, when the overlap is not there, artificial trenches were often observed in the grid, up to 1m in magnitude.

During the first leg, it was believed that the refraction was due an inaccurate sound speed value being applied at the transducer face, because the real-time feed was not updating (see Section B1d). An example of the refraction observed during the first leg, and how it affects the gridded bathymetry, is shown in Figure 16.

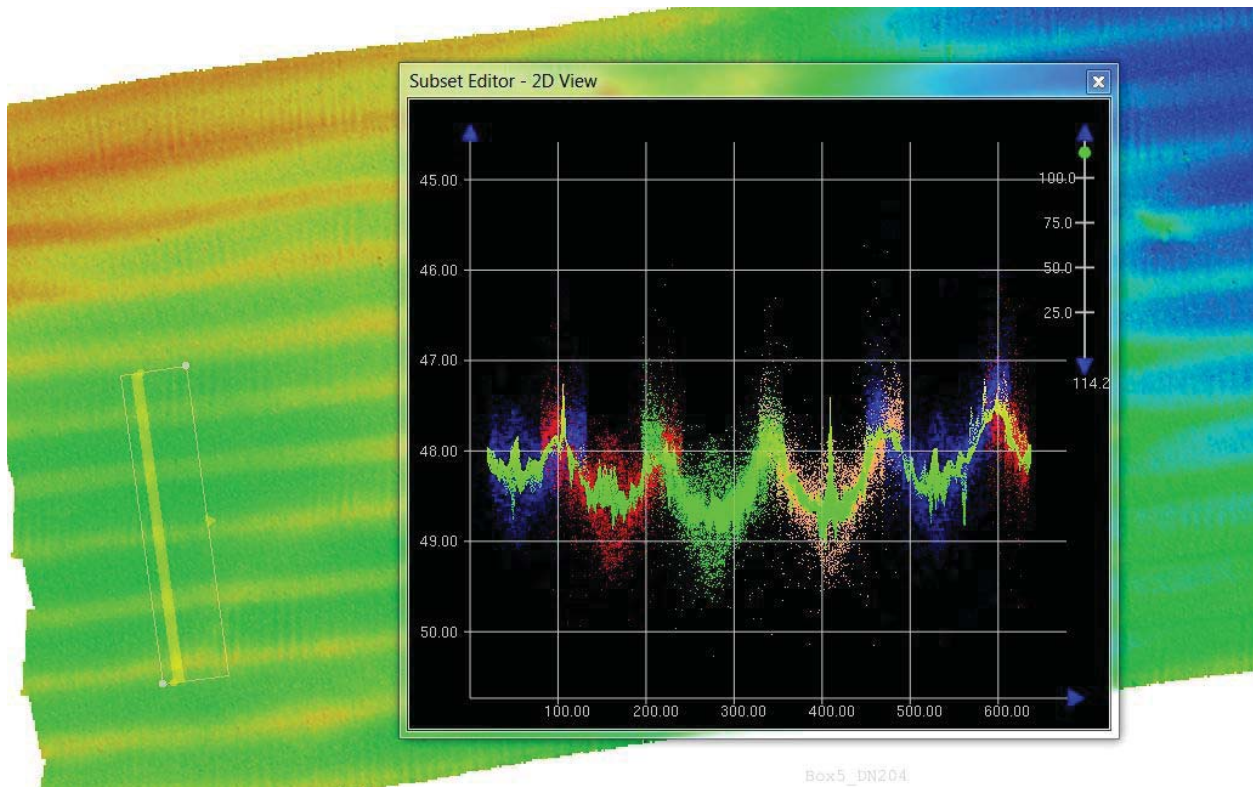
Figure 17. An example of refraction observed during the second leg of W00269 (after having fixed the real-time sound speed input), and the resulting gridded bathymetry. The refraction “smiles” are up to 1m in magnitude.

The real-time sound speed input into the ME70 was restored at the end of the first leg, and the resulting effects to the data were significant. The “frowning” generally observed (Figure 16) prior to the fix were not flattened as hoped; instead, a refraction “smile” became the predominant observation (Figure 17). Effectively, the direction of the refraction was reversed, but the magnitude of the error remained approximately the same.

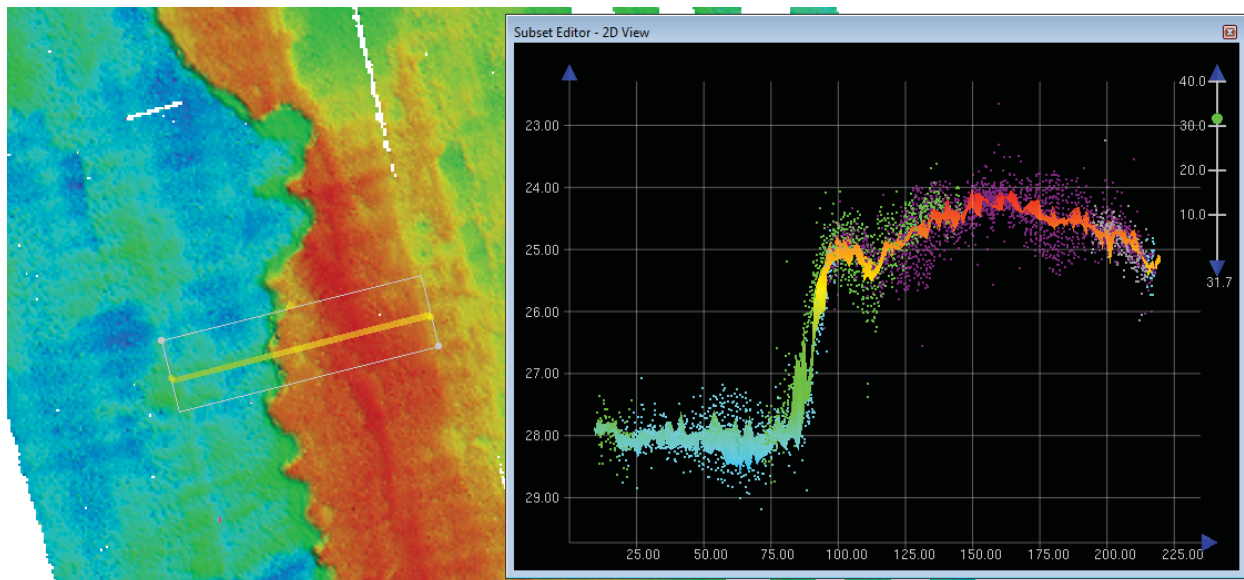
Figure 19. The lines acquired over the areas of dynamic relief in Box 106 were left unfiltered as to preserve the shoalest depths. Shown here is the bathymetric grid in plan view, with a 2D subset of the sounding data and surface.

On some days, the refraction error was not as pronounced, and within allowable tolerance levels. However, the filtering was still performed regardless, such that all the data fell into the same processing pipeline in preparation for submission to OCS. The only exception was portions of Box 106, acquired on 6/25/2013. The outer beams of the adjacent swaths aligned well, and of greatest importance was preserving the shoalest depths of the dynamic seafloor in this region. For those lines that acquired data over these formations, the data were left unfiltered, as shown in Figure 19.

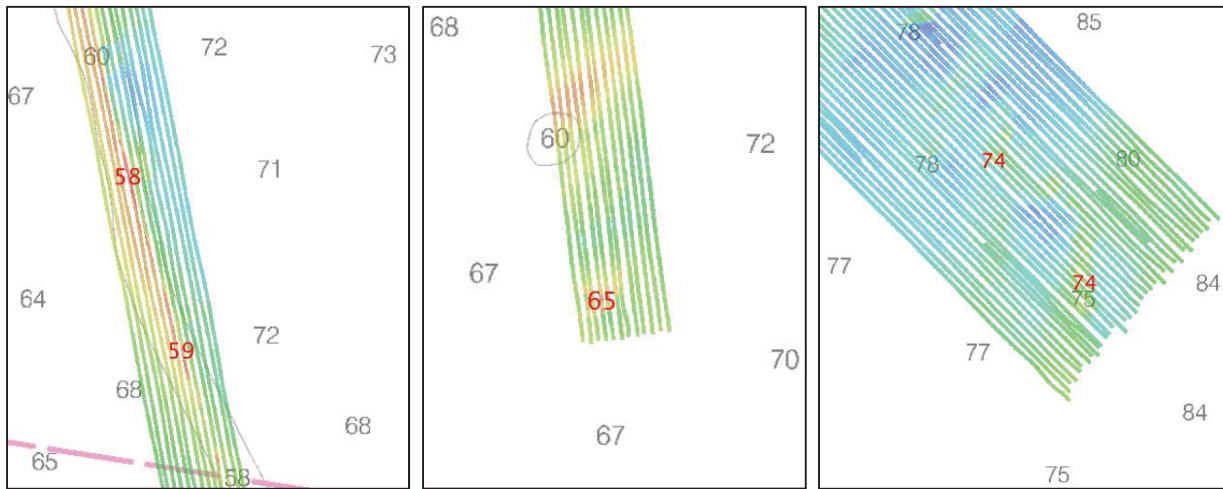
Figure 32. Filtered bathymetry and recommended soundings (red) from Box 108 (left), Box 97 (middle), and Box 92 (right). Charted soundings (grey) from Chart 11484. All soundings are in feet.

Using this methodology, a total of 18 soundings were identified as candidates to improve the chart, and are recommended to be added in a limited chart update. The soundings, and their relation to the currently charted soundings, are shown in Figures 30-33, and are included in the survey submission in a CARIS HOB file.

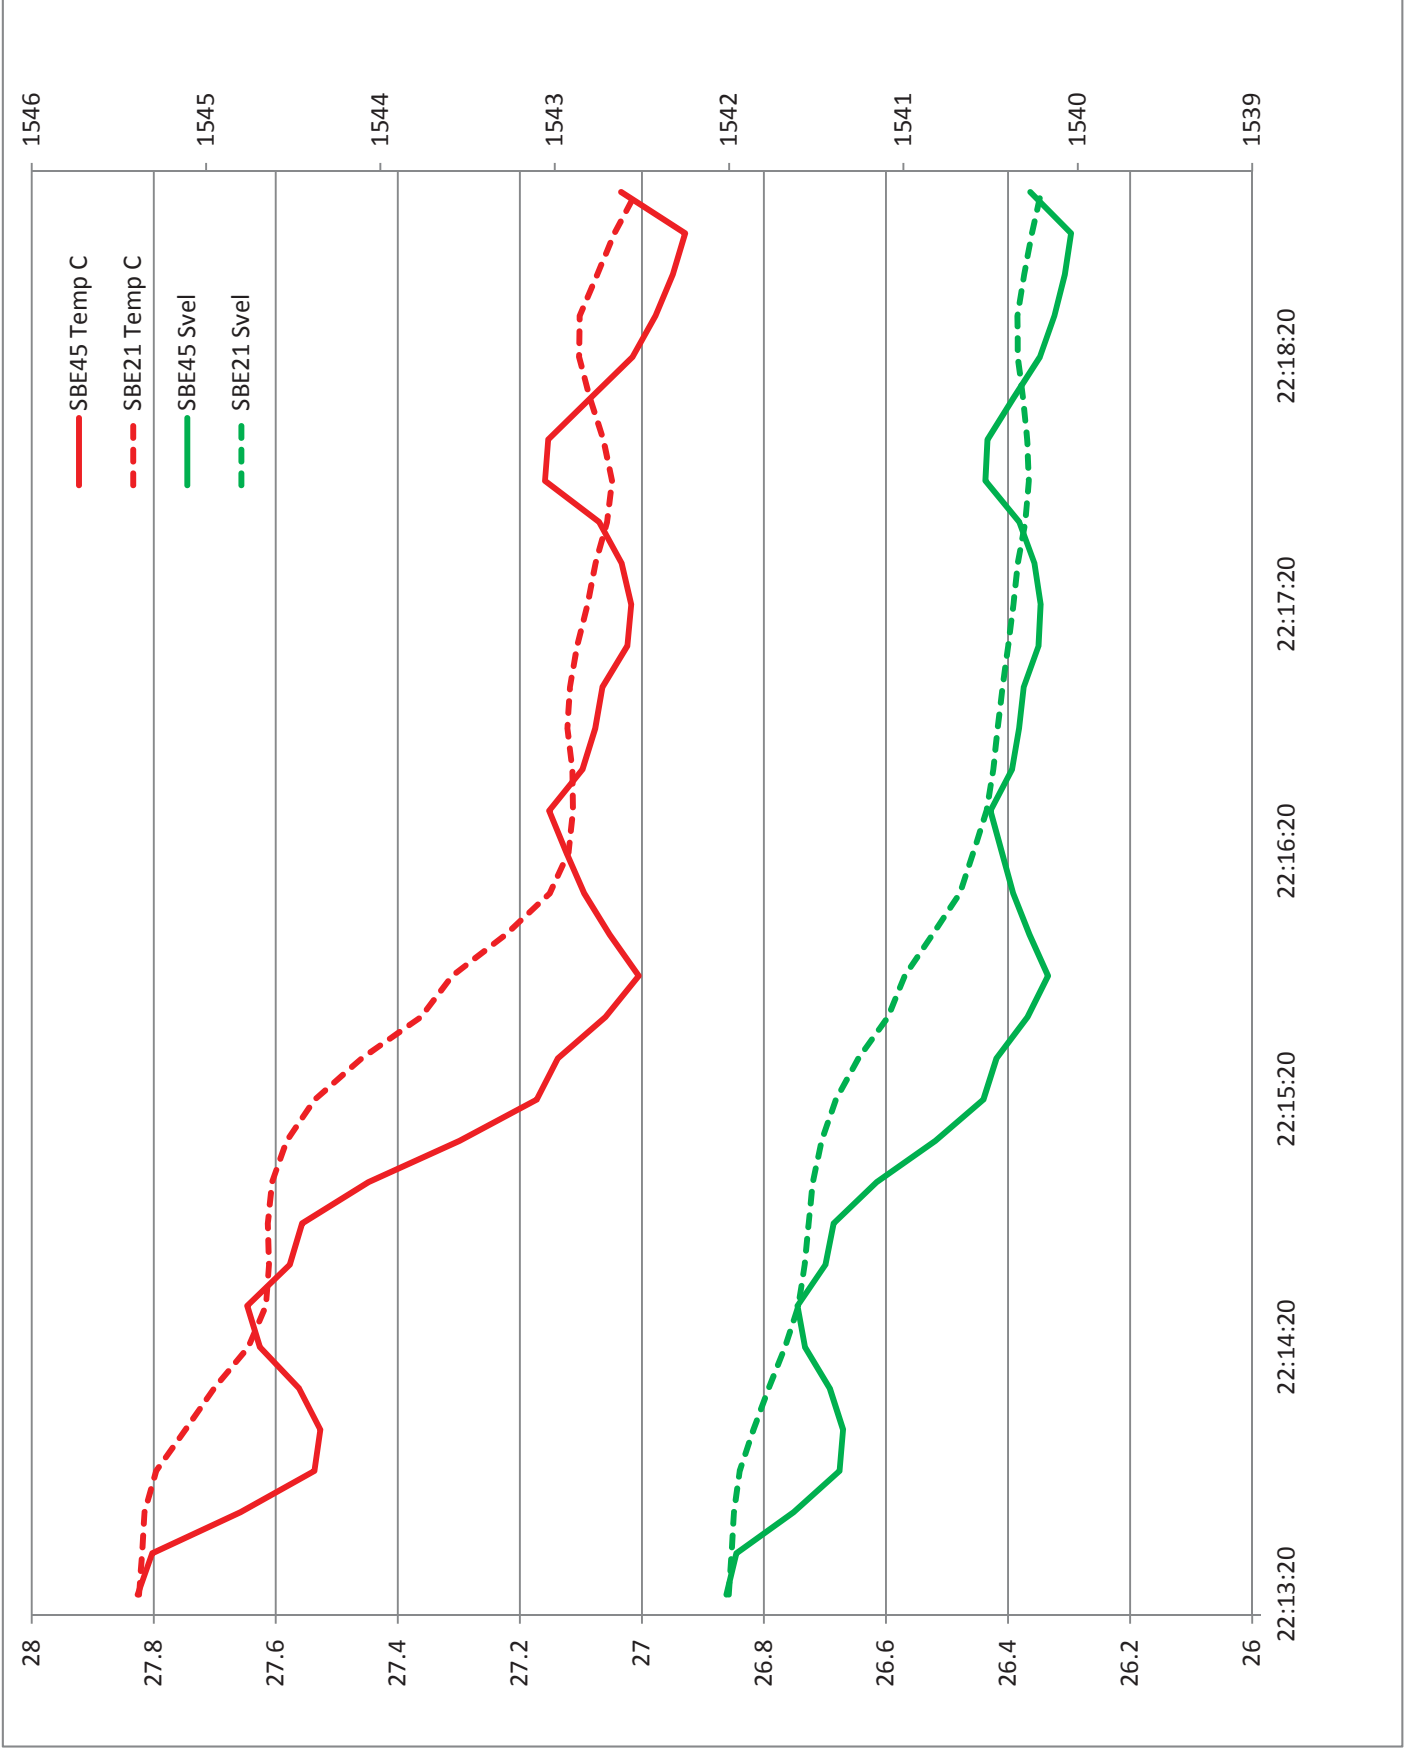
Pisces TSG (SBE45 and SBE21) Flow Experiment. June 24, 2013

- SBE45 Temp C
- - - SBE21 Temp C
- SBE45 Svel
- - - SBE21 Svel

- e. Now that SBE45 data is going into SCS, direct comparison of both the SBE21 and SBE45 data to CTD data can easily be performed to determine/confirm which TSG is providing the most accurate Sound Velocity data (currently without a SBE38). I would recommend having both flows to the SBE21 ON; however, further monitoring for backflow effects (water going from SBE21 -> SBE45 -> Turner Fluorometer) needs to be done, and actual instrument specific flow-rates need to be measured to ensure the SBE45 and Fluorometer are not under too much water pressure. Eventually, the entire flow/drain system for the underway Scientific Seawater Systems needs to be reconfigured.

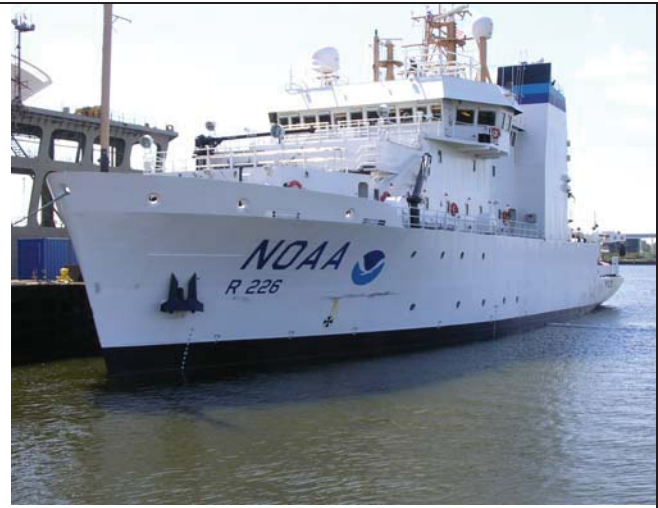
Lever Arms: (Units are in Meters)

Point	X Axis	Y Axis	Z Axis	Notes
Reference point	0.0	0.0	0.0	Granite block
Ref to IMU	-0.400	-1.341	-4.434	
Ref to Primary GPS	-4.830	1.356	-18.870	Starboard antenna
Ref to Secondary GPS	-4.842	-1.566	-18.870	Port antenna
Ref to AUX GPS	-17.250	-1.675	-26.194	Not surveyed-Estimated
Ref to Vessel	0.0	0.0	0.0	POS NMEA, message point of validity at target on IMU.
IMU frame w.r.t Ref frame	-0.662	-0.548	0.0	Rotation of IMU frame in comparison to ships frame.
Ref to Heave (COR)	0.0	0.0	0.0	Center of gravity (rotation) Information not available.
Ref to Sensor 1	0.0	0.0	0.0	Point of validity of HPR +Posn-Valid at IMU
Ref to Sensor 2	0.0	0.0	0.0	Point of validity-HPR +Posn-Valid at IMU

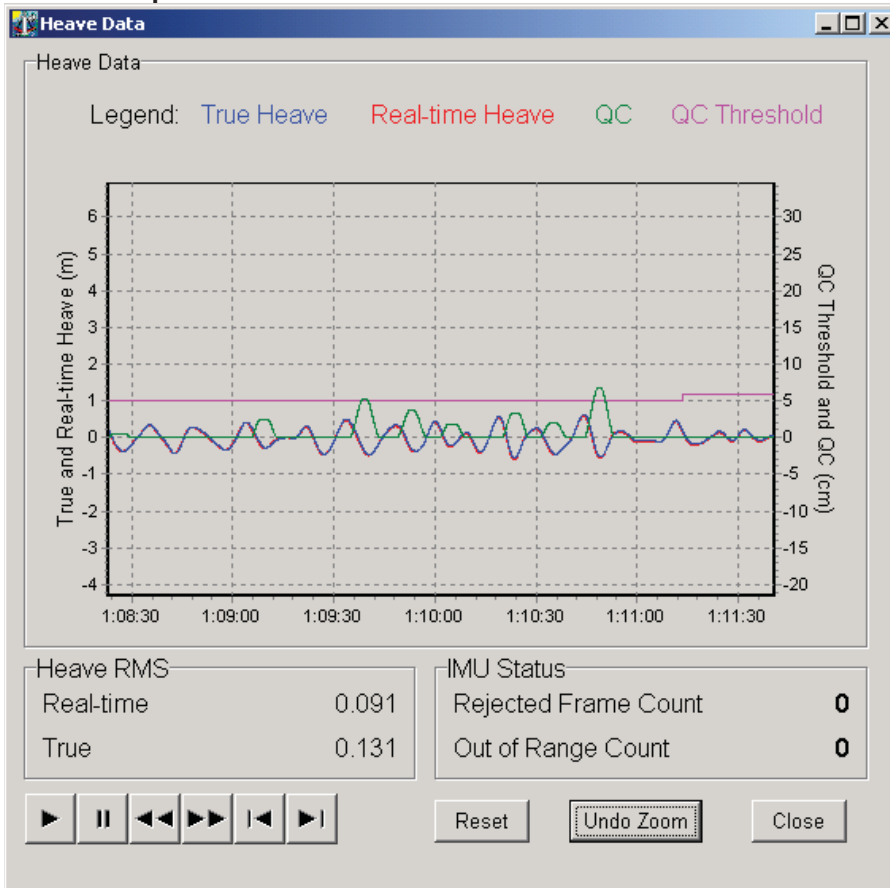
The heave plot above shows the relationship between the **Real-time (RT)** heave and the **True (or delayed TH)** heave measurements. The **green line** relates to quality control (QC) and represents the difference between the RT and TH values. When the delta between the RT and TH exceeds 5cm or 5% of total heave (**pink line**) then the radio light on the main controller screen will turn from green to red but does not affect the real-time heave data being collected. Quite often this occurs after the vessel makes a turn or an abrupt change in speed and is not necessarily cause for alarm. The heave filter has a 105 second buffer so the event which may have caused the impulse happened in the past. A red light merely calls the users attention to the difference and may also suggest that the filter settings need to be refined if the QC value is continually out of bounds.

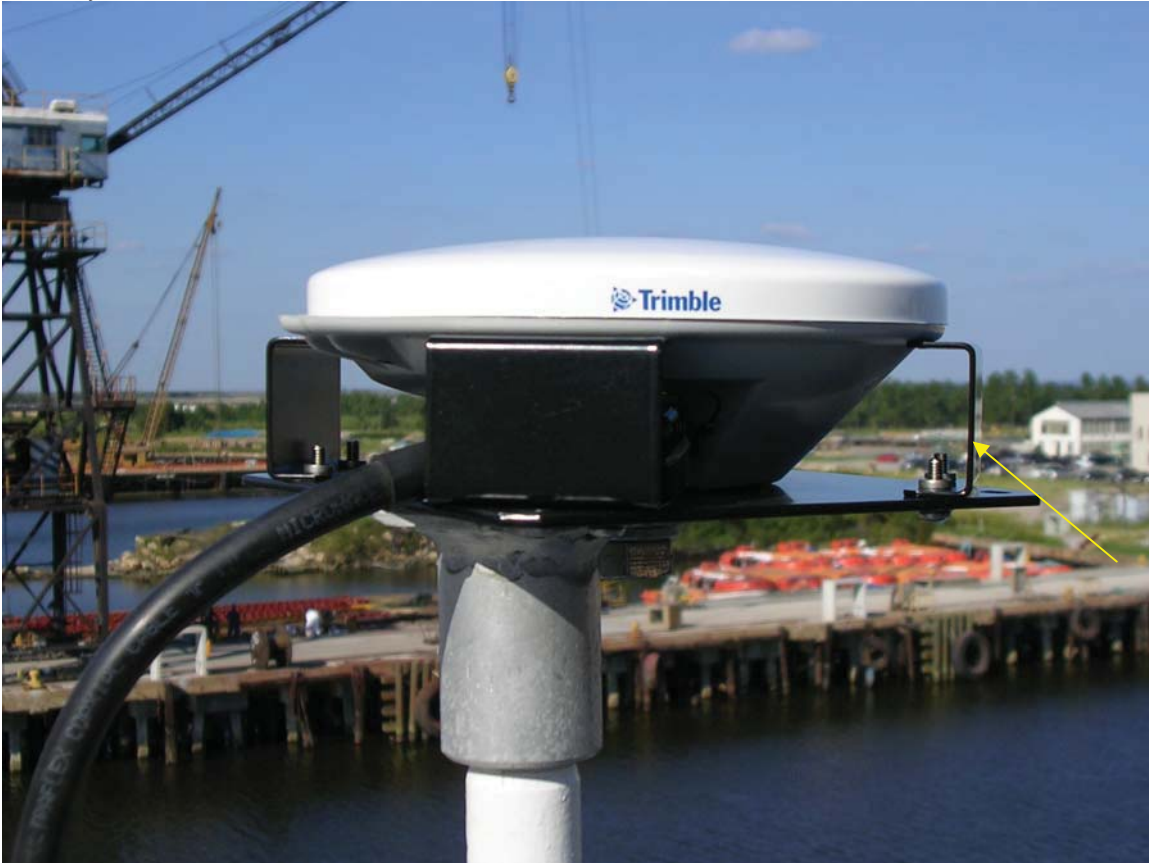
Antenna mounting: In an effort to make the antenna mount bit more rigid, Trimble have developed and specified that the add-on support pictured below should be used in all high vibration environments. Whether this will improve the longevity of the antenna remains to be seen but certainly can't hurt.
