**DESCRIPTIVE REPORT**

*Type of Survey*      **Hydrographic Multibeam Survey**  
*Project No.*         **OSD-UNH-10**  
*Registry No.*        **W00274**

*State*                 **Maine/New Hampshire**  
*General Locality*   **Isle of Shoals**  
*Sub-locality*        **Smuttynose Island to Duck Island**

**UNH Summer Hydrographic Field Course 2010**

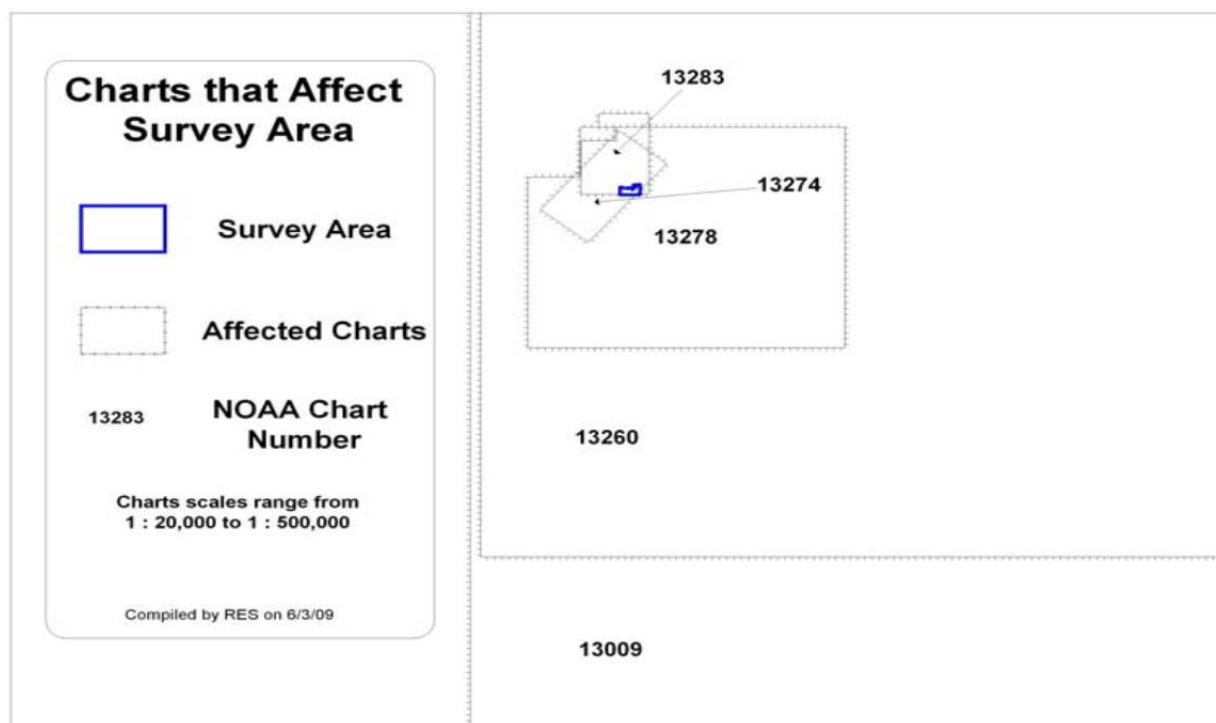
Figure 2 - Graphic of potentially affected charts in the vicinity of the Isle of Shoals

Table 5 lists the raster and corresponding electronic charts that may be affected by the Duck Island multibeam sonar survey. The charts range in scale from 1:20,000 to 1:500,000 and Figure 2 indicates the geographical coverage of the affected charts in relation to the survey limits.

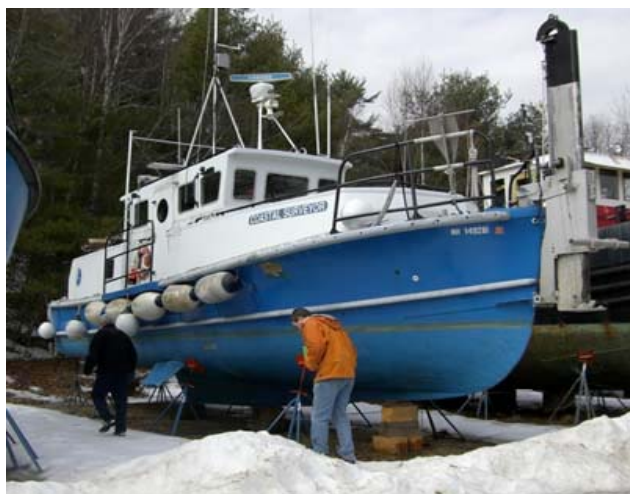
Figure 3 - RV Coastal Surveyor with bow ram for multibeam installation

The R/V *Coastal Surveyor* (Figure 3 and Figure 4) was used for multibeam data acquisition. The vessel is 40ft. (12.19m) in length, 12ft. (3.66m) in beam, has a draft of 5.5ft. (1.8m) and is equipped with a mechanical ram affixed to the bow for sonar/ instrument mounting. Refer to Appendix IV (Vessel Description and Offsets) for complete specifications of the R/V Coastal Surveyor.

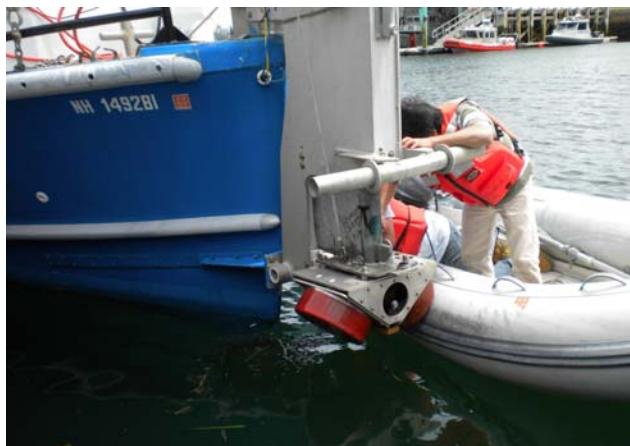
Figure 4 - EM3002 sonar heads mounted on the RV Coastal Surveyor

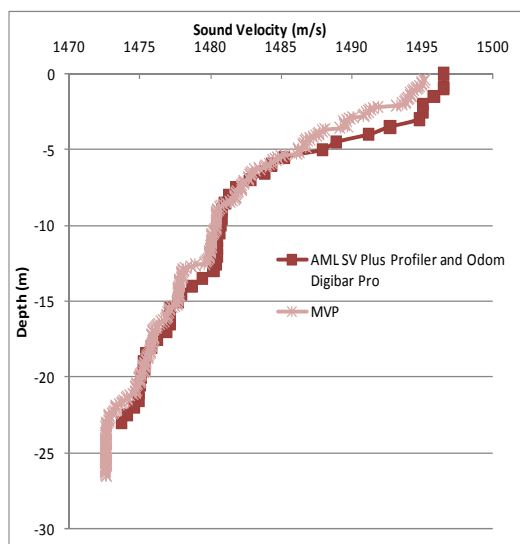
**Figure 11 – Comparison of the SVP acquired by the Odom Digibar Pro with that of the MVP30**

Figure 11 illustrates a comparison of the SVPs measured by the Odom Digibar Pro onboard the R/V *Coastal Surveyor* and the by MVP30 onboard the R/V *Cochecho*. Analysis of the two casts gives a shallow-water sound speed difference of less than 3m/s, while in deeper water the difference is negligible.
