**W00435**

**DESCRIPTIVE REPORT**

Sub-locality: St. Louis Bay

**Bay St Louis, MS  
New Marina and Bay Waveland Yacht Club**

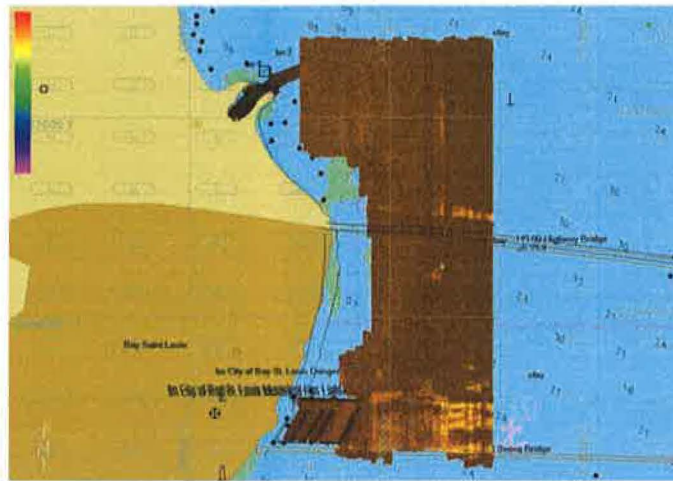
Figure 1 SSS Coverage

SSS coverage for areas 1, 2, and 3 is shown in figure 1. MBES coverage with the Odom MB1 for areas 1, 2, and 3 are shown in figure 2 and the coverage with the EdgeTech 4600 can be seen in figure 3.

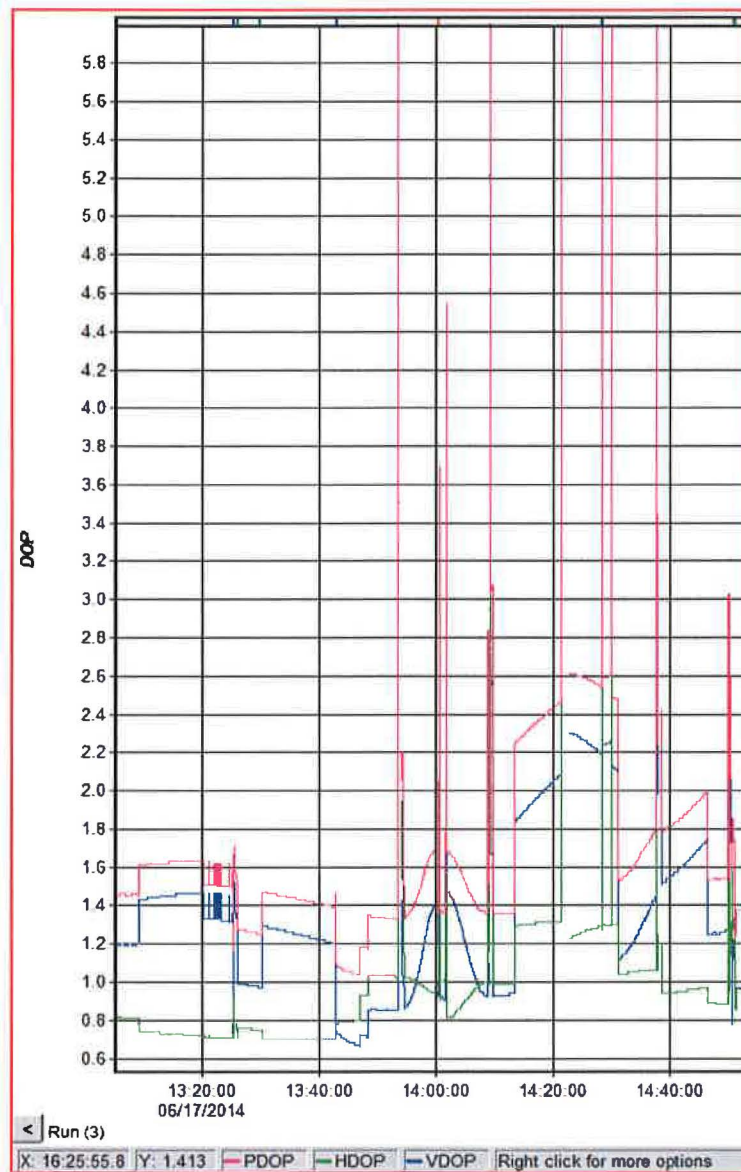
Figure 6 HDOP and VDOP value between the time period 1347-1444 UTC on (17 Jun 14)

QC reports were generated after cleaning all the surveyed lines to analyze the quality of the data. In the QC report, it was revealed that on 17 June 14 (Julian day 168) 5-product lines failed to meet the survey specification requirement (Order 1a). Further investigation revealed from Grafnav software (Used to obtain PPK solution) that though value of HDOP (horizontal Dilution of Precision) met the survey requirement but the PDOP (Position Dilution of Precision) for both Trimble and CNAV exceed the limit thereby failed to meet the required survey standard of IHO order IA for the period 1347-1444 UTC on (17 Jun 14). Following figure shows the HDOP and PDOP values for the mentioned time:

Hence, for those five lines (Julian day 168 Hypack line no 288\_1347, 289\_1401, 290\_1415, 291\_1429 and 292\_144) traditional tide was applied to compare the quality of the data. This time quality of the data improved remarkably and met the survey specification (order 1a). The QC report generated for both ERS and traditional survey lines to compare their result are shown in table 7 and 8:

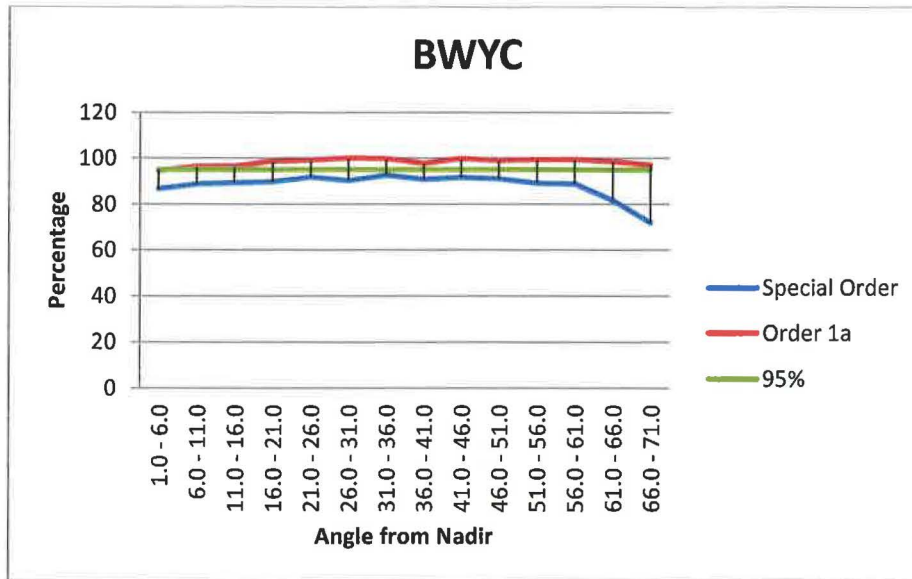
Figure 7 BWYC QC Report

BWYC: IHO Order 1a was accomplished

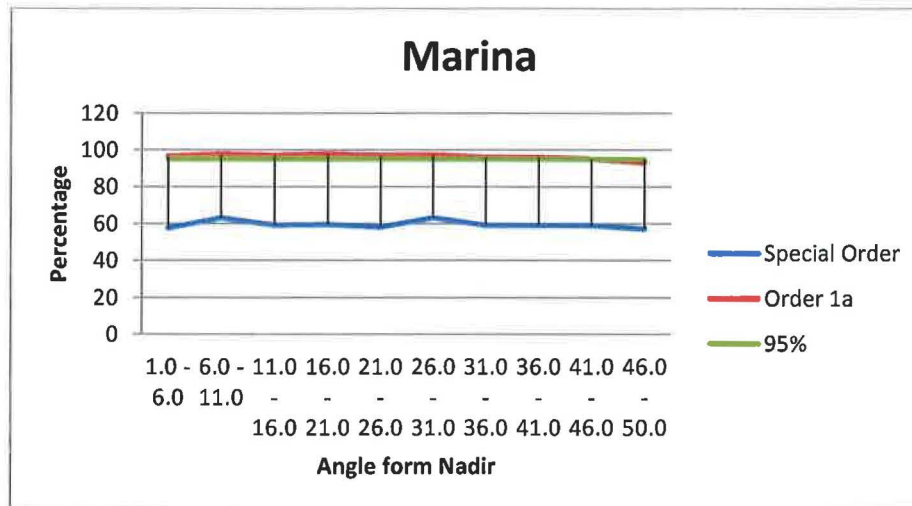
Figure 8 Marina QC Report

Marina: IHO Order 1a was accomplished after applying a 45 degree filter from nadir

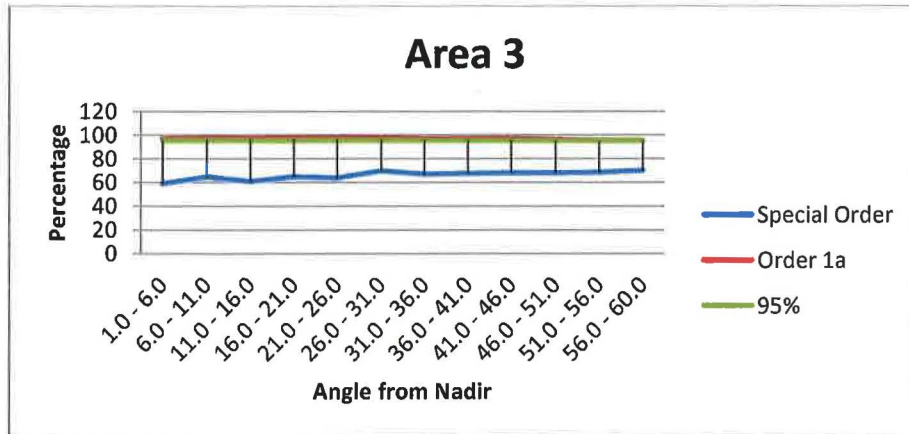
Figure 9 Area 3

Area3: IHO Order 1a was accomplished after applying a 40 degree filter from nadir

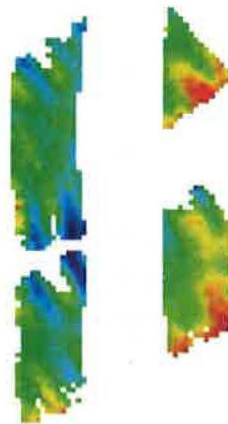
Figure 13 Difference Surface Between BWYC and Area 3

Two junctions were identified using the EdgeTech data. The first is between the marina and area 3 and the second is between the yacht club and area 3. A differencing surface was created between two depth surfaces, either the yacht club or marina and area 3.

The mean vertical difference at each location was most likely caused by processing with different navigation sources. Each area was surveyed on different days. Due to configuration errors the yacht club and marina data were processed using navigation data from different GNSS units. The Trimble GNSS was the primary source of navigation data for the yacht club and marina, while the CNAV was the primary source of navigation data for area 3. In addition, the GPS collected in area 3 in the vicinity of the junction was degraded as explained in B.2.2.

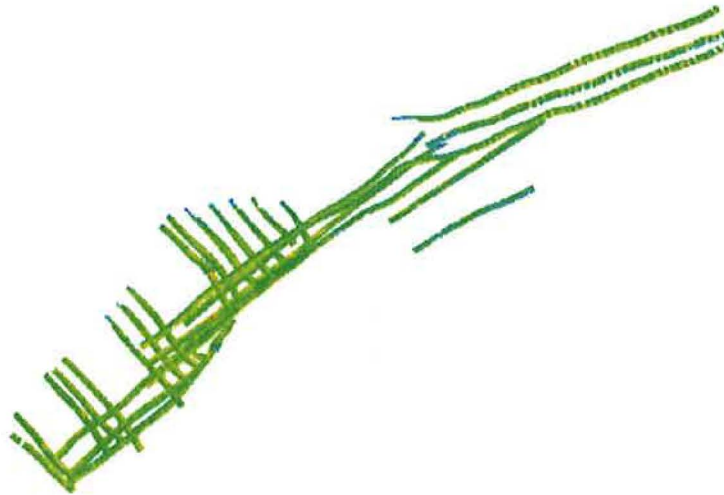
Figure 15 EdgeTech vs. MB1 BWYC Difference

The two sonars were used simultaneously in each area of the survey. Unfortunately due to delays in processing the EdgeTech data, the marina and area 3 data was not cleaned to the extent of the yacht club. The below comparison is the difference surface between EdgeTech BWYC and MB1 BWYC.

The surface was created with bin sizes of 1m. The green color indicates the area around the mean depth difference, -0.37m, at standard deviation of 0.07m. The bias between the two surfaces is theorized to be caused by the configuration settings of the PDBS. According to QC reports, crossline and surface, generated by the QC report feature in Caris HIPS both surfaces met both IHO order 1a and Special Order surveys. The actual difference is less than 0.2% as indicated in the reports. The PDBS, may be more susceptible to human error in configuration, but it offered a 70 degree swath from nadir, where MB1 MBES was limited to 45 degrees from nadir.

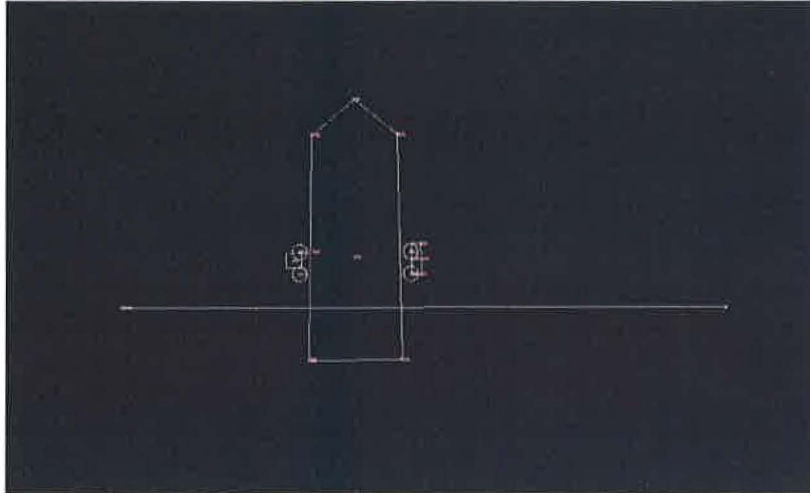
Figure 16 AutoCad VCS

Forward and reverse measurements were taken for each point and the measurements were adjusted using a least-squares 3 dimensional adjustment. The adjusted observation points were plotted in AutoCAD Civil 3D. All of the vessel observations were moved in the AutoCAD program so that the reference point (RP), which is also the IMU, becomes (0, 0, 0). The vessel was then rotated so that the X and Y axis are orientated properly in the X, Y, and Z directions.

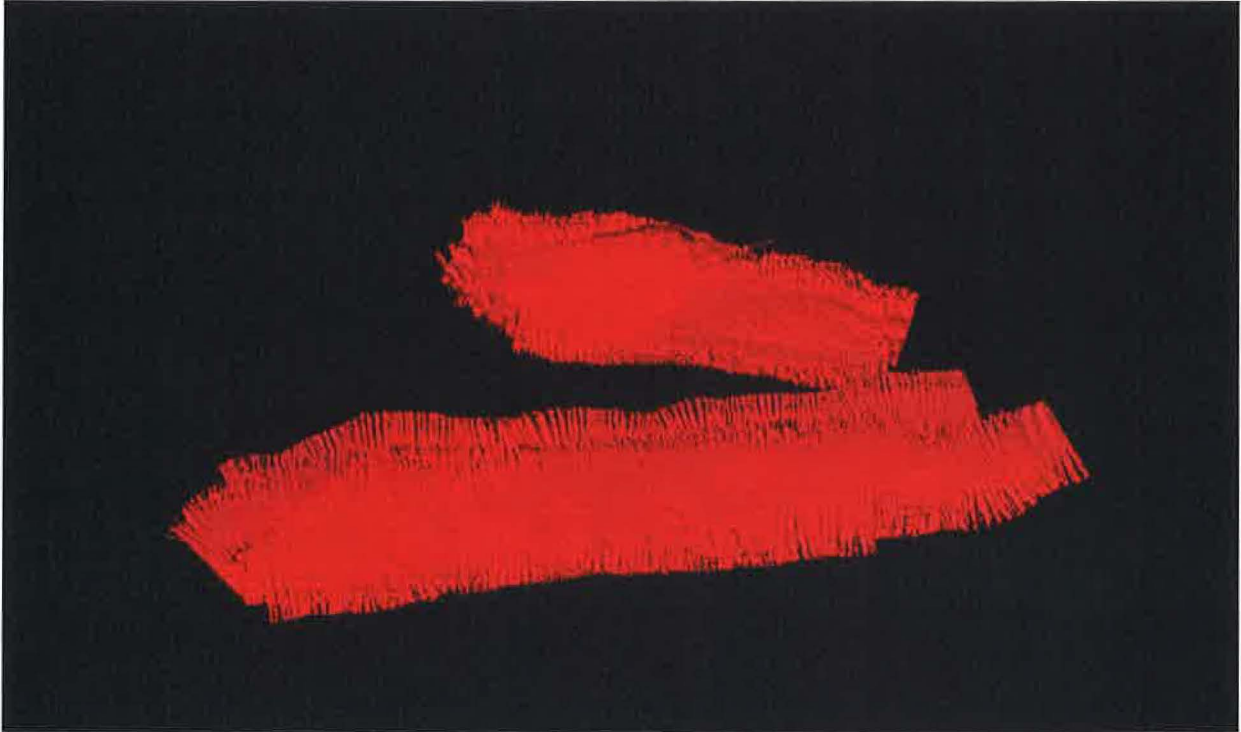
Figure 18 EdgeTech Patch Test Lines

Multiple patch test calibrations line sets were conducted but because of non-ideal conditions and lack of targets, the one conducted on June 18, 2014, (JD 169) in front of Pass Christian was used. This set of

lines was determined to be the best because of a slope in the area however, actual targets on the sea floor were lacking. Calibration values were obtained via the Caris calibration tool. The calibration values were applied to the Caris HIPS vessel file for data collected on June 8-19, 2014 (Julian days 159-170). Roll lines from JD 163 were used. Patch test lines and descriptions can be seen in table 14 and calibration values are shown in table 15.

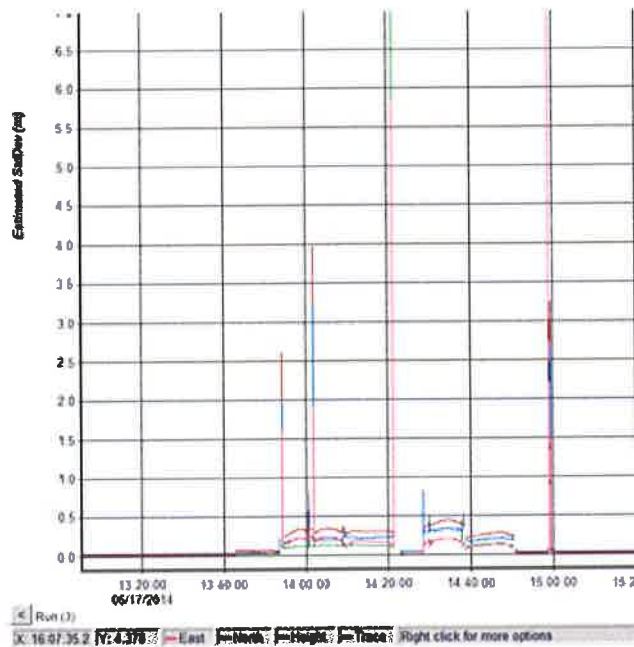
Figure 21 Standard Deviation during bad GPS period

Figure 28 Shows the Standard deviation obtained from the PPK solution for that particular time (13:47:34 to 14:44:24 on Jd 168\_14)

This figure shows that the horizontal standard deviation for that particular time was generally lower than 0.5m. Since the THU requirement for the survey ranged from 5.02 to 5.21 m, it was decided to use the horizontal GNSS data after cleaning “spikes” in the Navigation Editor of CARIS. The horizontal standard deviation was 0.194m before cleaning of the data.

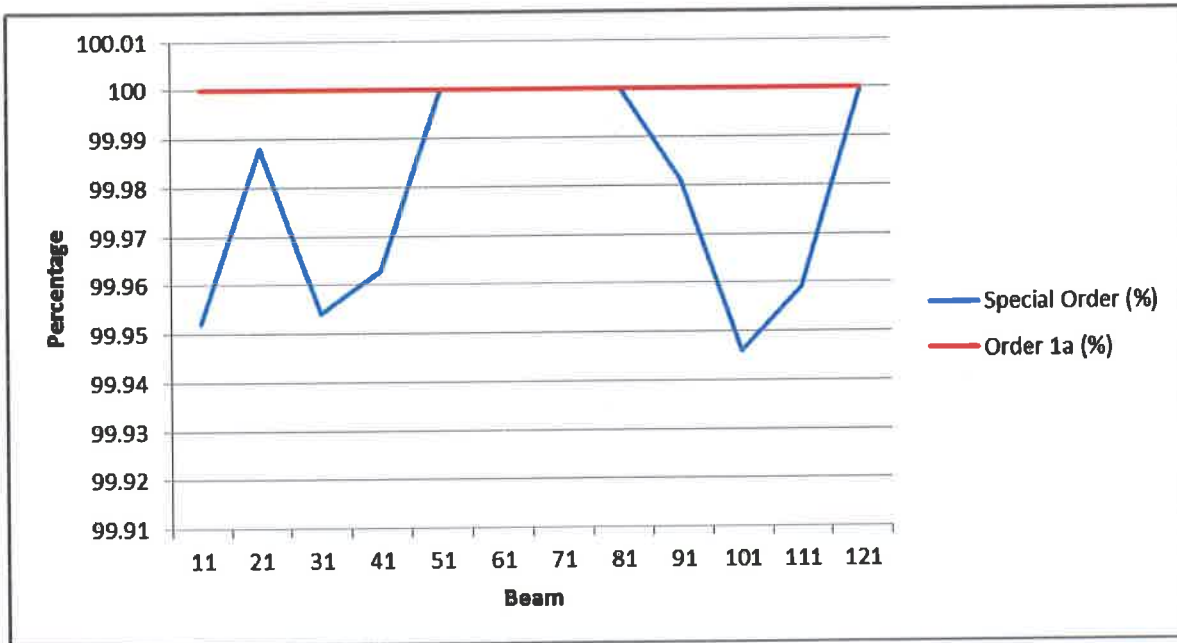
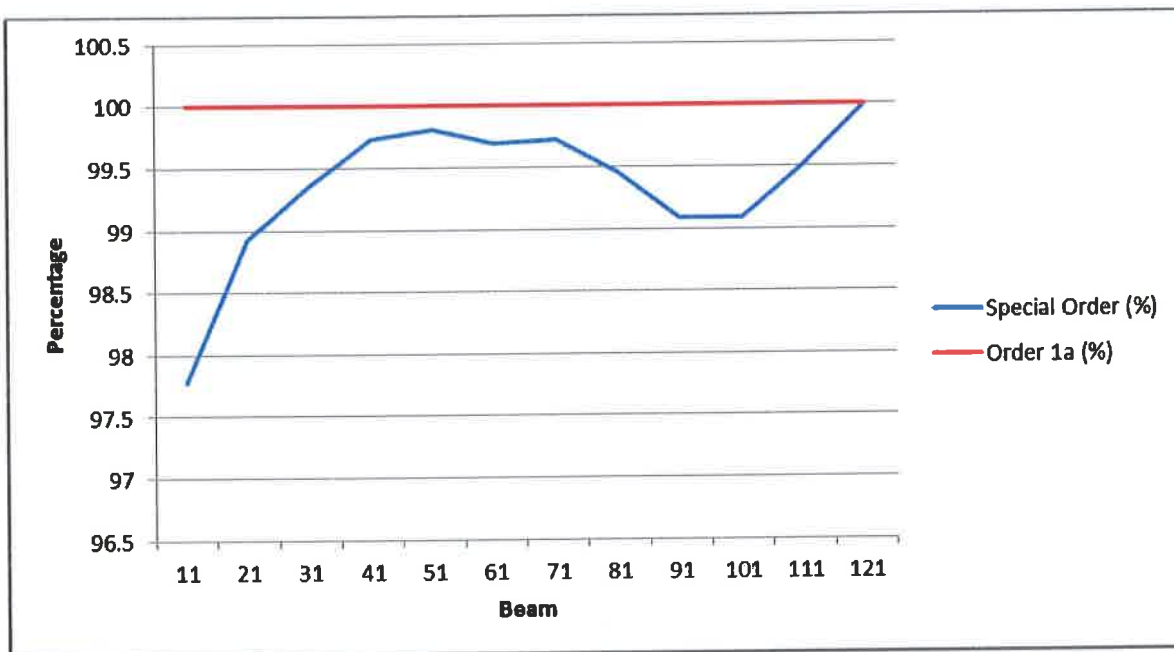
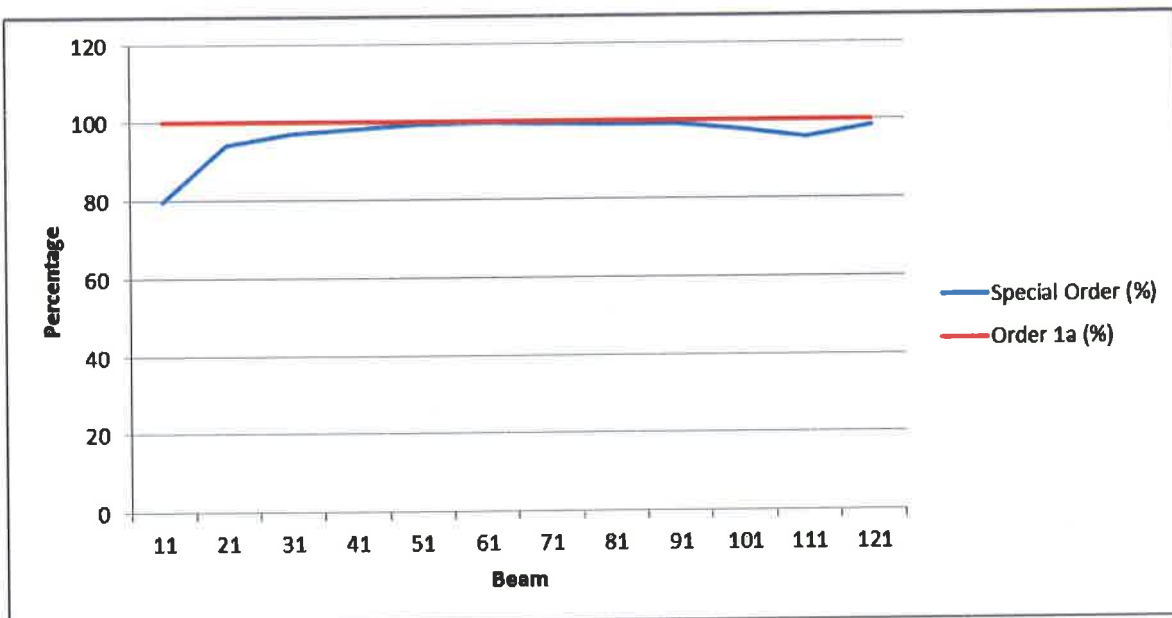
The results of the cross check lines within the 3 areas are shown below.

It can be seen that all the lines in the 3 areas meet IHO Order 1A. Table 31 Gives a summary of the result.

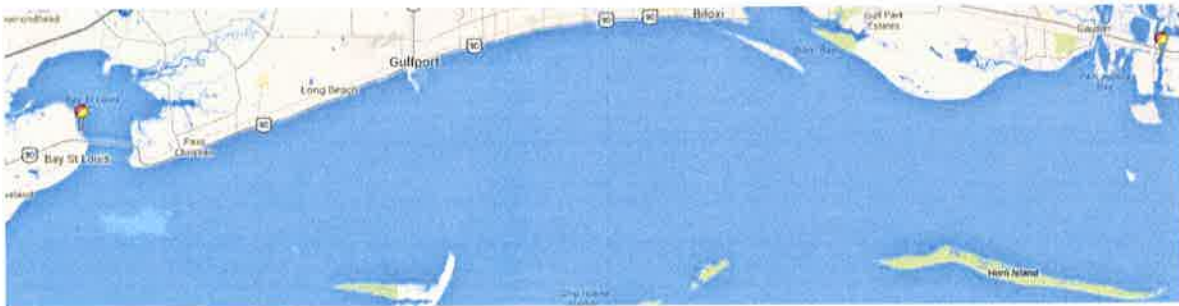
Figure 27 Showing the Span Between the Bay St. Louis Station and the Pascagoula Station.

NOAA requires tide zone delineation for phase differences greater than 18 minutes and amplitude differences greater than 6 cm between tidal stations. Ellipsoid referencing techniques eliminates the need for tide zoning. However, five survey lines in area 3 require tide measurements for vertical correction. Pre-survey, tides from Station 8747437 and Pascagoula NOAA Lab Station 8741533 were used to determine one tide zone can be used to survey Saint Louis Bay.

Looking at Table 18, the difference between the great diurnal range at Pascagoula and Bay St. Louis is 0.06 cm. The amplitude between the two stations changes only 6 cm, falling within NOAA specifications for one tidal zone. The high water interval (HWI) between Pascagoula and Bay St. Louis is 90 minutes, and using a ratio, it was determined the HWI between the top of the survey area to bottom of the survey area to be less than 3 minutes, and therefore only one tide zone is required for the entire survey area.

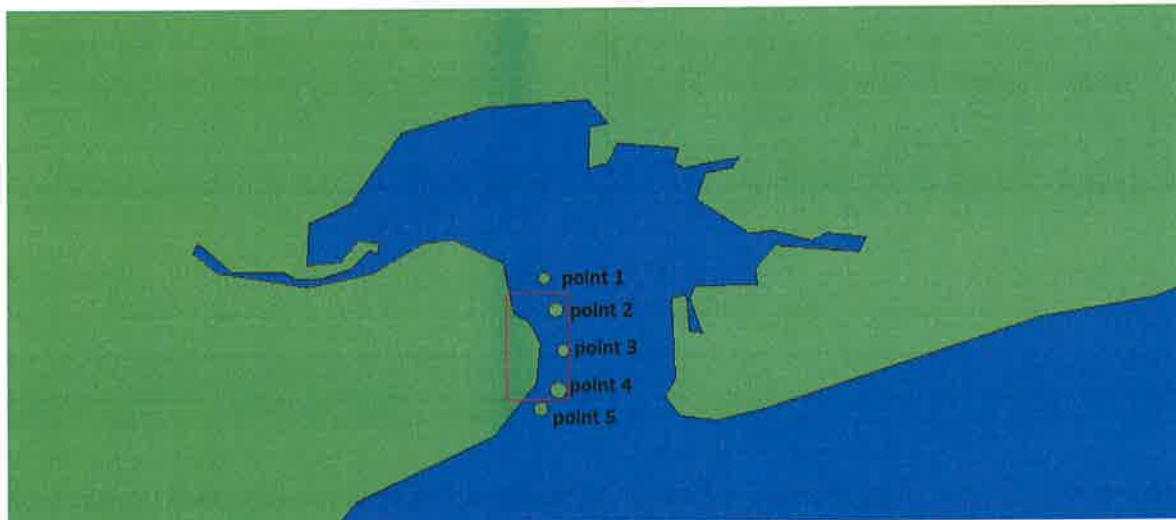
Figure 28 Points Chosen in Tide Analyst for Tide Generation in NAVOTAS.

The red box falls within our survey area.

The requirement for only one tide zone was also verified using NAVOTAS. Two tide stations within Bay St. Louis were selected and harmonic constituents were derived from each one, see Figure 21. Using those harmonic constituents, tides were generated from five points within the survey area to determine if the differences between phase and amplitude were small enough to justify one tide zone. There was little phase offset, and the largest amplitude offset was 4 cm. See Figures 21– 24.

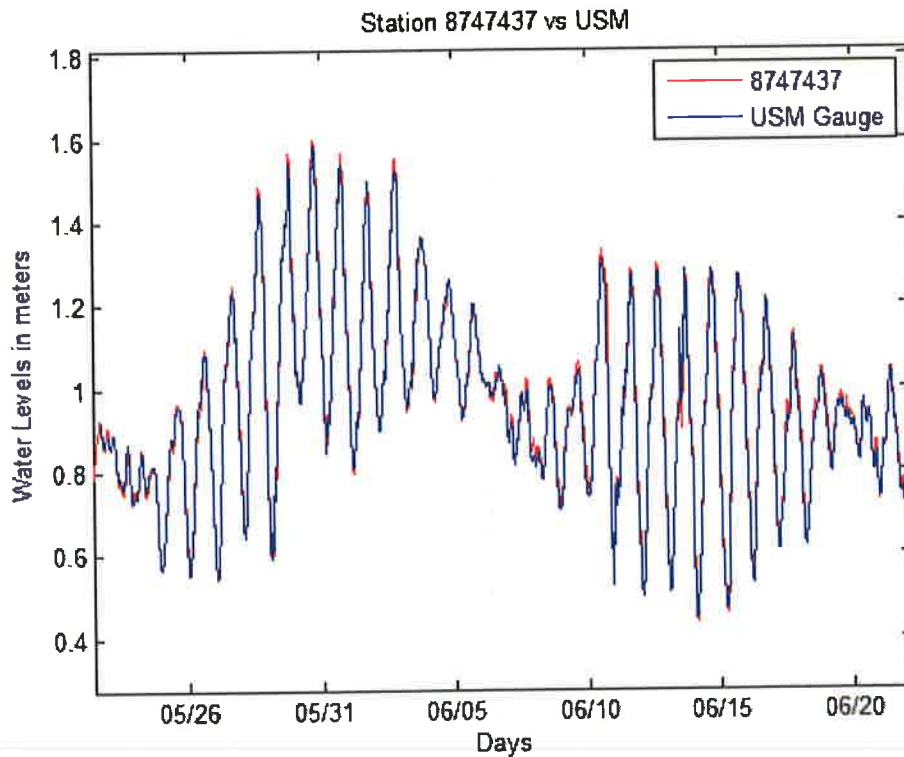
Figure 32 USM Gauge and NOAA Gauge

Figure 25 shows the tides collected from the USM tide gauge and the tides collected by the NOAA gauge during the survey. The tides line up, showing no difference in phase or peak to peak amplitude values.

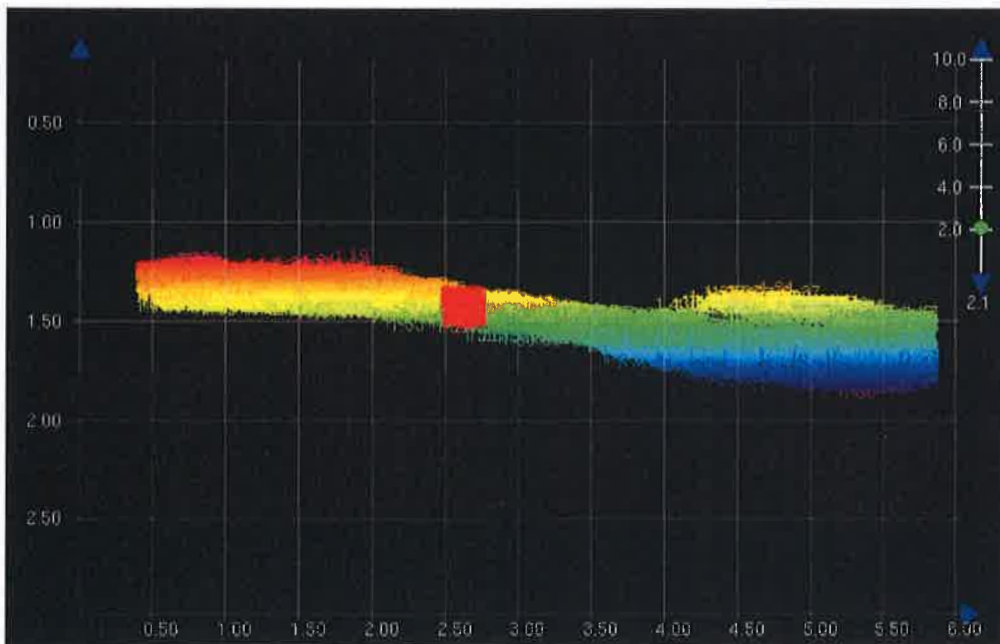
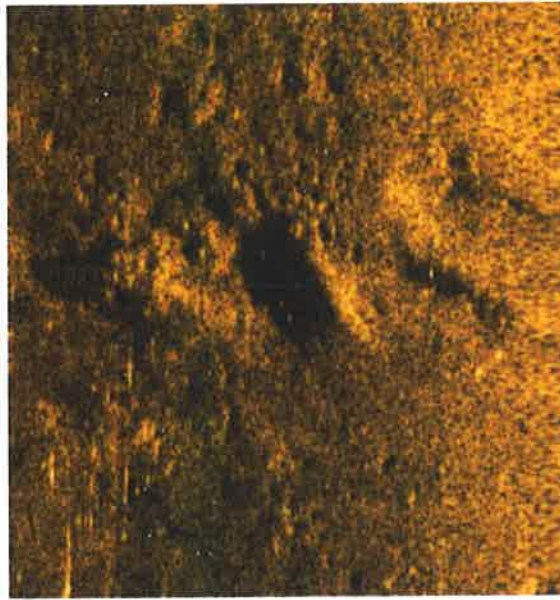
Feature sits approximately 0.61m above the surrounding seabed and is located inside the Bay Waveland Yacht Club. The water depth in this area is only 1.28m, and this feature lies in the main entry way to the Yacht Club. Due to the significant variation from the surrounding seabed, the feature may present a hazard to navigation.

Figure 29 CARIS HIPS subset over feature at 2.0x exaggeration

Figure 30 View of feature (25m range scale)

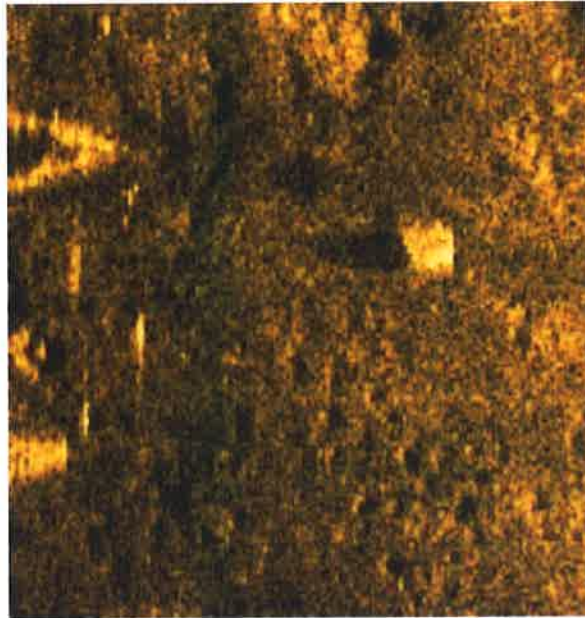
Figure 31 SSS view of feature (25m range scale)

Feature sits approximately 0.62m above the surrounding seabed and is located inside the Bay Waveland Yacht Club. The water depth in this area is only 1.05m. This object is off of the main passage and by a slip. Due to the significant variation from the surrounding seabed, the feature may present a hazard to navigation. However, the feature was not picked up in multibeam data.

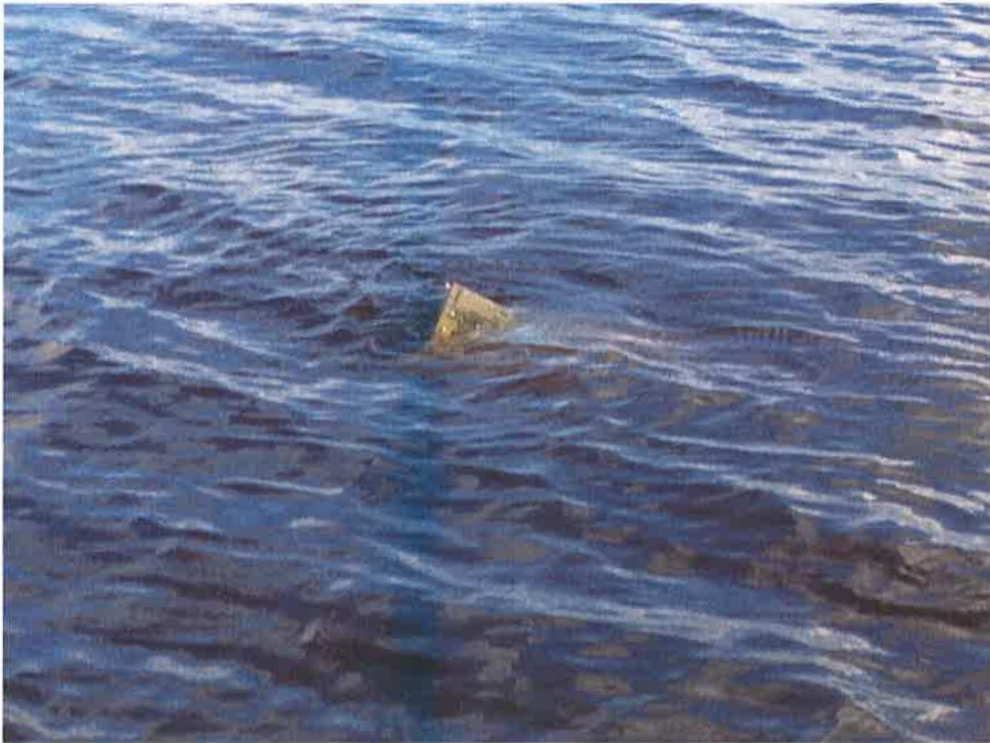
Object appears to be an old channel marker that is awash at high tide. It protrudes about 5 cm out of the water at low tide. It is located south of the Bay Waveland Yacht Club near the shore. The water depth in this area is approximately 0.59m. Due to the lack of visibility, the feature may present a hazard to navigation.

**Figure 32 Image of Obstruction Protruding from Water at Low Tide**
