DESCRIPTIVE REPORT

Type of Survey: Navigable Area

Sub-locality: Pass Christian Harbor

Pass Christian Harbor and Approaches

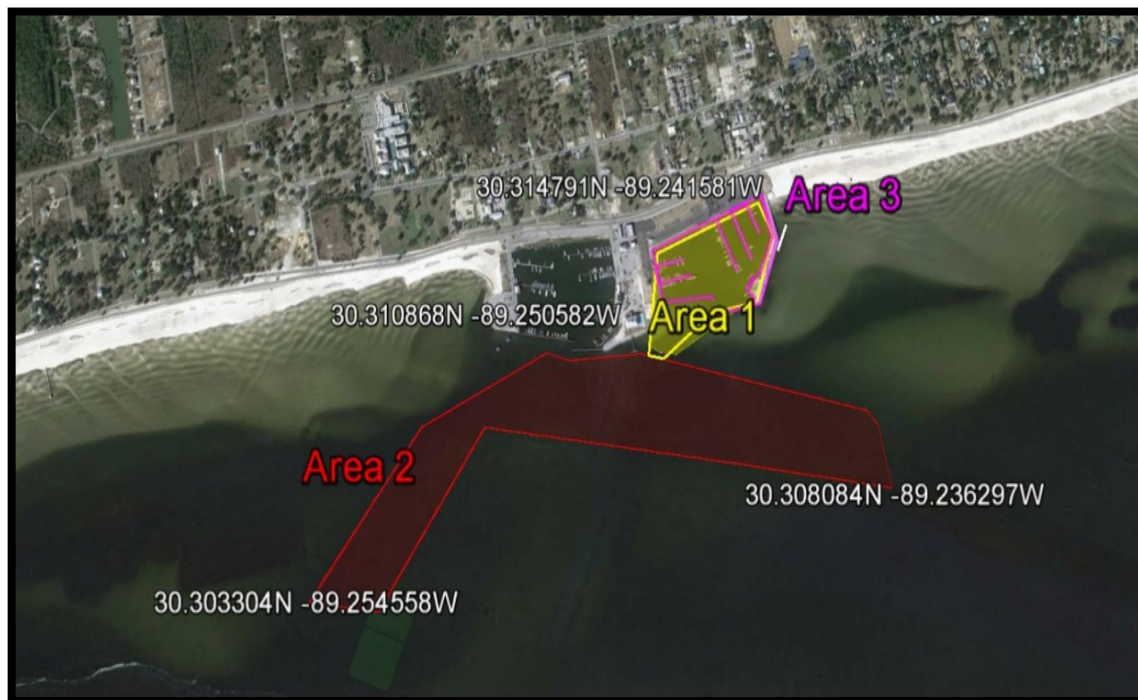
Figure 1. Surveyed area overlaid on Google Earth and extents are portrayed in DD WGS84.

The survey area was divided into three-areas. Area 1 was specified as the primary or highest priority area of the survey. A new harbor, constructed in the past year, is an expansion of the existing Pass Christian Harbor. Current charts do not depict the new harbor. Area 2 designates the west and east approaches to the entrance of the new harbor, and Area 3 was assigned for shoreline delineation of the harbor structure.

Dredging and construction for the harbor expansion began in 2011 and was completed in 2014. The new harbor provides berthing for up to 102 commercial fishing boats and up to 62 recreational boats. The primary objective of conducting a hydrographic survey in this area was to investigate the bathymetry and sediment movement around the harbor using a tilted Multibeam Echo Sounder (MBES) and a pole mounted Side Scan Sonar (SSS). The survey also provided positions for the newly constructed Aids to Navigation (ATONs), for the new harbor approaches, and bathymetry for those approaches. The survey areas are shown in Figures 1 and 2.

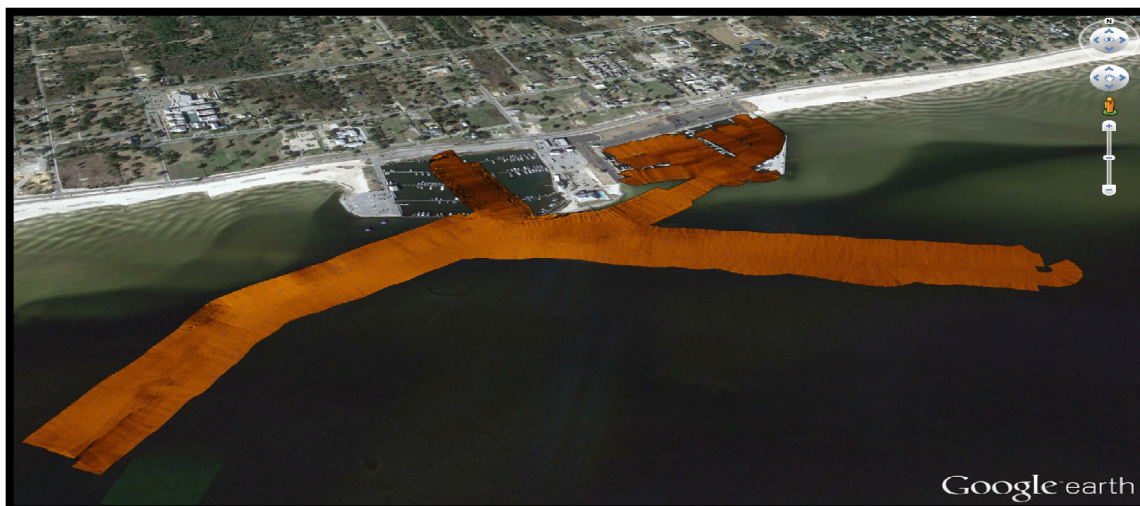
Figure 6. SSS mosaic georeferenced and exported into Google Earth for visualization.

After importing the SSS data files into SonarWiz they were checked and amended, if needed, for a correct bottom track. For the final gain settings Beam Angle Correction (BAC) was enabled with a value of 30 for Pings and 20 for Average. The Empirical Gain Normalization (EGN) Table was rebuilt and EGN was enabled with an intensity of -4 for both port and starboard side. The resulting mosaic had a relatively equal intensity and clarity for the entire survey area. Small objects could be detected easily by the depicted echoes and distinctive shadows. Georeferenced Tiff files were exported (Figure 6) as a deliverable, as well as target reports for possible Dangers to Navigation (DTONs).

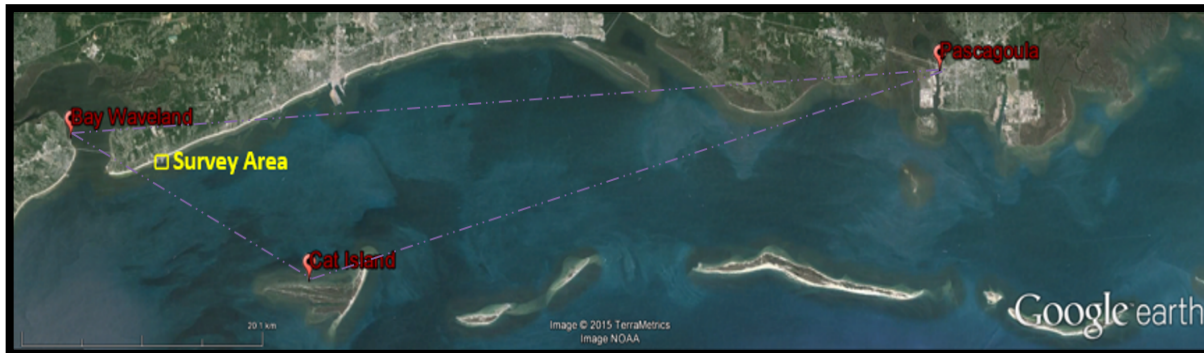
Figure 7. Nearest NOAA tide station to the survey area.

Pass Christian project site is relatively small in terms of area coverage and is situated in between two operational NOAA tide stations—Bay Waveland and Pascagoula. Bay Waveland tide station is about 7.5 km from the survey area and 72 km from Pascagoula. There used to be a NOAA tide station at Cat Island, which is about 15 km southeast of Pass Christian. All three stations (Figure 7) have published datums corrected to the present NTDE Epoch 1983-2001.

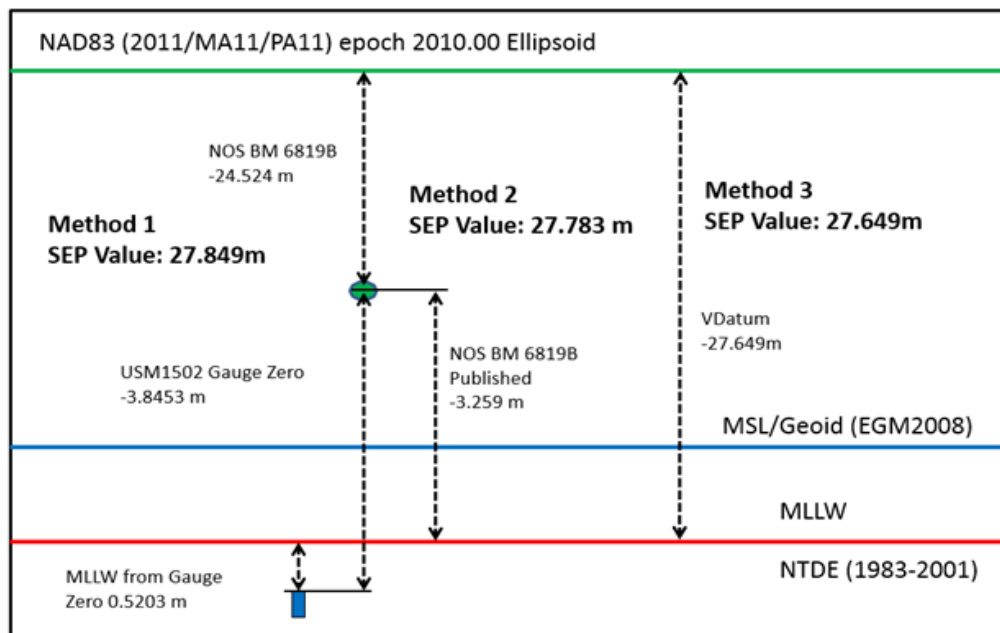
Figure 9. SEP value from three different methods.

By using the derived ellipsoidal height from the GNSS static observation, benchmark elevations (from three-wire leveling), and MLLW/MSL values from the tidal datum transfer, an SEP value can be calculated (Method 1). Another Method (2) was derived by using the established chart datum/tidal relationships for the NOS BM 6819 B data and ellipsoidal height from the GNSS static survey. Method 3 utilized NOAA’s VDatum Vertical Datum Transformation (v3.4) program to determine a SEP value by providing the datum, coordinates, and zero height over the primary benchmark. SEP values for each method are summarized in Figure 9. Uncertainty values were calculated to a 95% confidence interval and are shown in Table 10.

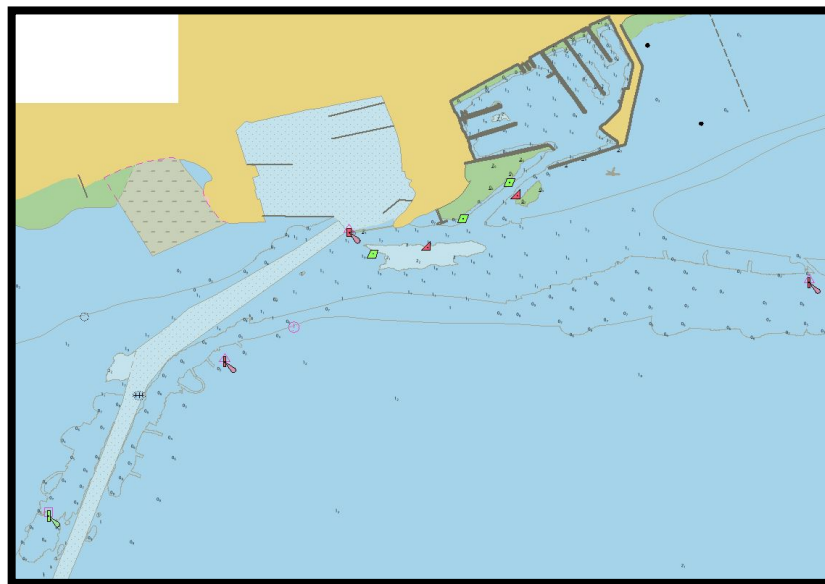
Figure 11. ENC US6MS99M with new harbor added. Also has updated depth areas and AWOIS. All soundings are in meters.

shorelines (COALINE) were added to the 15USM02 ENC US6MS99M (Figure 11). DEPART, DEPCON, and soundings were also added to the US6MS99M ENC for this area. These areas are approximately 0.3 m shoaler than the dredged depth listed on the harbor's website. The accuracy of the depth listed on the website could not be verified from any source data or any other reliable source. There were no obstructions or DTONs found in this area. Shoaling and sediment deposition can be seen around the harbor structure (seawalls and retaining walls) as well as in the harbor itself. It appears that sediment is moving in through the entrance and being deposited throughout the harbor. There was one AWOIS around Area 1 that was charted as always being dry. This wreck was not found by visual inspection at low tide and very shoal waters prevented sonar investigation. This AWOIS can be seen charted on ENC US5MS11M in Figure 10.

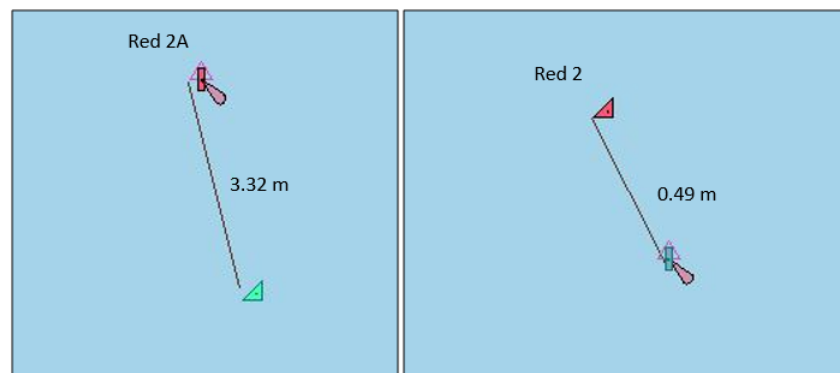
Figure 12. Movement of ATONs Red "2A" and Red "2".

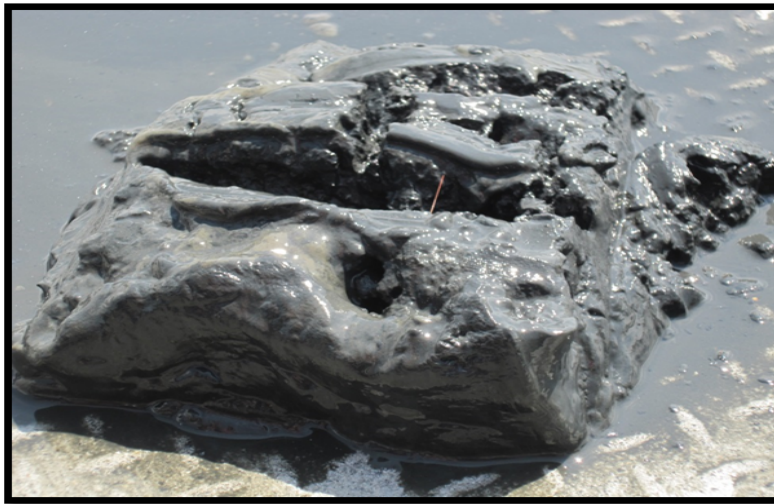
Figure 13. Bottom sample 1.

Sediment samples (Figures 13 -16) were collected in the center of each area at the positions listed in Table 11. Backscatter intensities were used to identify potential bottom sample locations. Only one area outside the new harbor presented any significant change in backscatter and, when sampled, showed that it was most likely an oyster reef.

Sample Number	Time UTC	Latitude	Longitude	Sediment Description/NAT	NATQUA	Color
1	10:52	30 18 48.4923 N	89 14 28.8855 W	Mud (1) Clay (2)	Sticky (5)	Black (2)
2	11:45	30 18 47.3716 N	89 14 35.4756 W	Mud (1) Clay (2)	Sticky (5)	Black (2)
3	19:57	30 18 39.3883 N	89 14 38.4546 W	Mud (1) Clay (2)	Sticky (5)	Black (2)
4	15:03	30 18 26.7588 N	89 15 02.2506 W	Shell (Mainly Oyster) (17)	Calcareous(9)	-

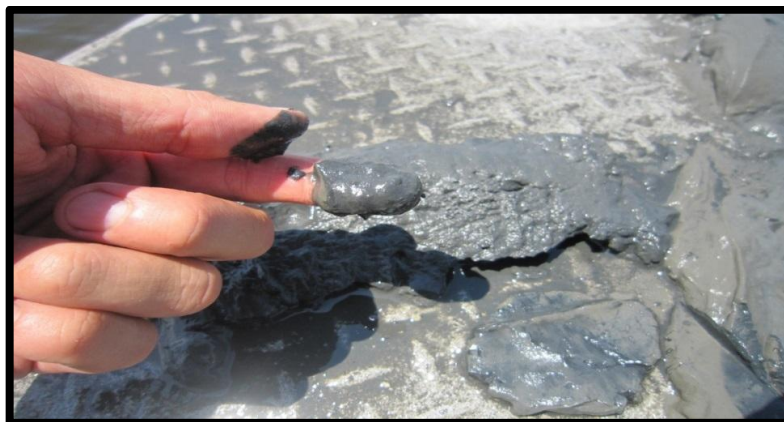
Figure 14. Bottom sample 2.

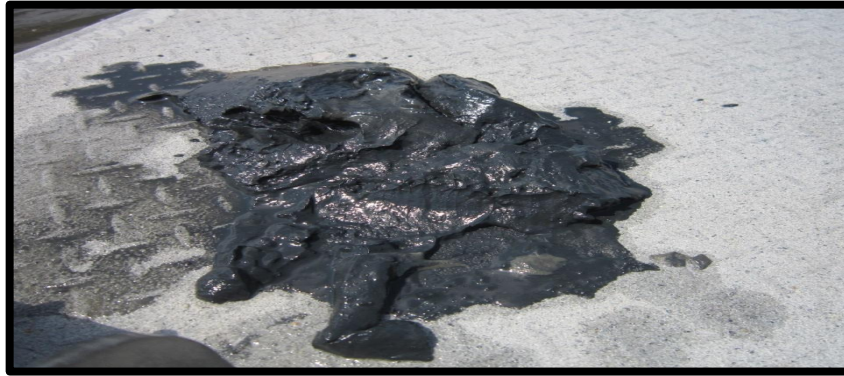
Figure 15. Bottom sample 3.

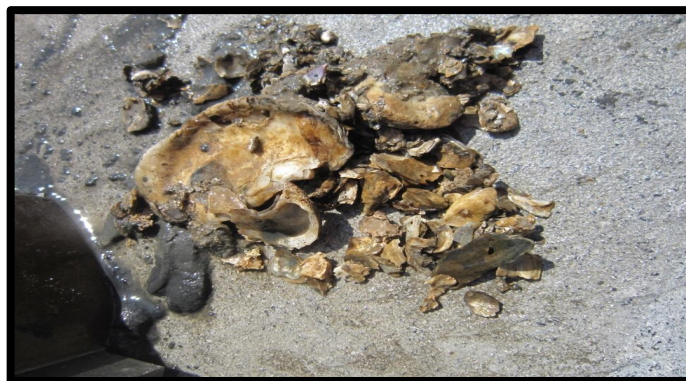
Figure 16. Bottom sample 4.

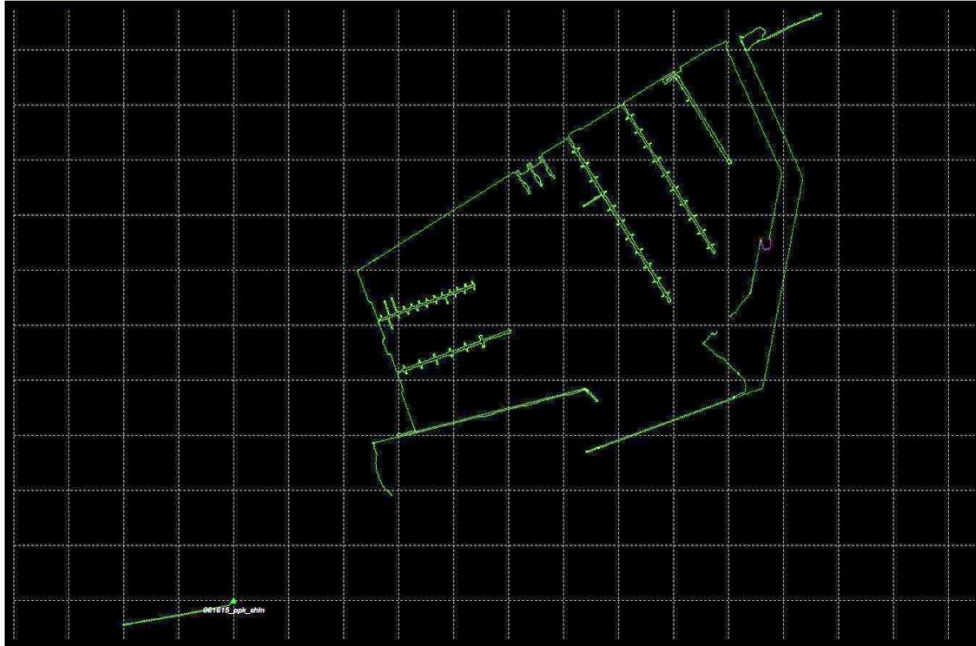
Figure 17. Shoreline delineation of new harbor using PPK GNSS data.

Delineation of the new harbor sea walls, piers, and docks was completed with a rolling wheel pole mounted with a GNSS TopCon GR3. These data were post processed to obtain a PPK solution, using another GNSS TopCon GR3 as a base station. Due to the high accuracy of the data, the widths of the finger piers and seawalls were also captured by the GNSS survey. There was no need to follow the NOAA guideline of time of data collection relative to a high or low stand of mean sea level because all structures are permanently constructed and always dry. Figure 17 shows the shoreline delineation data in GravNav after PPK processing. Figure 18 shows the data overlaid on Google Earth and shows how well the Landsat 7 georeferenced imagery fits with the delineated shoreline.
