## **Data Acquisition & Processing Report**

Project Number: ESD-PHB-18

E/V Nautilus  
EM302 Multibeam Echosounder  
System Review  
NA055  
March 30 – April 5, 2015

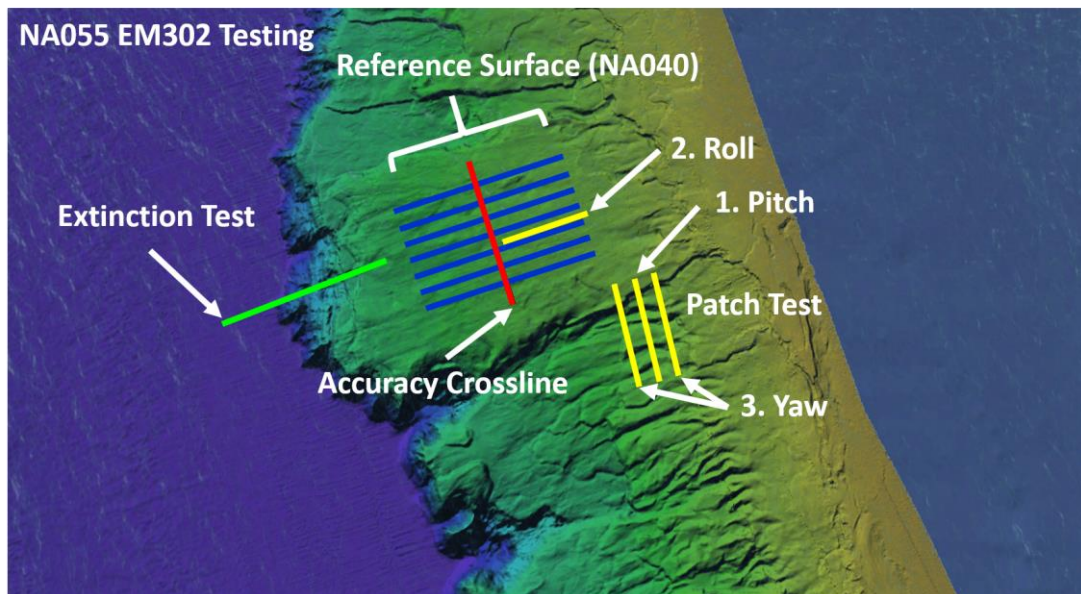
Figure 2. Layout of NA055 operational areas for EM302 evaluation (presented in Google Earth using historic multibeam echosounder data downloaded from the National Geophysical Data Center).

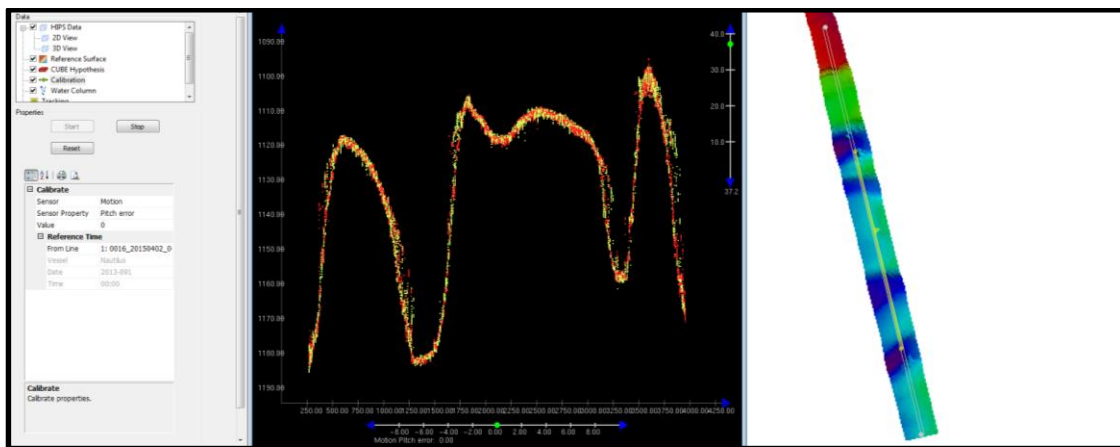
Figure 3. Example subset of pitch calibration data in Caris HIPS 9.0 yielding a residual MRU pitch offset of 0.00°. No change was made to the MRU pitch offset in SIS.

Figure 3 to 5 depict example transects using the Caris HIPS Subset Editor calibration tool for the pitch, roll, and yaw calibration data sets. The final value for each offset is based on examination of multiple transects in the Subset Editor calibration tool. The results, in agreement with results from the SIS and Qimera calibration tools, represent the residual angular offsets applied to the MRU Installation Parameters in SIS (Table 2).

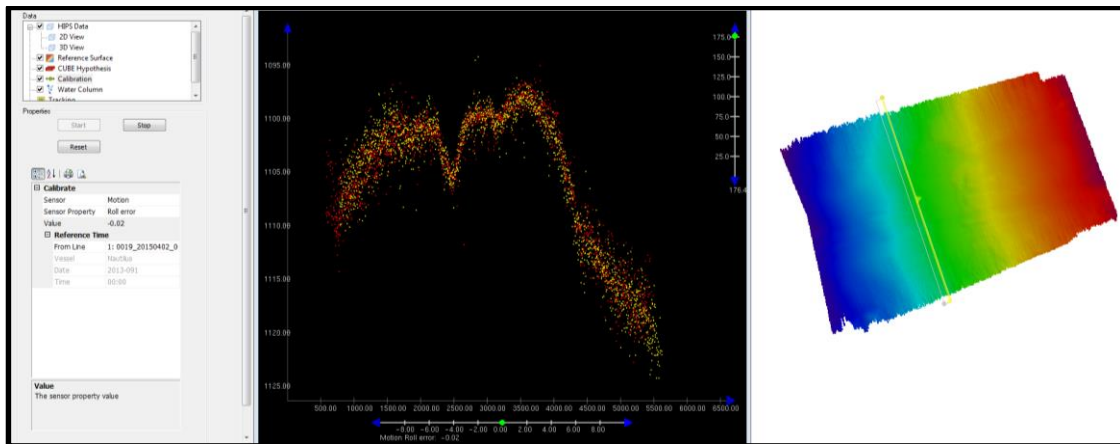
Figure 4. Example of subset of roll calibration data in Caris HIPS 9.0 yielding a residual MRU offset of -0.02°. This value was added to the existing MRU pitch offset before collecting yaw data and then validated during a second set of roll calibration lines.

No clear trends requiring residual angular offsets were observable for the pitch or yaw datasets when evaluated using all three of the calibration tools. Accordingly, pitch and yaw were left unchanged from post-NA040 values in SIS. The roll calibration lines suggested a residual angular offset of -0.02° which was added to the post-NA040 value, applied in SIS, and verified by collection and examination of a second set of roll calibration lines with excellent results (zero residual evident). No evidence indicating latency in the system was observed at any point during NA055.

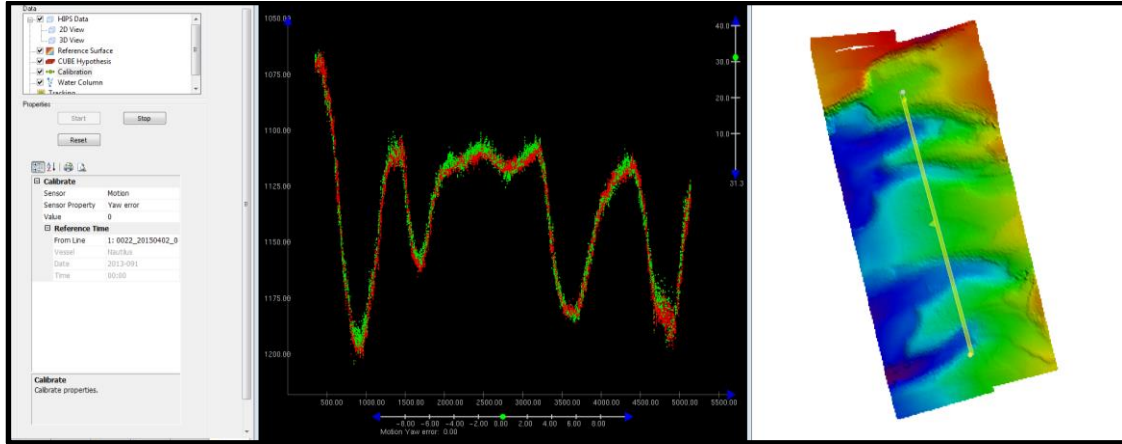
Figure 5. Example subset of yaw calibration data in Caris HIPS 9.0 yielding a residual MRU yaw offset of 0.00°. No change was made to the MRU yaw offset in SIS.

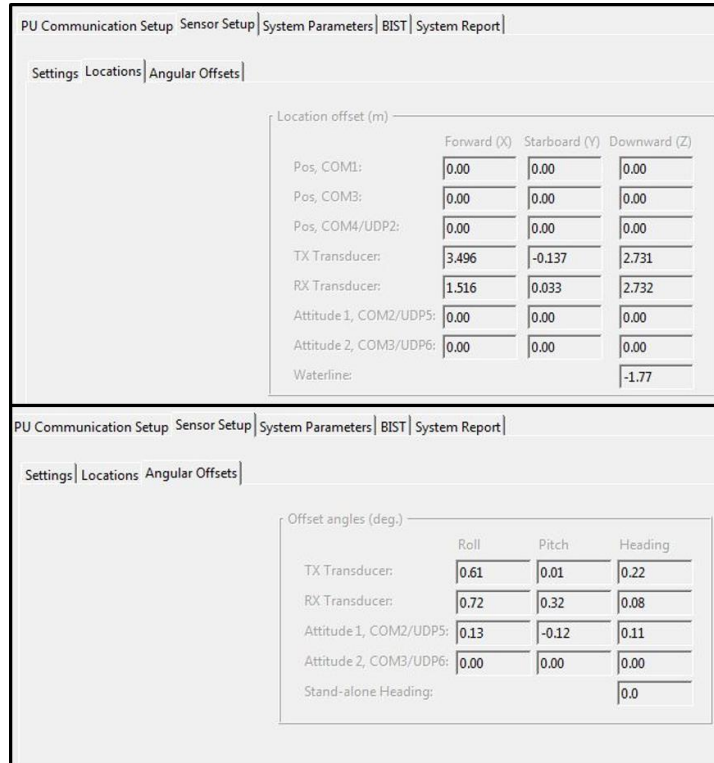
Figure 6. SIS screen captures of PU parameters for linear and angular offsets off system components after NA055.

Table 3 includes the SIS configuration for the linear and angular offsets of the TX and RX arrays and the MRU at the end of the NA055 leg on April 5, 2015. Aside from applying the residual MRU roll angular offset determined from the NA055 patch test, no further modifications were expected or made to the SIS Installation Parameters (Figure 6). Additional screenshots of SIS parameters are available in the Appendix C. These offsets represent the survey configuration which will be used at the start of the 2015 Nautilus operational season based on existing documentation and patch test results. All values are with respect to the Kongsberg (SIS) reference frame. These parameters are to be used until sensor locations or orientations are modified or it is determined that a new patch test should be undertaken.

Table 3. SIS PU parameters for linear and angular offsets at the end of NA055. Note that MRU linear offsets are not specified because navigation data from the Seapath 330+ navigation system are referenced to the center of the TX array, per Kongsberg convention for navigation input.

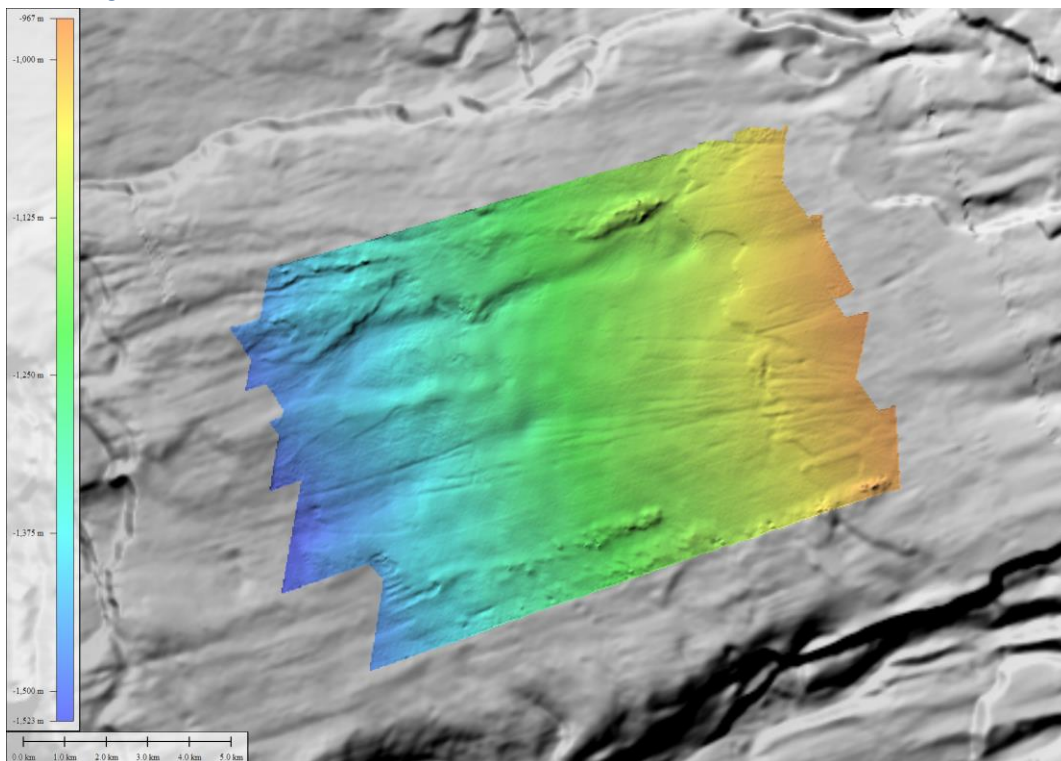
Figure 7 Overview of the reference surface created during NA040 (2014) and employed for deepwater accuracy evaluation during NA055 showing all data collected for the area.

Reference surface lines collected during NA040 (2014) were reprocessed with Caris HIPS 9.0 and gridded at 30 m using the Combined Uncertainty and Bathymetry Estimator (CUBE) algorithm (Figure 7). A slope filter was then applied to the data to exclude areas having slopes greater than 5° from the cross line statistical analyses (Figure 8).

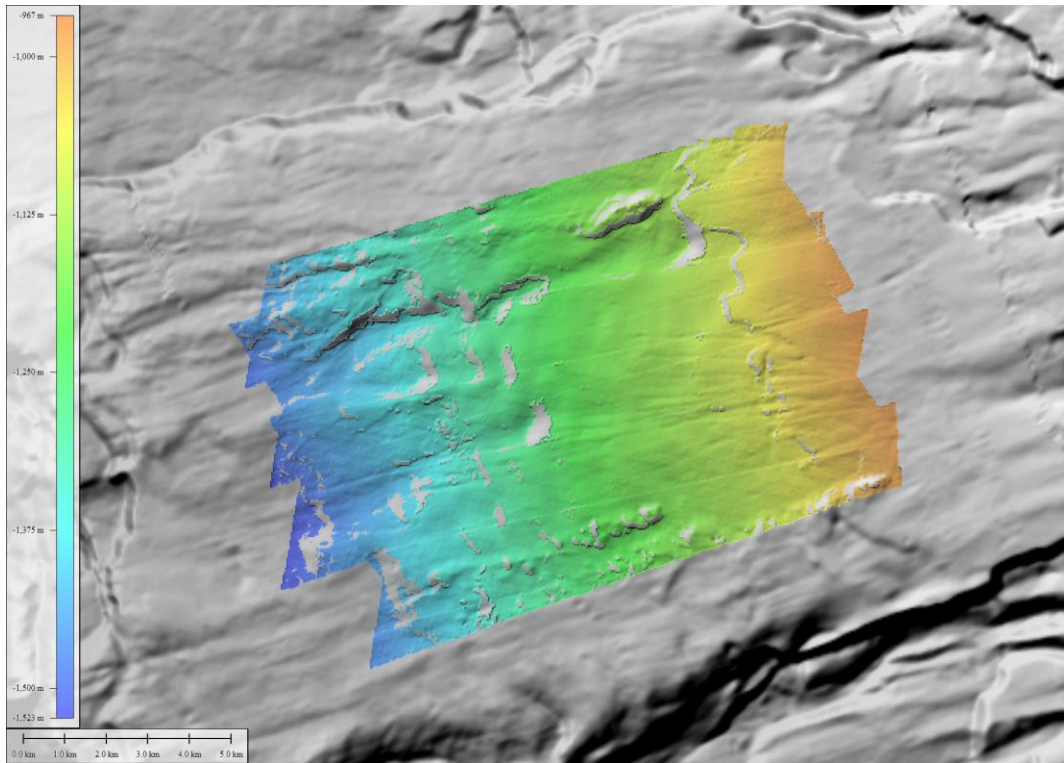
Figure 8. Reference surface with areas of slopes greater than 5° masked.

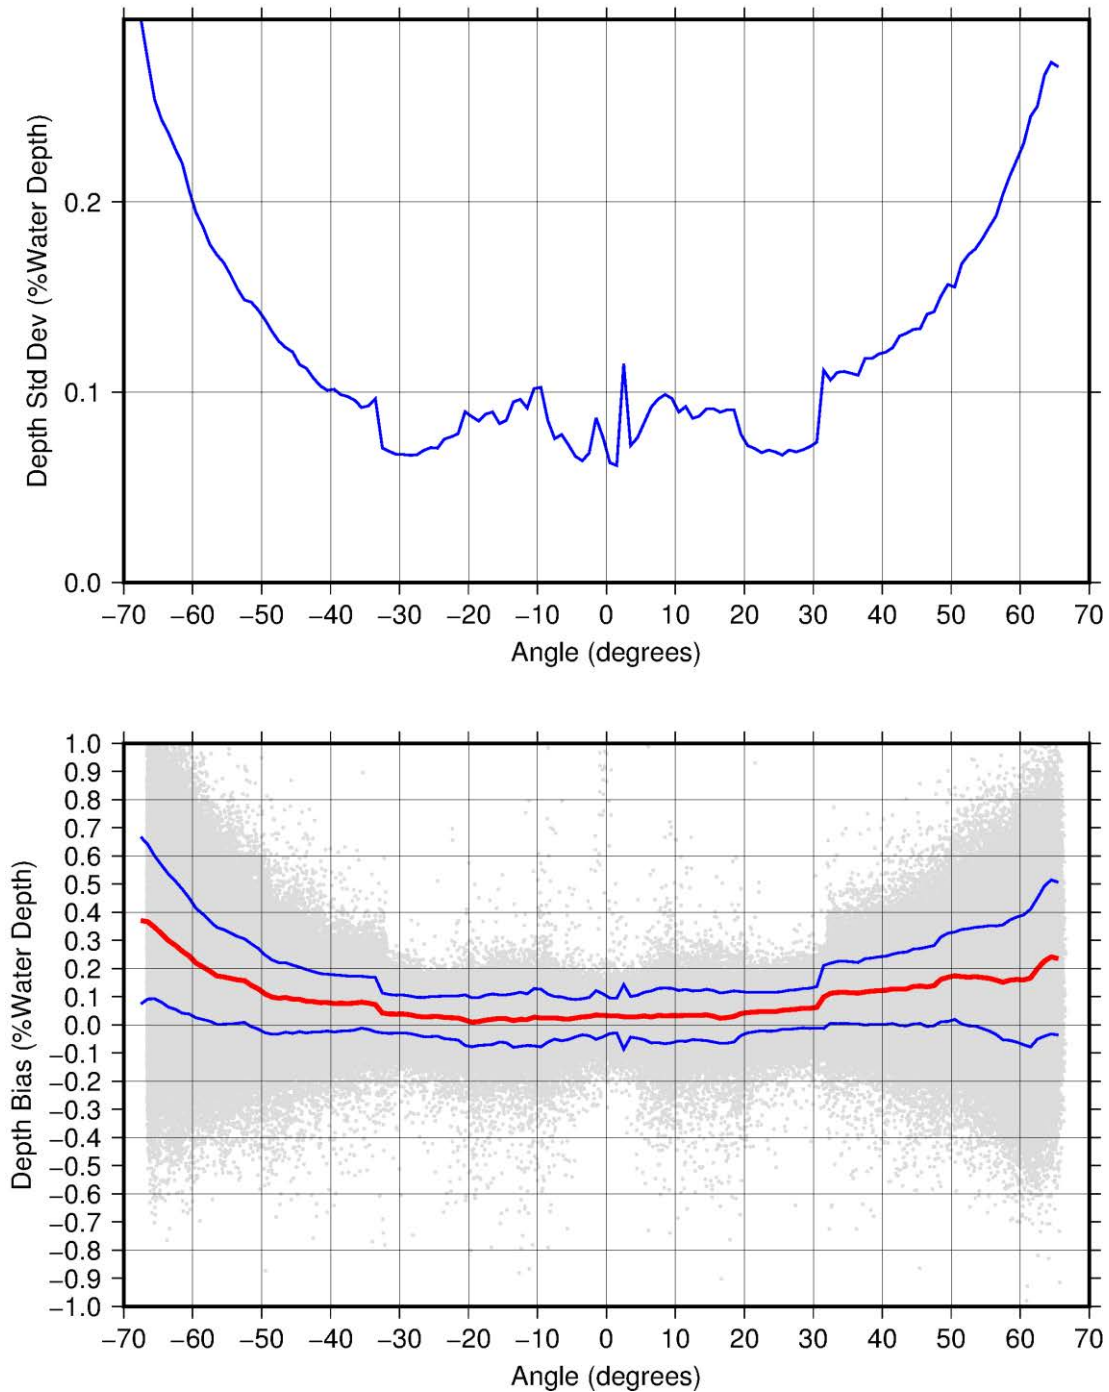
### NA055 – EM302 – XLine Settings 1

Figure 9. Depth standard deviations (top) and biases (bottom) as percentages of water depths for all cross line soundings collected at 8 kts and 10 kts using FM, dual-swath configuration (cross line settings 1). The bottom figure includes all raw soundings (grey points), the mean depth bias (red line), and the standard deviation of depth bias (blue lines) for each beam angle.

Examining Figs. 9-12, it can be seen that the EM302 provides fairly unbiased soundings over the majority of the swath in all modes tested. As in the NA040 evaluation, and despite updating sound speed data with an XBT profile before every other cross line, a small non-linear refraction-like bias is apparent in the outermost sectors for almost all test cases. The refraction-like biases could be minimized with even more frequent collection of XBT profiles or the selection of an alternative area with a more stable water mass for data collection.

The observed mean biases and standard deviations are within the expected performance tolerances of the system as a whole, with no significant difference in performance compared to 2014. A majority of the swath shows beam-wise depth biases of less than 0.1% of water depth. The standard deviations about the mean bias are typically within  $\pm 0.15\%$  to  $\pm 0.25\%$  water depth ( $1-\sigma$ ) across the majority of the swath with higher uncertainties at the limits of the swath, as expected and typical for these systems. Also, as expected, the CW modes perform more consistently across the entire swath than the FM modes, which tend to support longer ranges but exhibit noisiness at sector boundaries and increased vertical scatter in the outer swath.

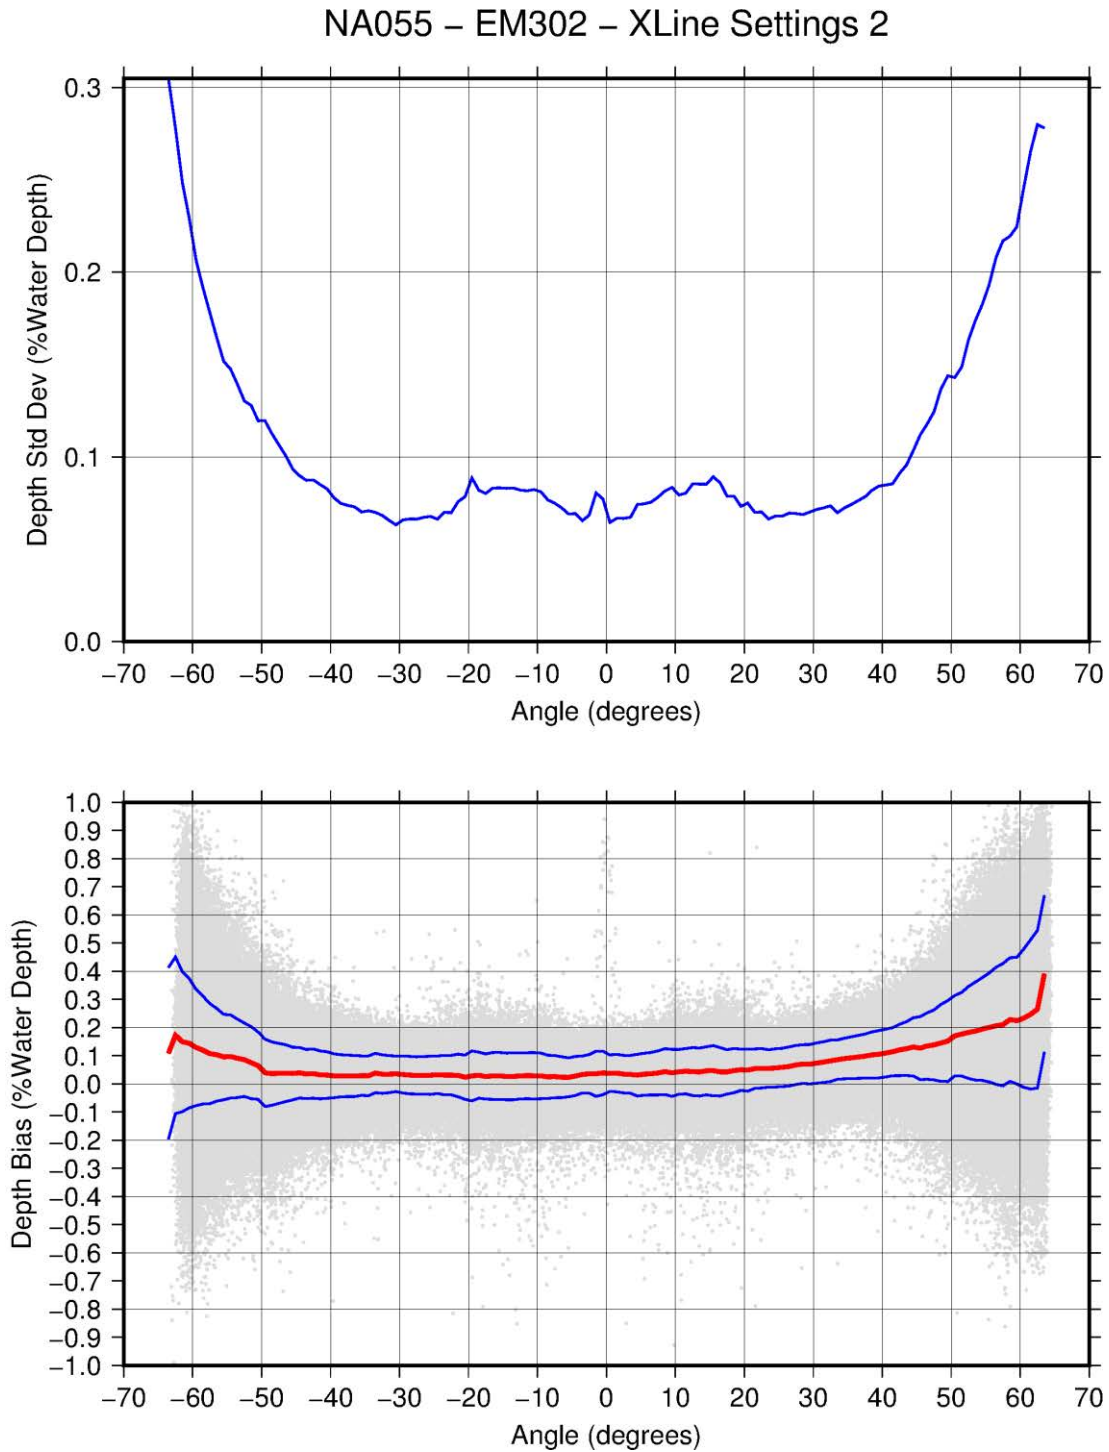
Figure 10. Depth standard deviations (top) and biases (bottom) as percentages of water depths for all cross line soundings collected at 8 kts and 10 kts using CW, dual-swath configuration (cross line settings 2). The bottom figure includes all raw soundings (grey points), the mean depth bias (red line), and the standard deviation of depth bias (blue lines) for each beam angle.

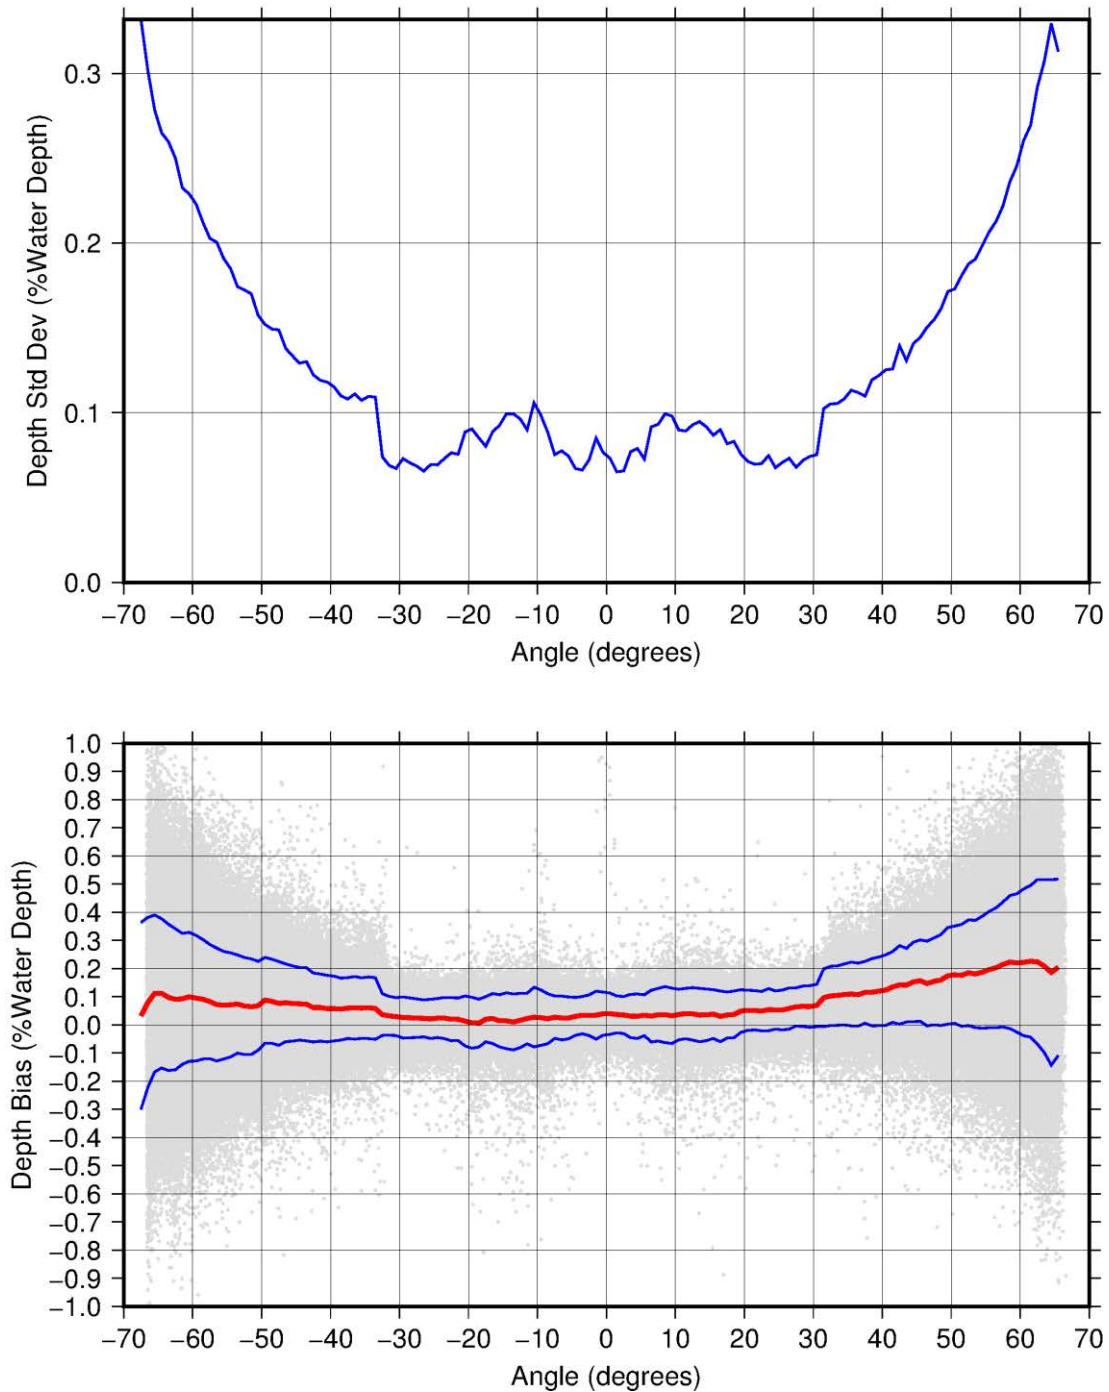
### NA055 – EM302 – XLine Settings 3

Figure 11. Depth standard deviations (top) and biases (bottom) as percentages of water depths for all cross line soundings collected at 8 kts and 10 kts using FM, single-swath configuration (cross line settings 3). The bottom figure includes all raw soundings (grey points), the mean depth bias (red line), and the standard deviation of depth bias (blue lines) for each beam angle.

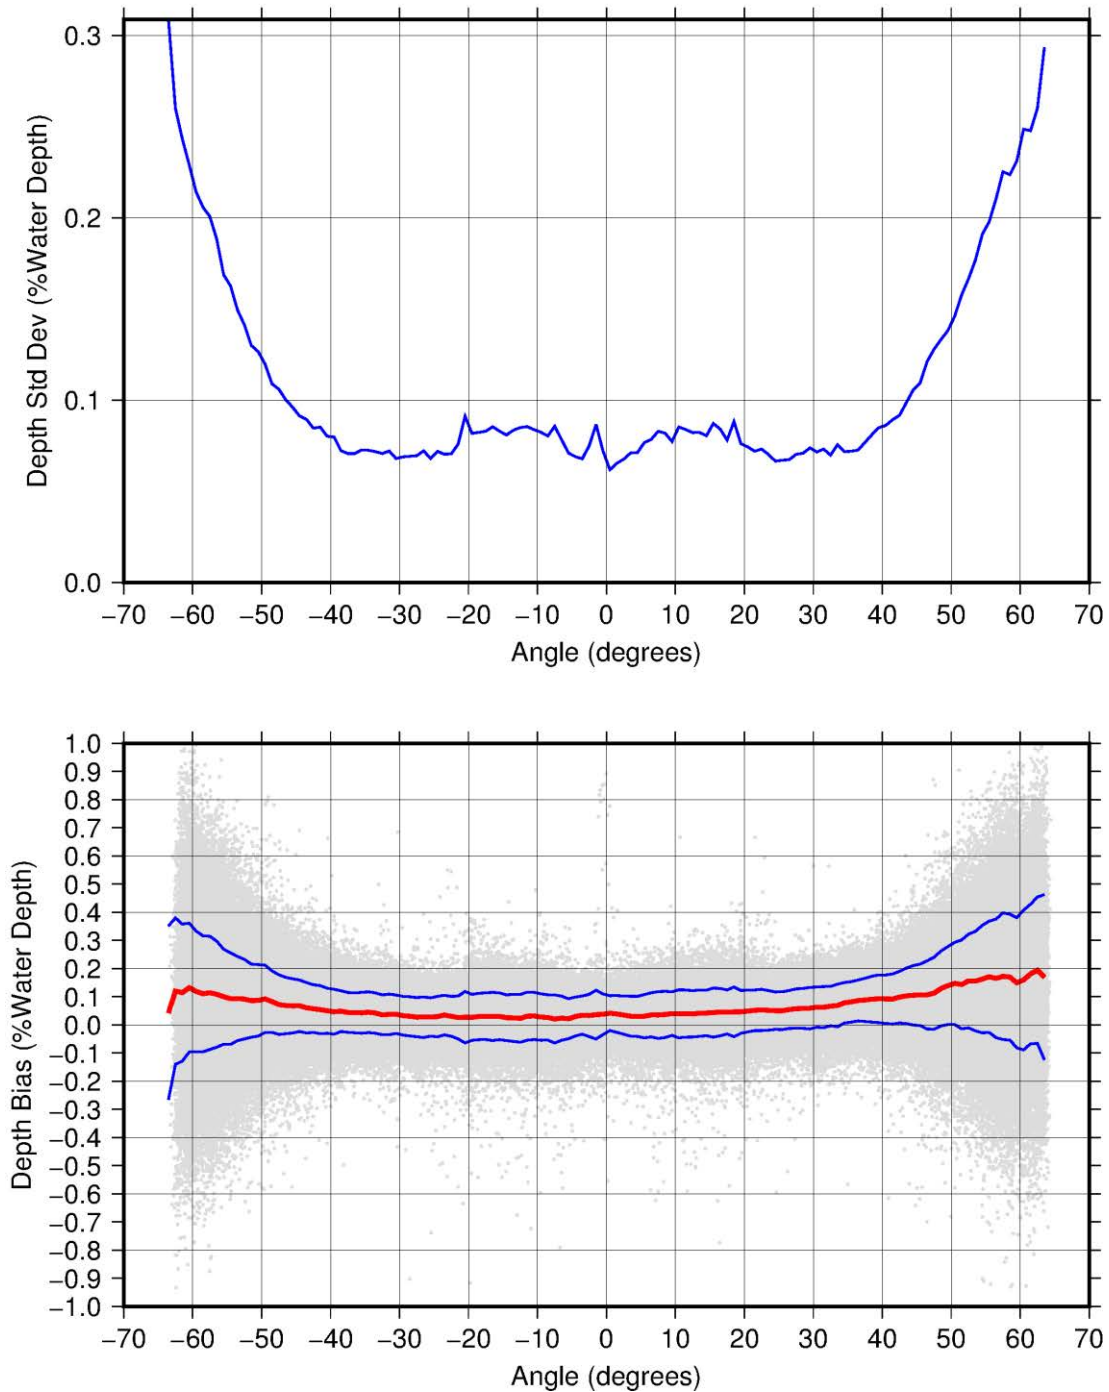
### NA055 – EM302 – XLine Settings 4

Figure 12. Depth standard deviations (top) and biases (bottom) as percentages of water depths for all cross line soundings collected at 8 kts and 10 kts using CW, single-swath configuration (cross line settings 4). The bottom figure includes all raw soundings (grey points), the mean depth bias (red line), and the standard deviation of depth bias (blue lines) for each beam angle.

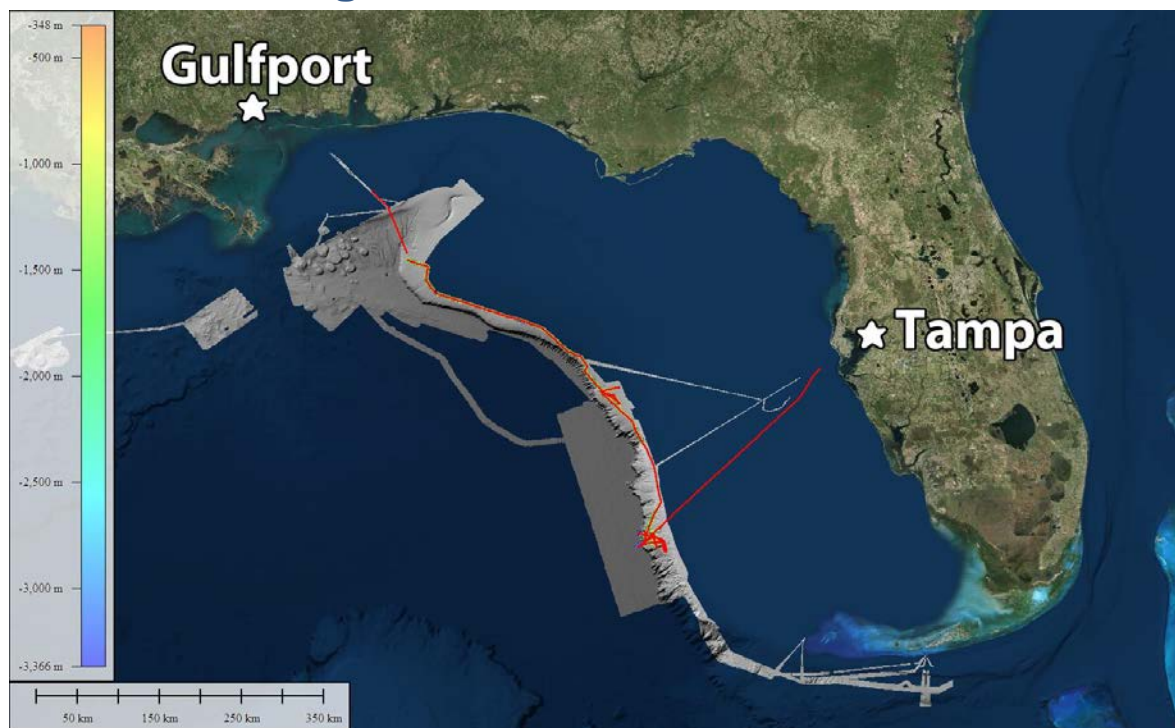
Figure 13. Red line shows the ship navigation extracted from the EM302 data included in the swath coverage calculation.

The swath coverage performance was evaluated by tracking the outermost port and starboard soundings from all data acquired during the patch test, reference surface collection, extinction test and parts of the transit to Gulfport (Figure 13). Figure 14 depicts the across-track coverage versus depth up to approximately 3350 m. Ideally, all data included in the swath coverage analysis should have been collected in automatic angular coverage mode, automatic depth mode,

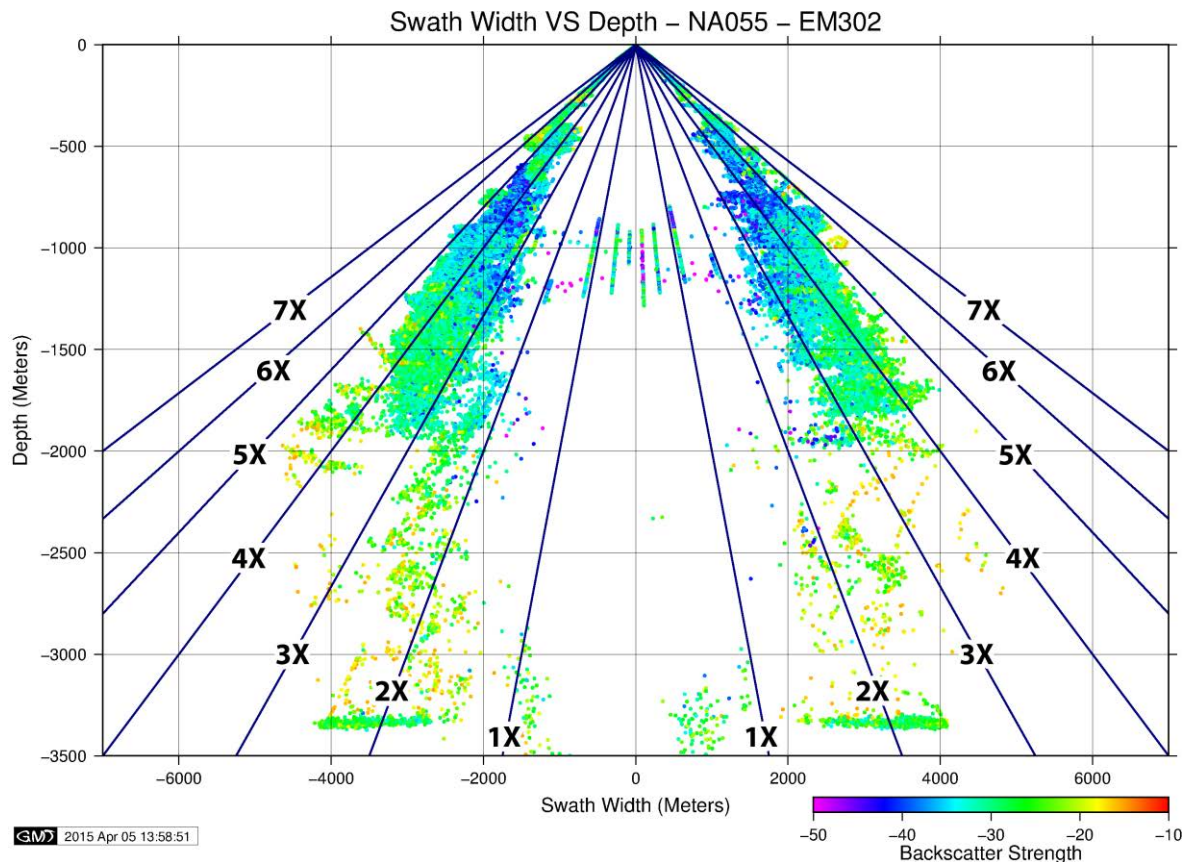
Figure 14. EM302 coverage evaluation plot showing outermost sounding coverage (i.e., swath width) versus depth. Colors of the points are based on the backscatter strengths of the contributing sounding.

Swath width compared favorably with NA040 results, providing across-track coverage of 6 times water depth in shallow waters up to 500 m depth and 5 to 4 times water depth to approximately 1500 m depth. At depths greater than 1500-1800 m, the system tracked consistently between 3 and 2.5 times water depth down to 3,350 m. Soundings deeper than 3,350 m in this plot are outliers and do not represent the observed maximum depth during testing. The coverage achieved up to 3,350 m depth is comparable to other EM302 installations and indicates that the system is performing well. Note that a major difference in Fig. 13 compared to NA040 (Fig. 10 in the 2014 report) is that outer beam soundings with backscattering strengths greater than -15 dB have been eliminated. These soundings likely fell on rugged features of the continental shelf break, such as canyon walls, facilitating stronger backscatter values and atypically wide across-track ranges.

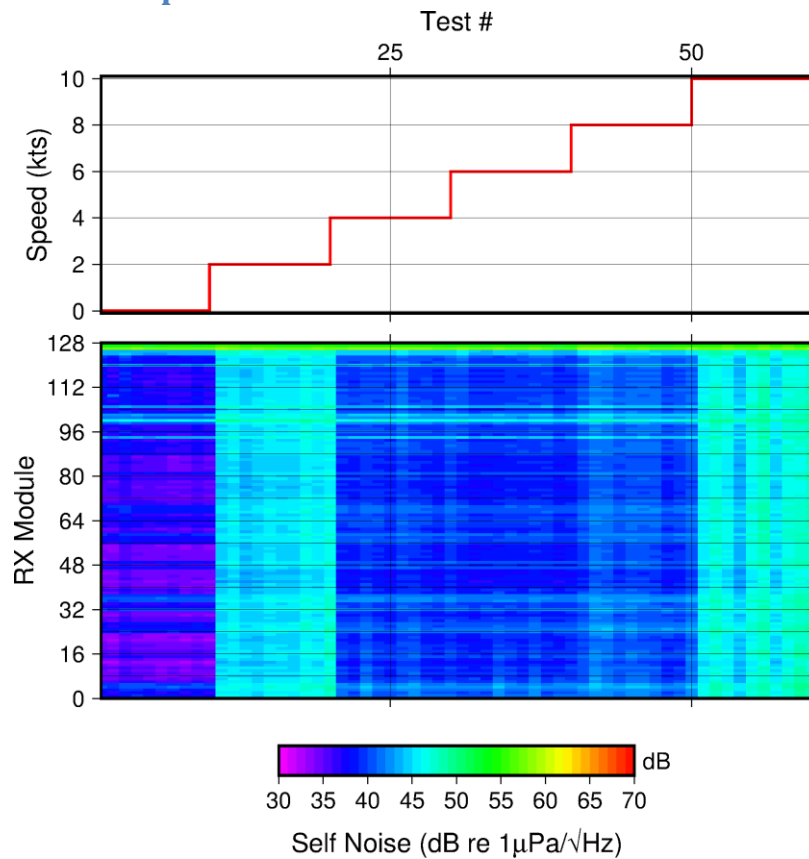
Figure 15. Receiver module self noise versus test number at vessel speeds of 0-10 kts while heading into a 1-m swell. Ten test measurements were made at each speed.

To assess vessel noise at the transducers, measurements were made at the receiver while the vessel operated at a variety of speeds and headings relative to the swell. Speed-dependent self noise was measured at 2-10 kts while heading into a 1-m swell (Figure 15 and Figure 16) and then measured at 3-12 kts while heading with the swell (Figure 17 and Figure 18). These plots clearly show significant and consistent elevated noise at 2-4 kts and 10-12 kts, with reduced noise at 6-8 kts. Engine constraints during NA055 frequently required speeds of 10 kts, presenting a concern for the elevated noise measured by the EM302. The self noise data suggest that surveys should be conducted at 6-8 kts, though a repeat noise test with test survey lines under identical conditions would be required to establish whether the vessel noise appreciably affects data quality and accuracy.

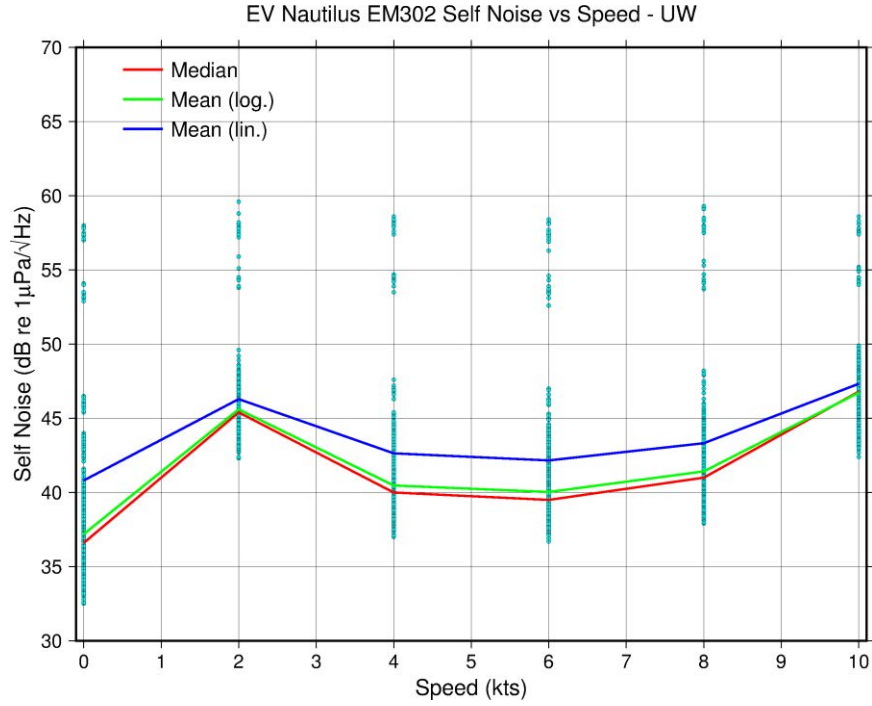
Figure 16. Receiver module self noise versus speed while heading into a 1-m swell.

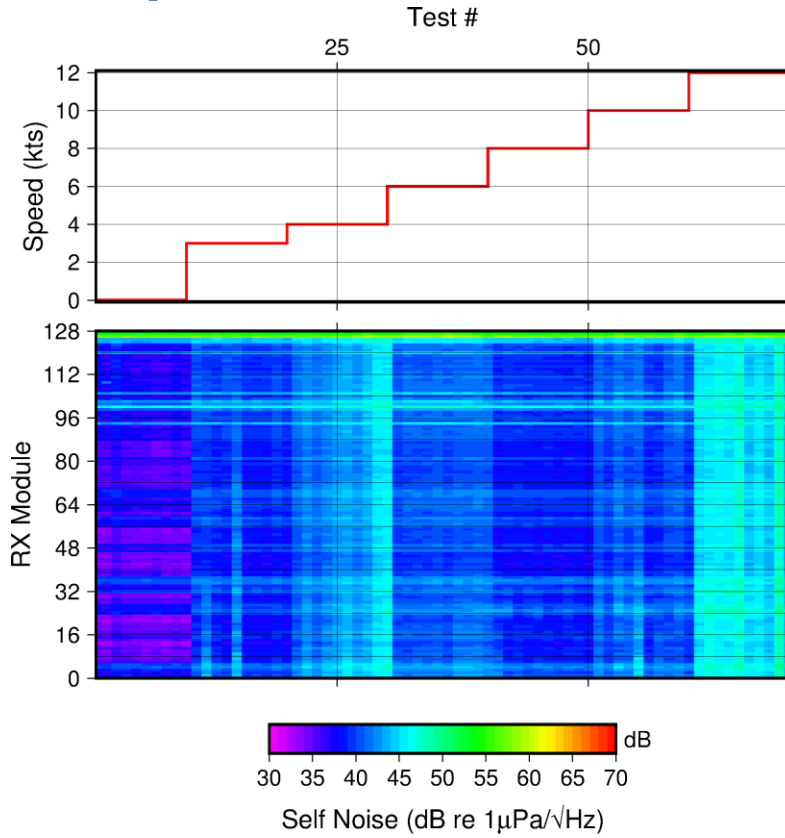
Figure 17. Receiver module self noise versus test number at vessel speeds of 0-10 kts while heading with a 1-m swell. Ten test measurements were made at each speed.

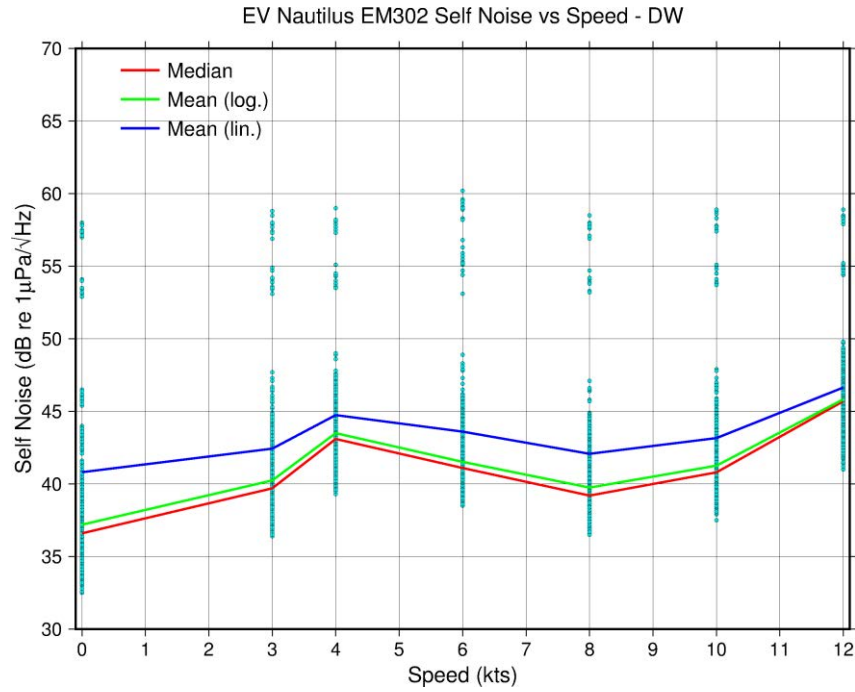
Figure 18. Receiver module self noise versus speed while heading with a 1-m swell.

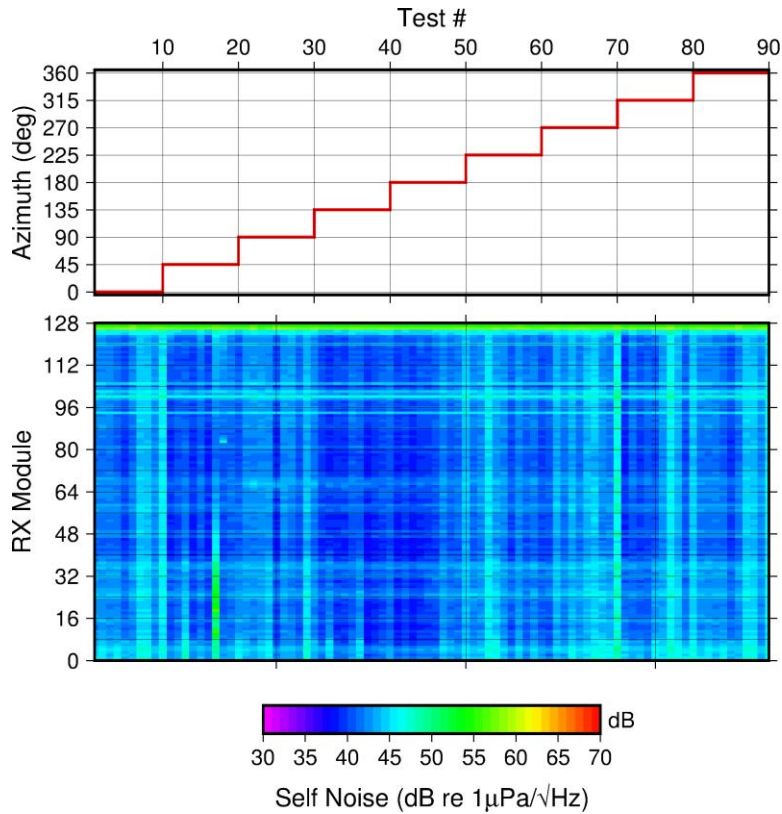
Figure 19. Receiver module self noise versus test number at vessel azimuth relative to the prevailing seas (2-m swell). Azimuth of 0° corresponds to vessel heading with the swell. Vessel speed was 10 kts for all tests and ten measurements were made at each heading.

Conditions developed sufficiently on the last day of NA055 to produce a 2-m swell from the northeast (045°) and facilitate measurement of azimuthal noise relative to prevailing seas. Receiver noise was measured in eight directions separated by 45°, starting with the swell, while the vessel transited at 10 kts (Figure 19 and Figure 20).

The results of noise testing relative to sea direction show the unexpected results of reduced noise heading into the swell and increased noise heading with the swell. Though primary swell direction was from 045° (relative to true north), other swell patterns were observed from a variety of directions which may complicate this analysis.

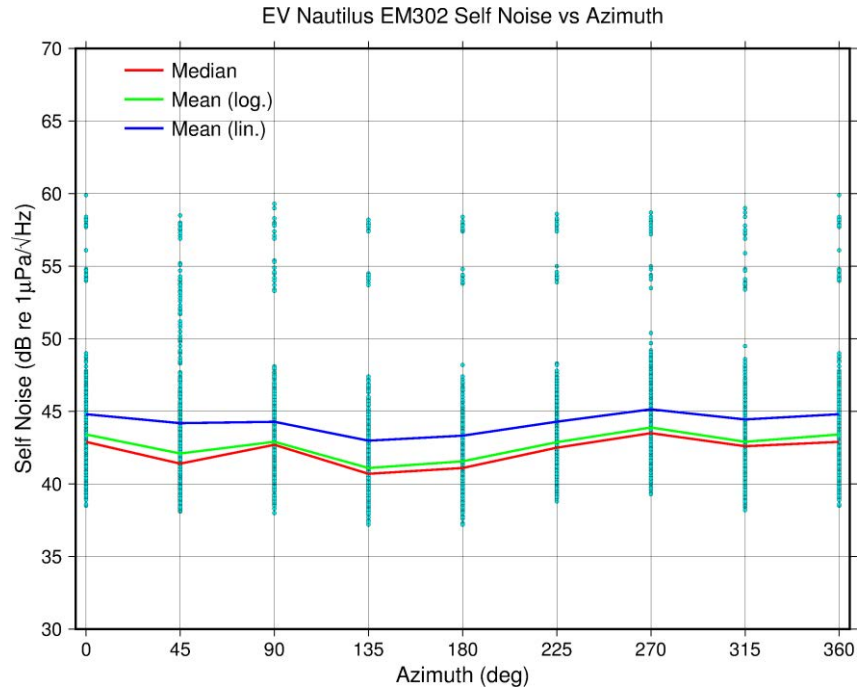
Figure 20. Receiver module self noise versus azimuth relative to a 2-m swell. Azimuth at 0° is with the swell directions, while azimuth 180° is into the seas.

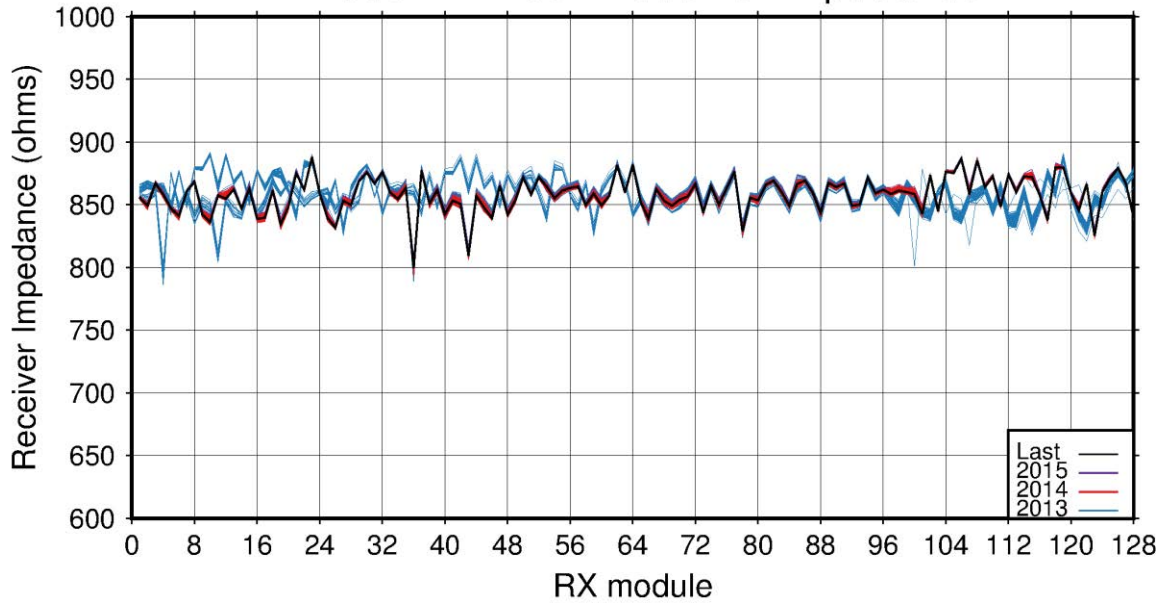
Figure 21. EM302 receiver impedance measurements. Historic measurements are colored and measurements from this evaluation in black. The impedance range on the Y-axis represents the range defined by Kongsberg within which the system will pass a BIST test.

The EM302 receiver and receiver transducer impedances, as measured through the BIST routines, were compared to measurements made throughout the 2013 and 2014 seasons, as well as those conducted during previous system acceptance tests. NA055 BIST results were found to be within the nominal acceptable range expected by the manufacturer (Figure 21 and Figure 22). All but one transmitter impedance value fell within normal ranges (Figure 23). This figures shows that

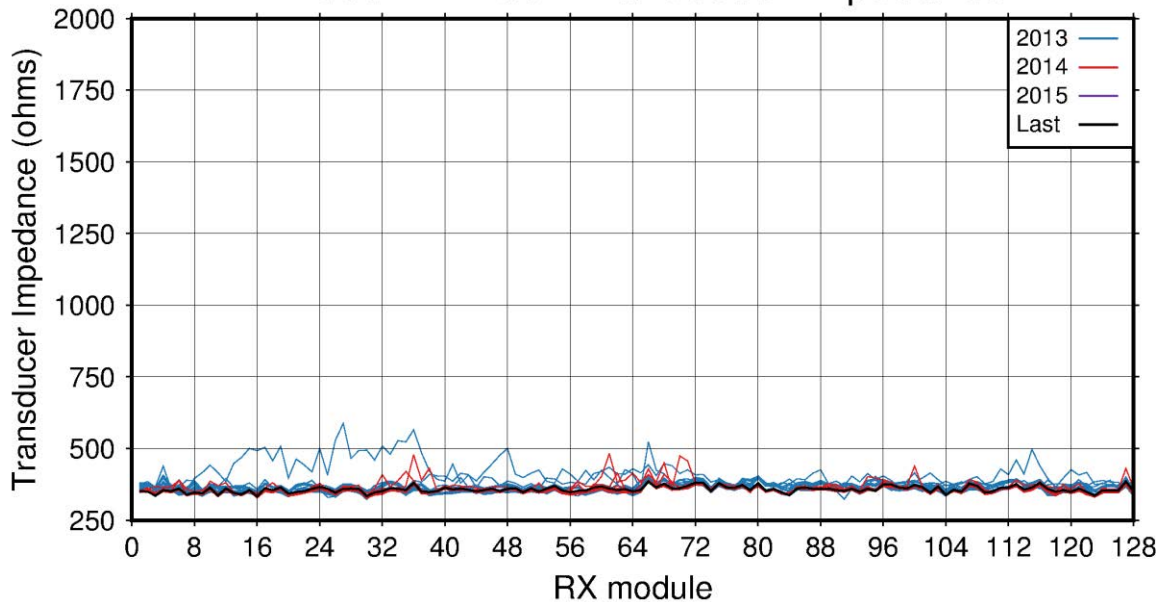
Figure 22. EM302 receiver transducer impedance measurements. Historic measurements are colored in black. The impedance range on the Y-axis represents the range defined by Kongsberg within which the system will pass a BIST test.

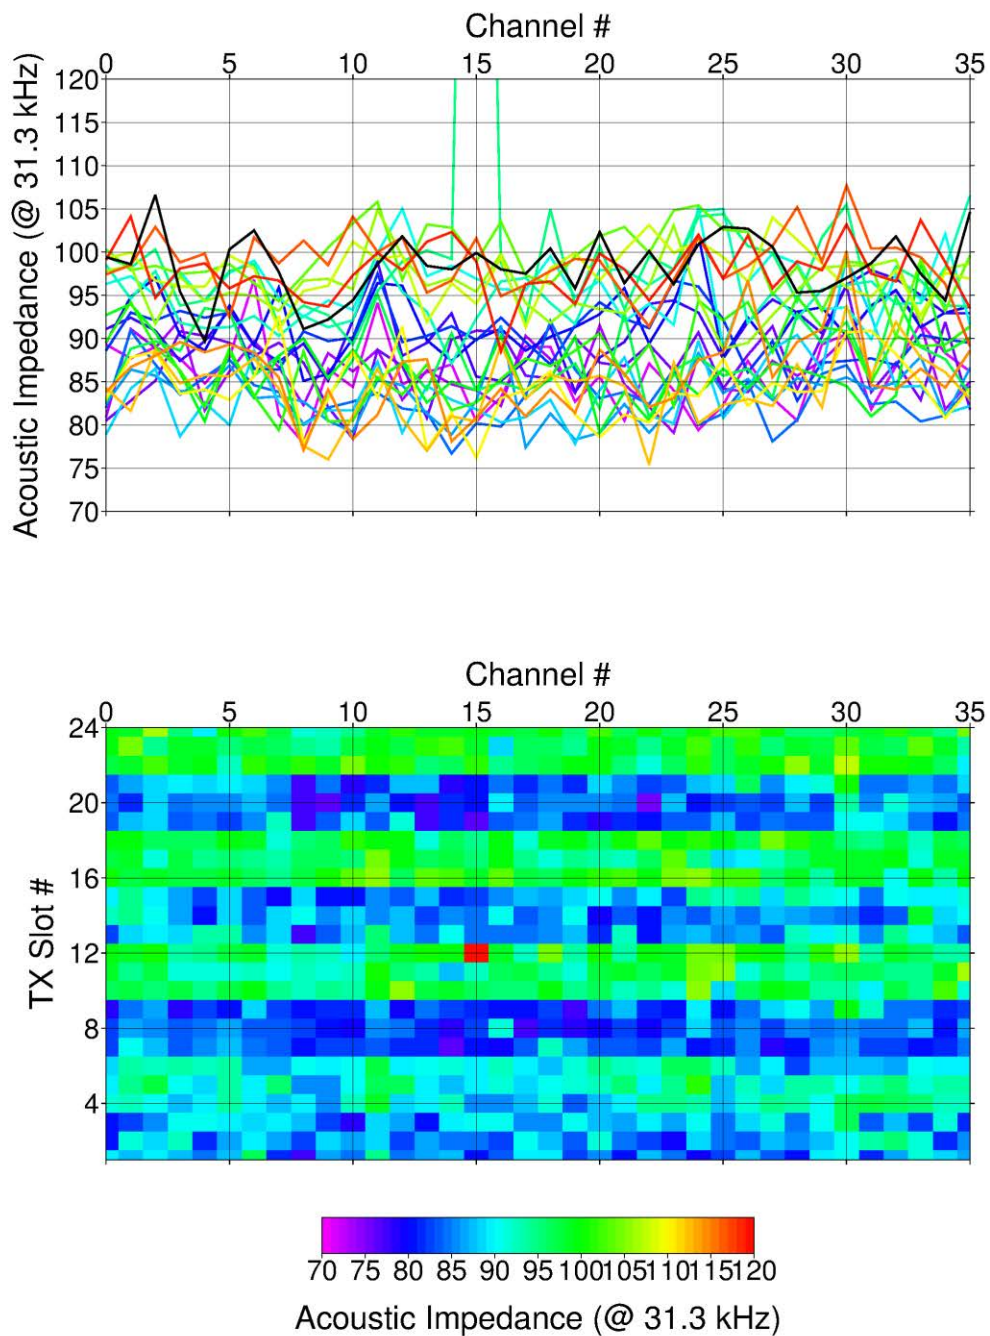
Figure 23. EM302 transmitter acoustic impedances as observed during NA055. Individual colors in the top figure correspond to individual slots across all channels. Slot 12, channel 15 exhibited high impedance in 2014 and 2015, shown by the turquoise line with a spike in the top figure and red square in the bottom figure. There has been no noticeable change in transmitter acoustic impedance between 2014 and 2015.

channel 15 in TX slot 12 reported a high impedance in 2014 and 2015, however, this is not expected to significantly impact transmitter performance.
