## **Data Acquisition & Processing Report**

Project Number: ESD-PHB-18

E/V Nautilus  
EM302 Multibeam Echosounder  
System Review  
NA055  
March 30 – April 5, 2015

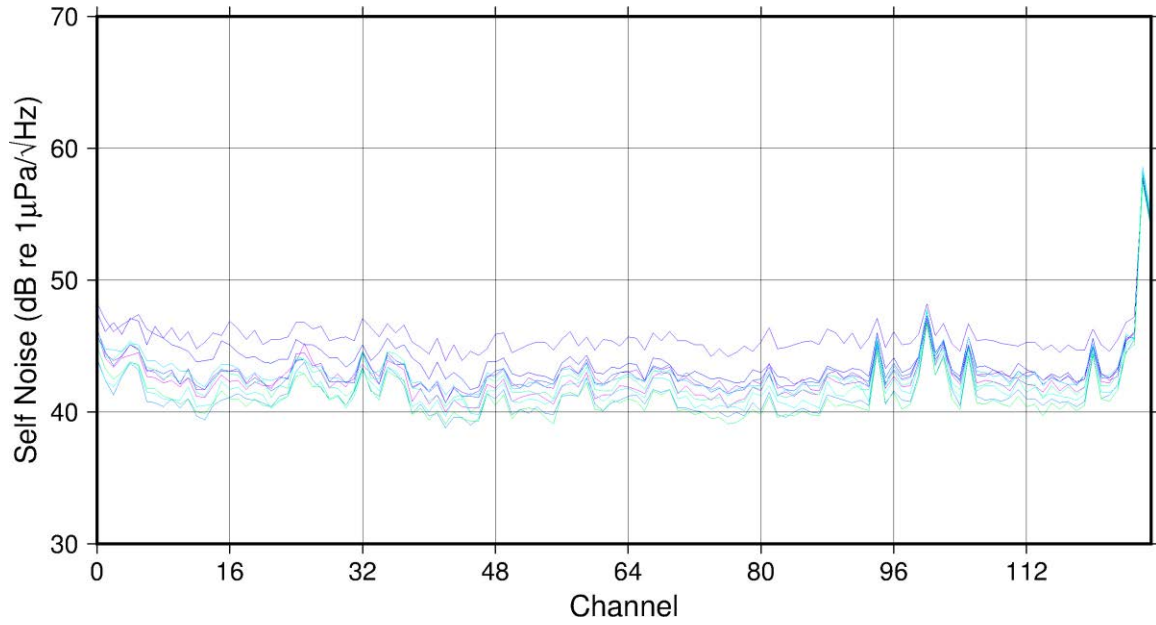
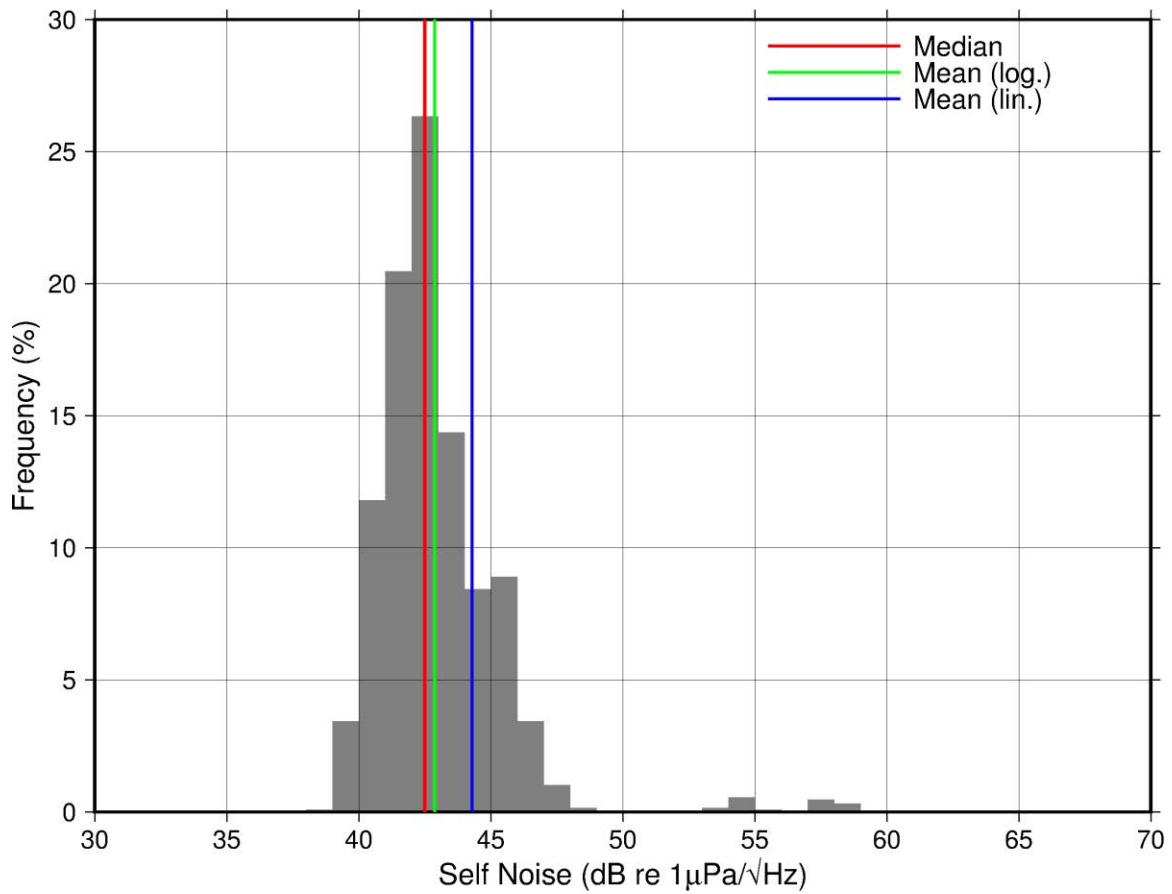
EV Nautilus EM302 Self Noise -- 090 deg

## Self Noise Results - Swell - 090°

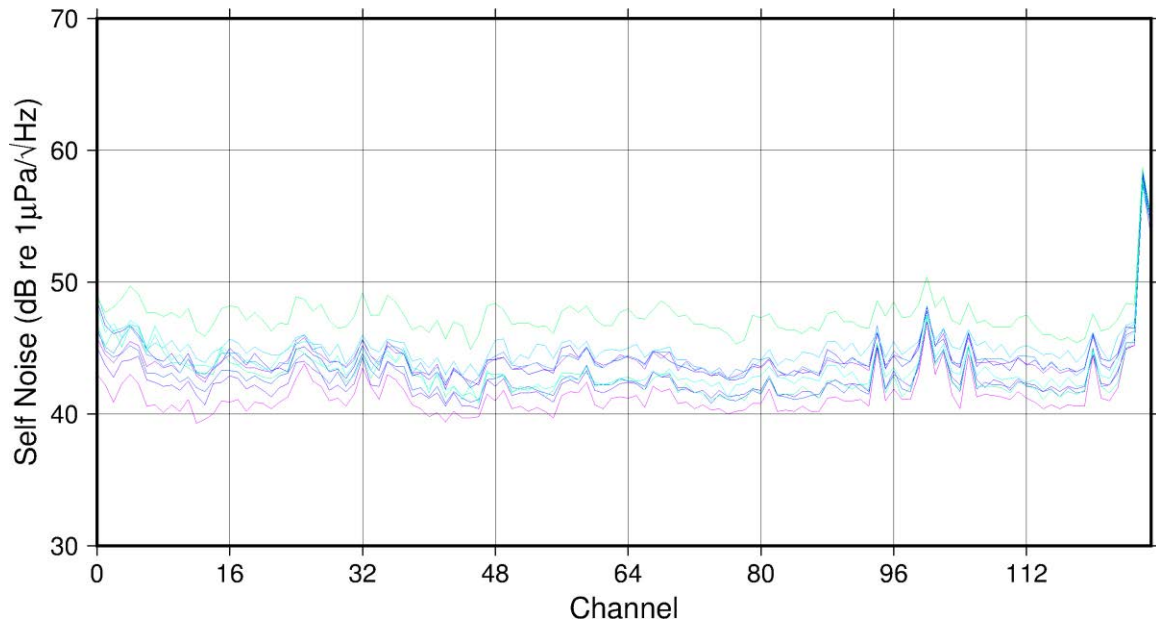
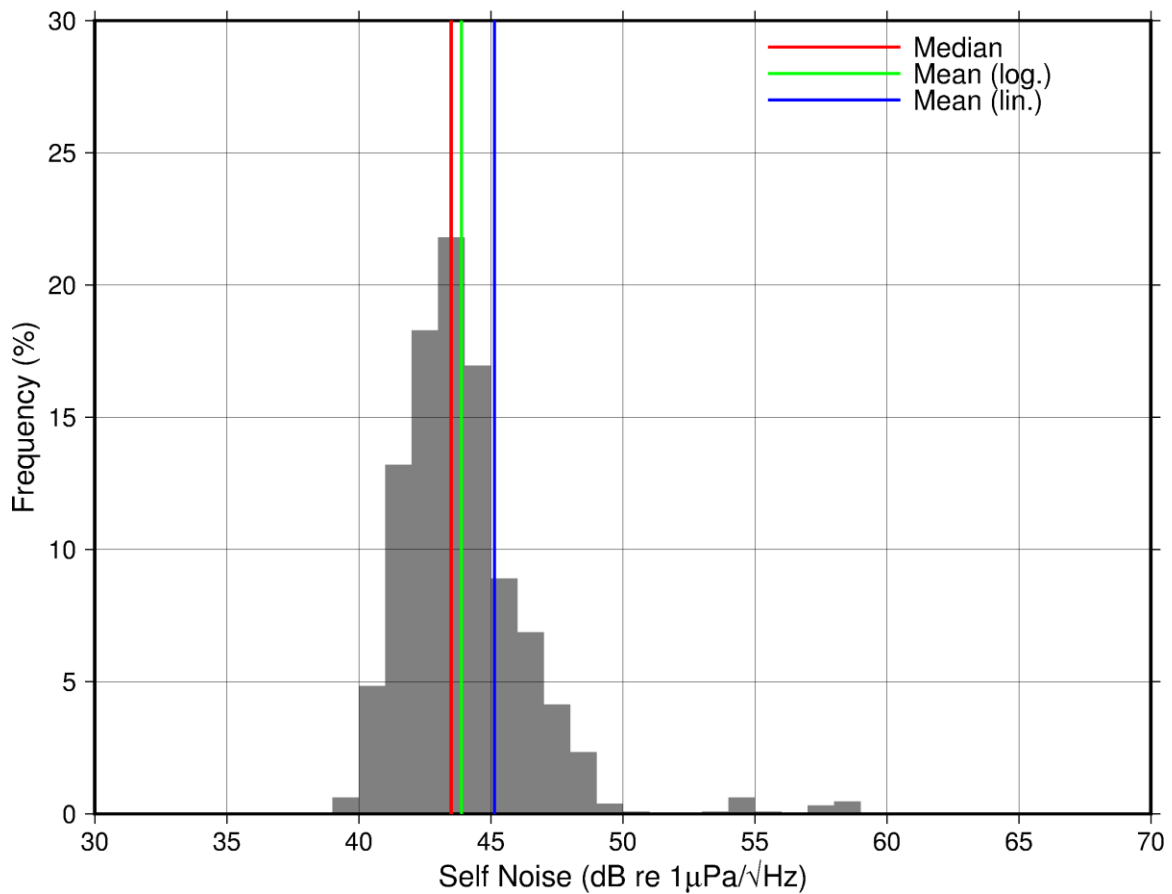
EV Nautilus EM302 Self Noise -- 135 deg

## Self Noise Results - Swell - 135°

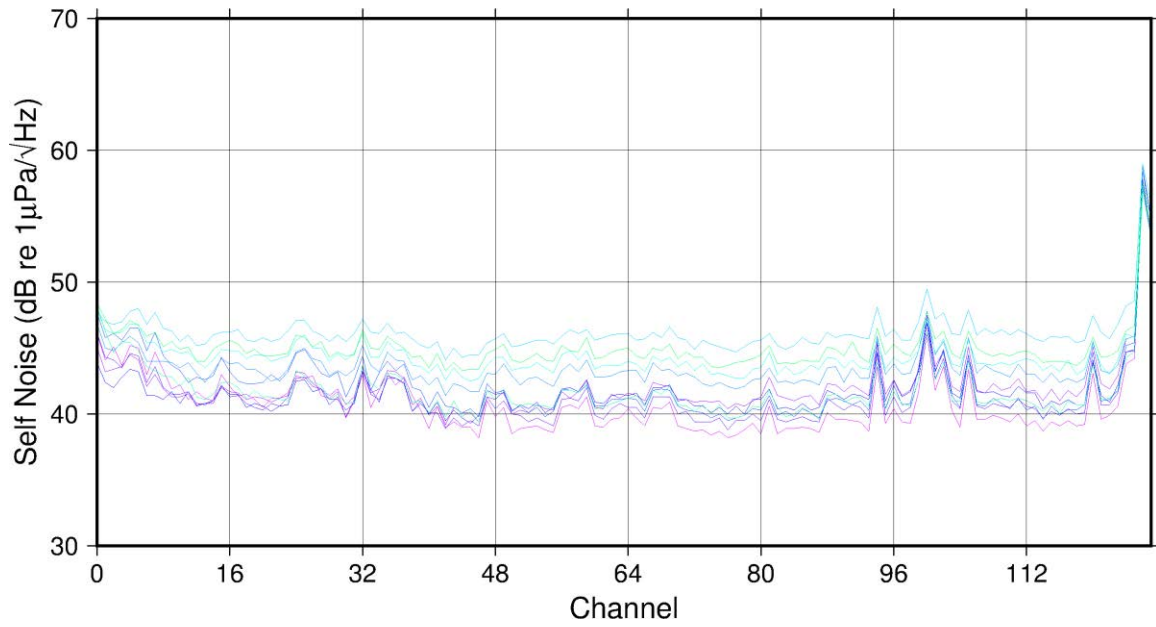
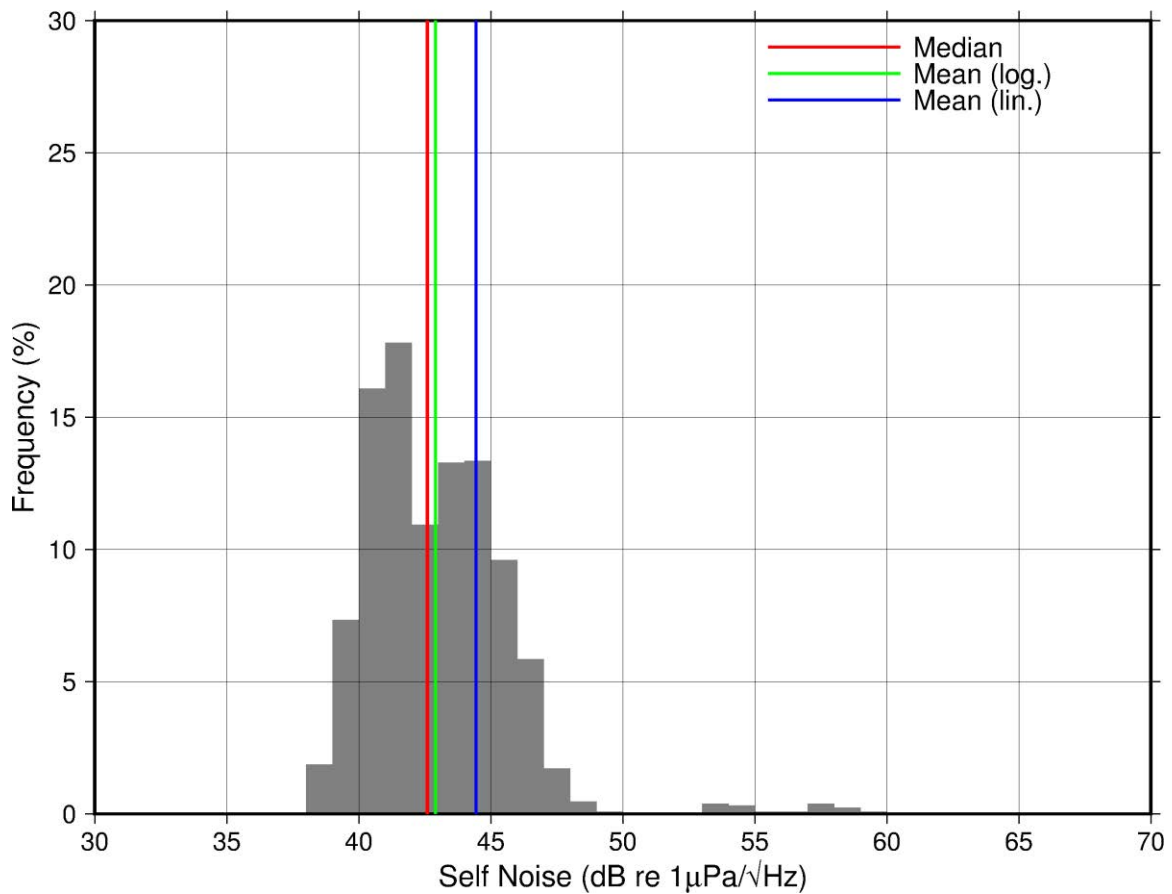
EV Nautilus EM302 Self Noise -- 180 deg

## Self Noise Results - Swell - 180° (Into Swell)

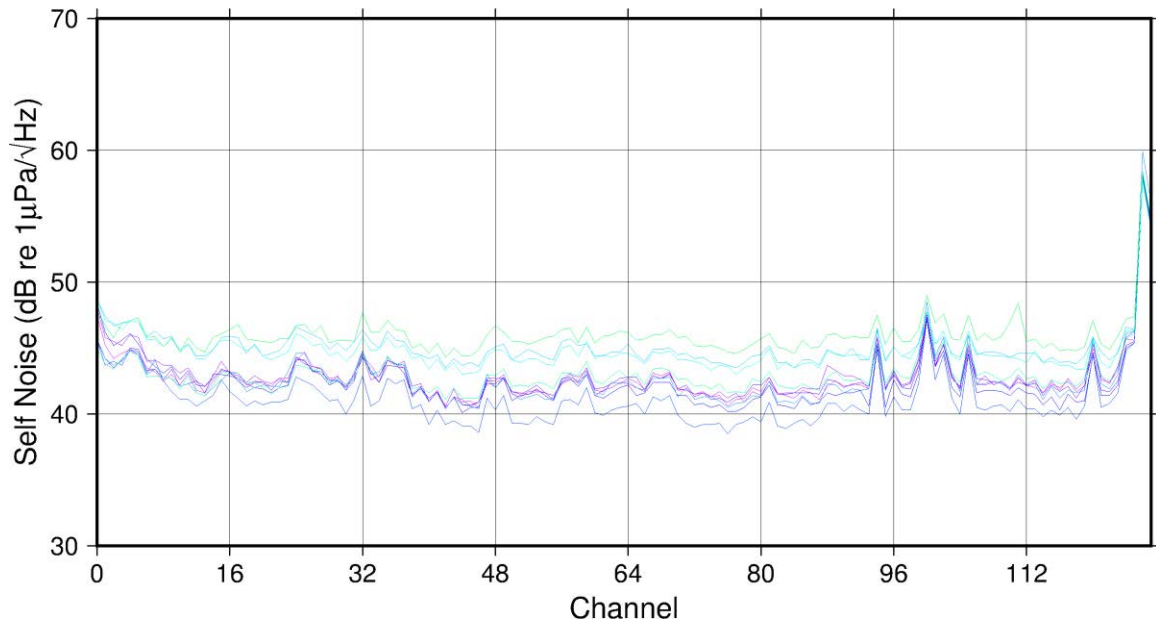
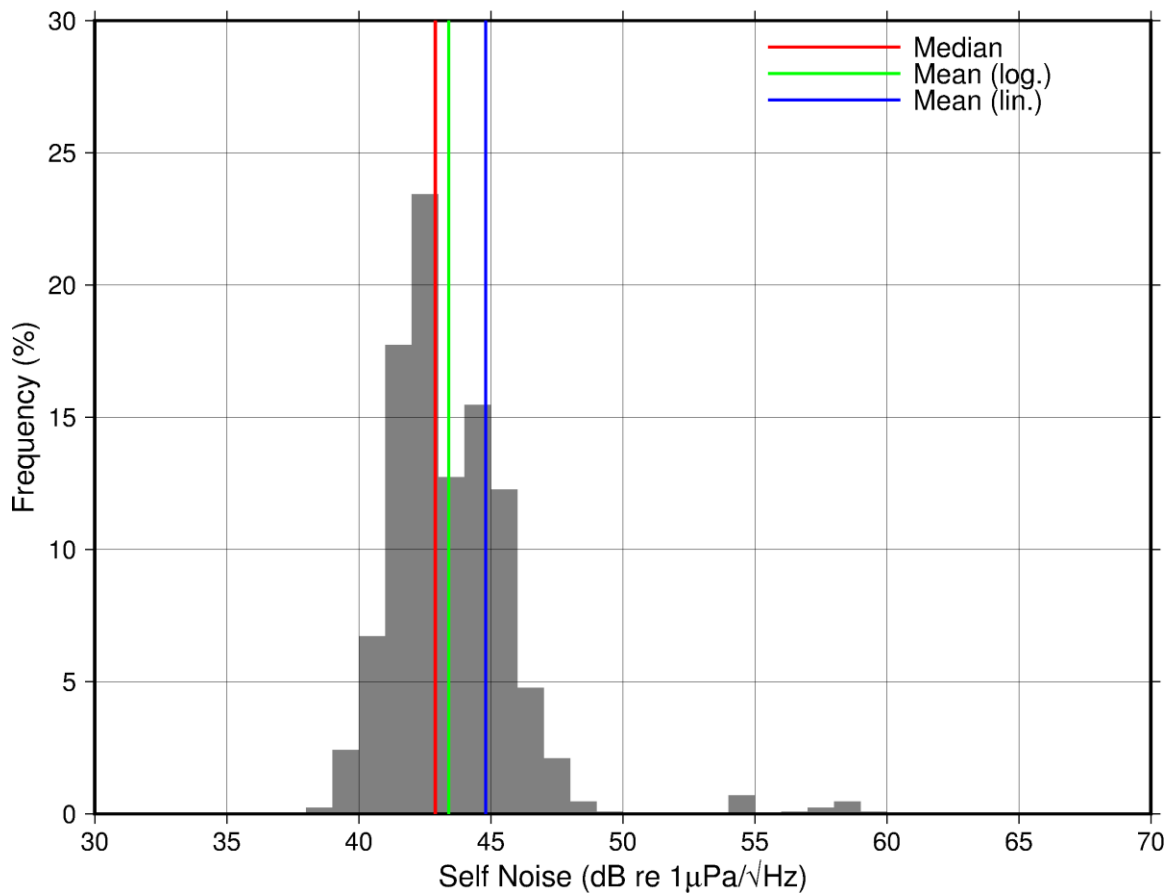
EV Nautilus EM302 Self Noise -- 225 deg

## Self Noise Results - Swell - 225°

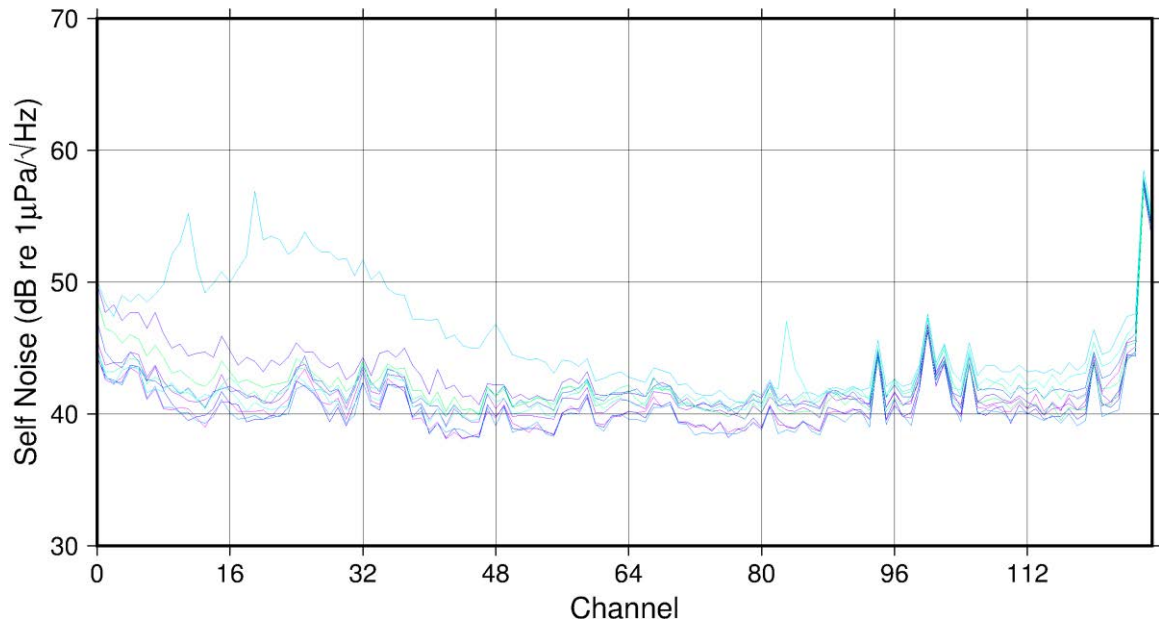
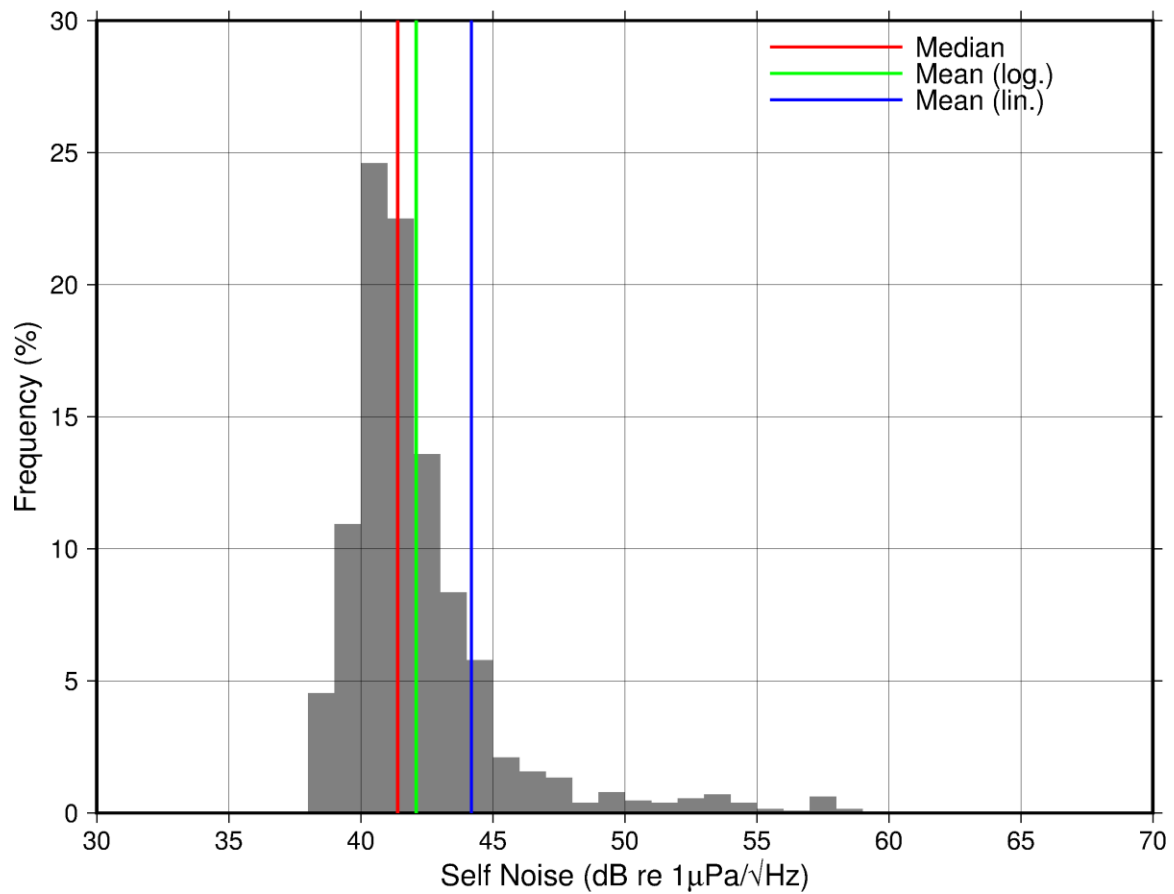
EV Nautilus EM302 Self Noise -- 270 deg

## Self Noise Results - Swell - 270°

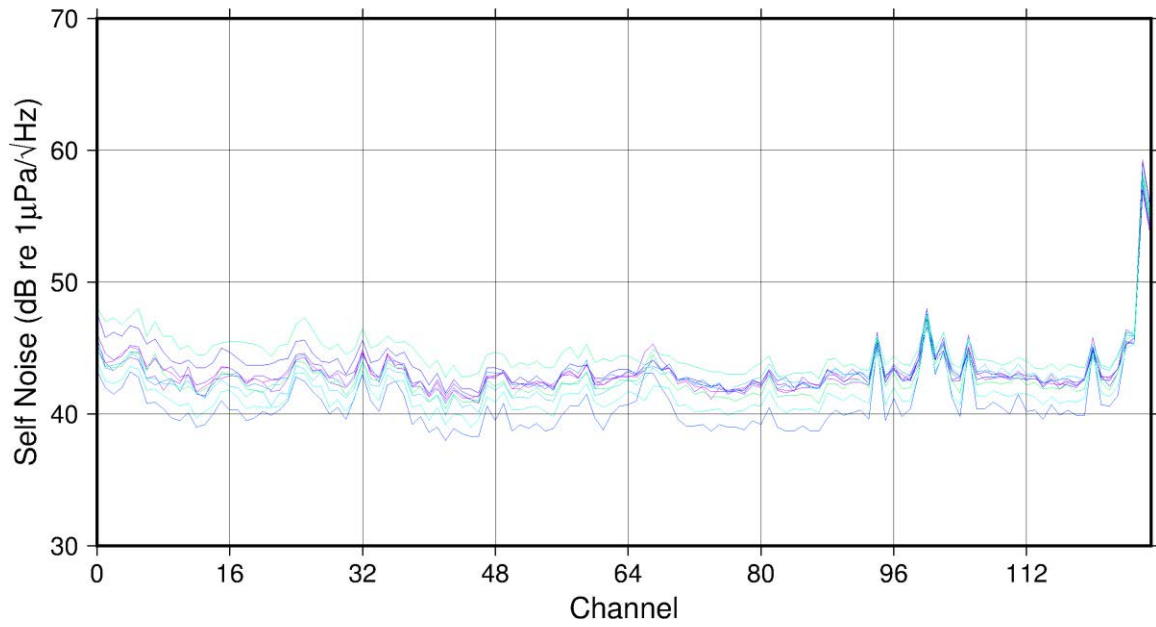
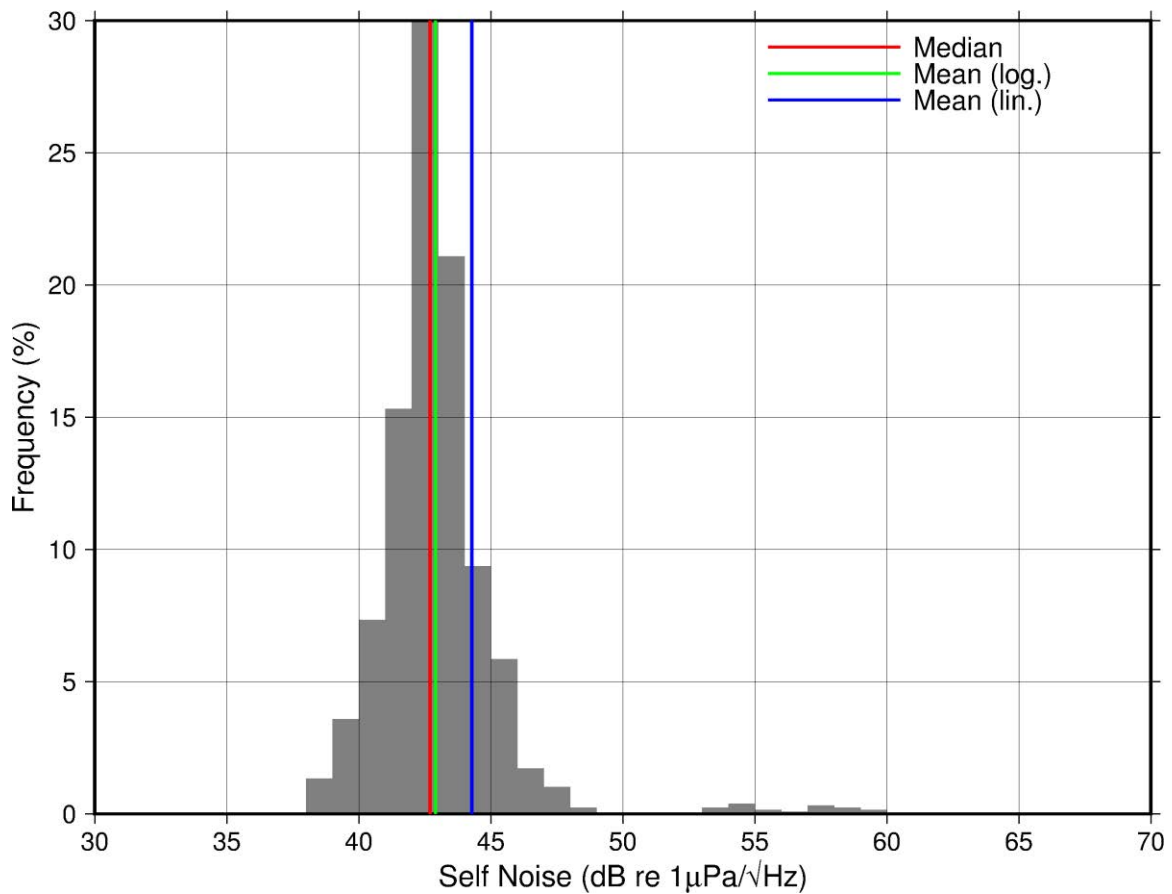
EV Nautilus EM302 Self Noise -- 315 deg

## Self Noise Results - Swell - 315°
