**DESCRIPTIVE REPORT**

Type of Survey: Navigable Area

Sub-locality: Port of Gulfport

## Gulfport Summer Survey

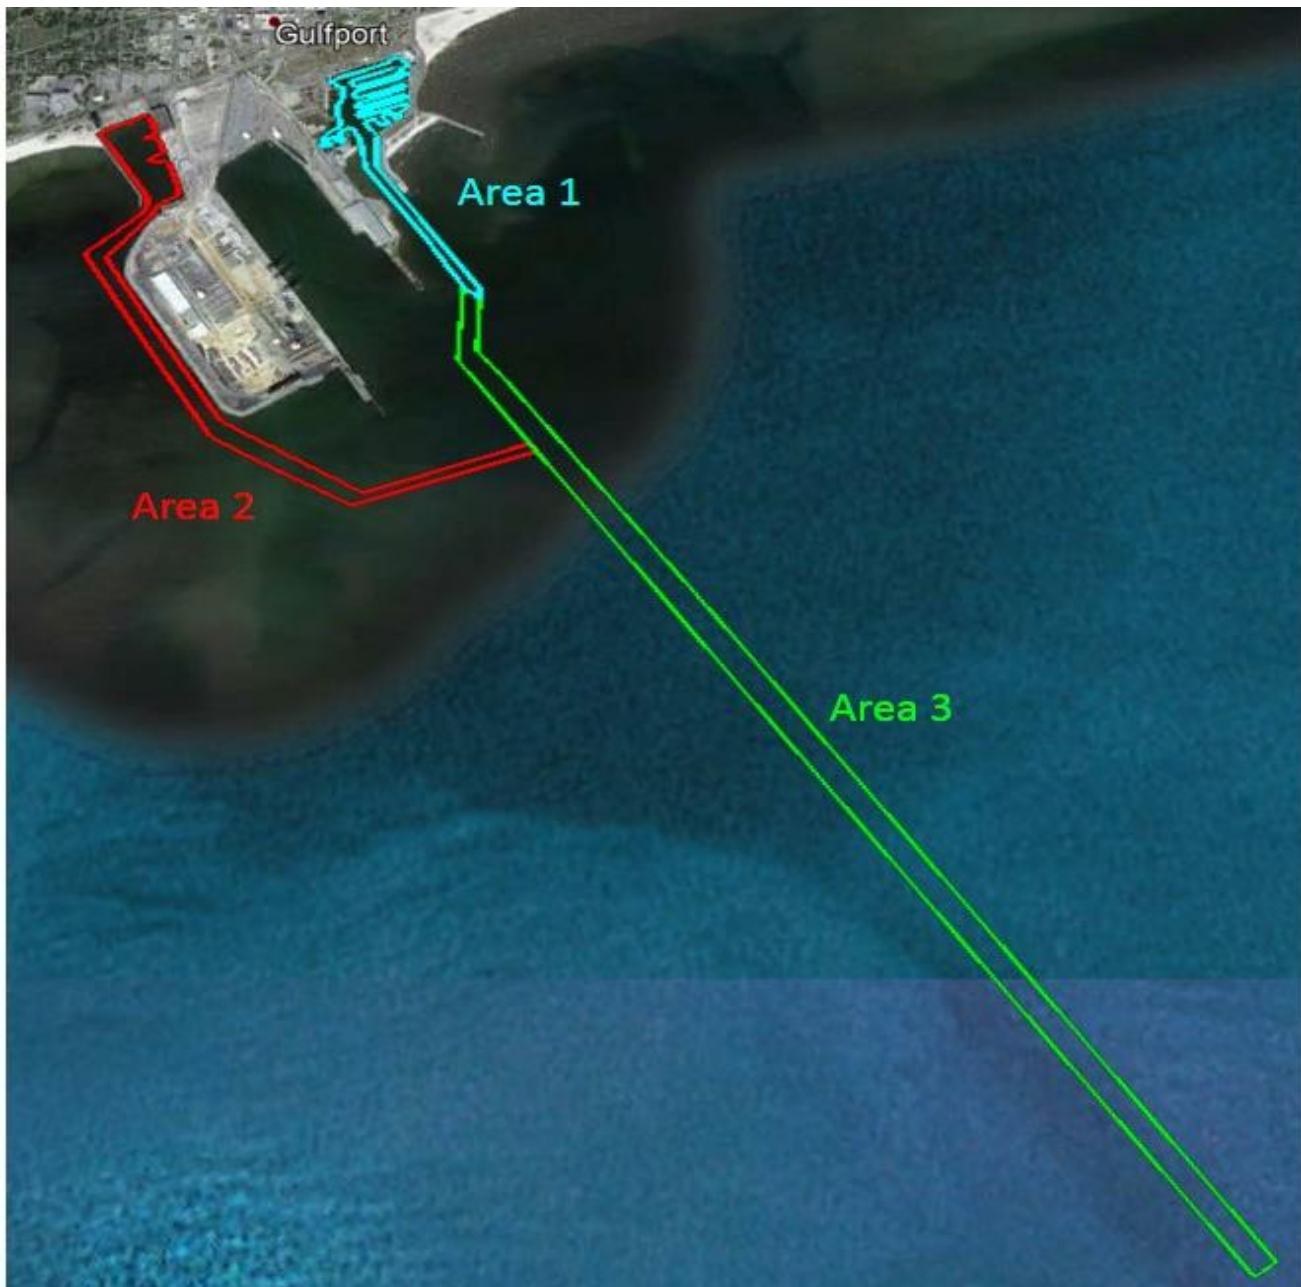
**Figure 2. Priority Areas overlaid on Google Earth imagery (WGS84)**

The three survey areas were then named in order of their priority, as seen in Figure 2, with Priority Area 1 (PA01) being the highest priority, Priority Area 2 (PA02) of next highest importance, and Priority Area 3 (PA03) being the lowest priority. The original goal was to survey each of the PAs in order; as the survey began however, plans changed in order to complete PA03. As this area was the most exposed, it became necessary to conduct survey operations whenever the weather would support due to volatile handling of the R/V GCGC. The survey areas were focused on the main channels that have the most use by commercial and recreational boating traffic and not necessarily on the geographic constraints of the area. Navigable depths were a continuous concern for the vessel and the safety of the survey equipment

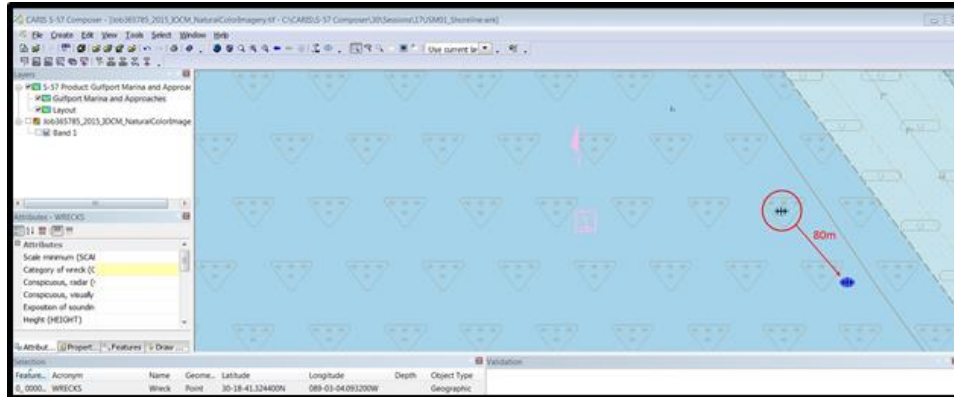
Figure 12. Inclusion of additional wreck debris to the SE.

Average sounding values throughout PA03 were adjusted by 0.6 m and were the most significant of all sounding adjustments. A significant change in PA03 involved the wreck described as being located at 30.311934 N -089.05162 W. SSS confirmed that although a fraction of wreck is located at the charted position, the majority of debris is actually 80m to the southeast as seen in both MBES and SSS in Figure 11-13 below. No other significant changes were made in PA03.

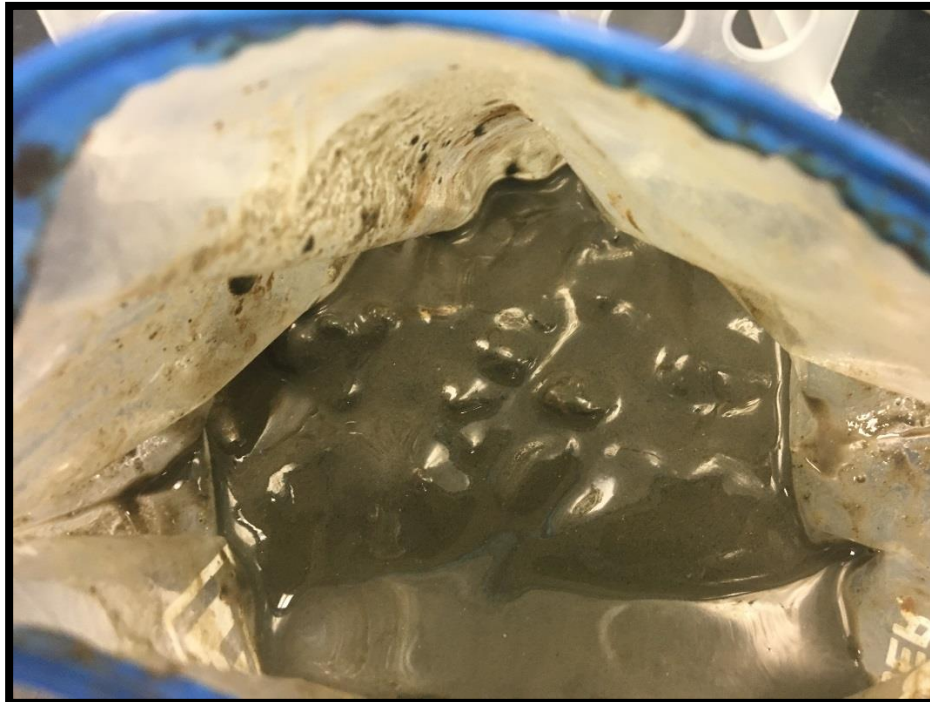
**Figure 23. Bottom sample from PA03 (10m channel).**

Sample Number	Date/ Time UTC	Priority Area	Latitude	Longitude	Sediment Description/NATSU	NATQUA
A1_01	20170609 /2052	1	30.3596	-89.088	Mud, sand	Soft, soft
A1_02	20170608 /1805	1	30.3634	-89.0892	Mud, sand	Soft, soft
A2_01	20170609 /1937	2	30.3457	-89.0932	Sand, shells	Coarse, broken
A2_02	20170609 /1925	2	30.3557	-89.1004	Mud, sand	Soft, soft
A3_01	20170609 /2000	3	30.3169	-89.0541	Silt, clay	Fine, sticky
A3_02	20170608 /1830	3	30.3168	-89.0546	Silt, clay	Fine, sticky
A3_03	20170612 /1805	3	30.3351	-89.0705	Silt, clay	Soft, soft

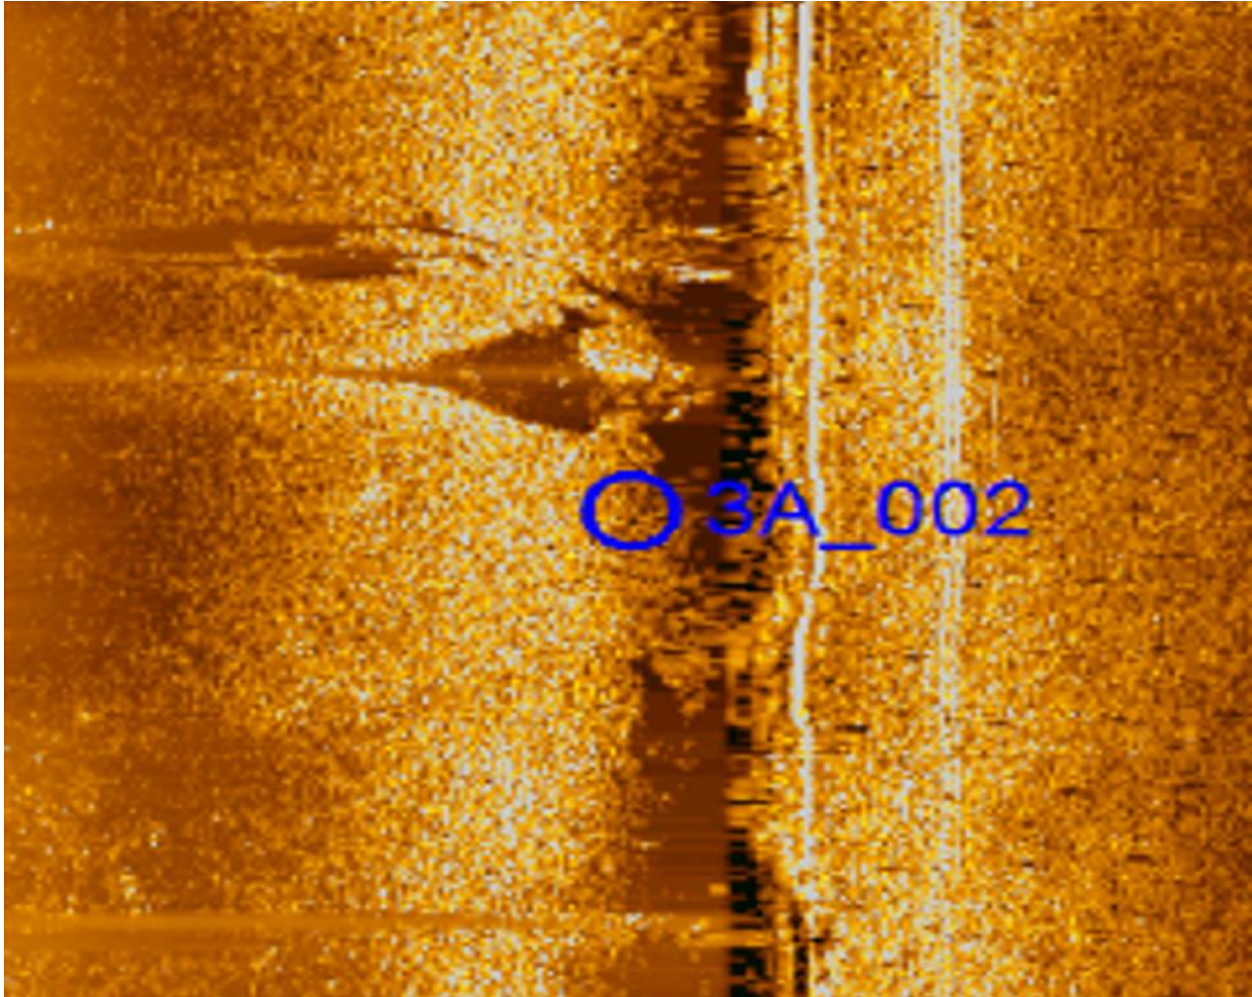
Figure 31 PA03 Contact 002 (SSS only).

Two DTONs referred to in this report as 3A\_001 (Figure 28) and 3A\_002 (Figure 29) were able to be identified in PA03 and classified as the debris of a ship wreck. Although listed as a single feature IAW NOAA's HSSD requirement for features within 4mm on the 1:40,000 scale chart, the features are approximately 8mm apart at 1:5,000 scale ENC and therefore warrant charting as separate features. AWOIS confirms that the sunken shipwreck is known to be scattered, therefore this is not a new DTON. The smaller portion is located at the original coordinates listed on the ENC, and measures 1.77m proud in 2.7 m of water but was only captured by SSS as seen in Figure 29. However the majority of the wreck is located 80m south east of its charted position with a maximum height of 1.58m in similar water depth and can be seen in Figure 28 in both MBES and SSS. Due to the relatively shallow depths of the wreck, it is listed as dangerous. All other obstructions and wrecks charted in this area were investigated, but could not be identified in MBES nor SSS imagery. All DTON images can be found in Appendix B of this report to include all identifiable attributes; length, width, and height derived from shadow size via SSS.

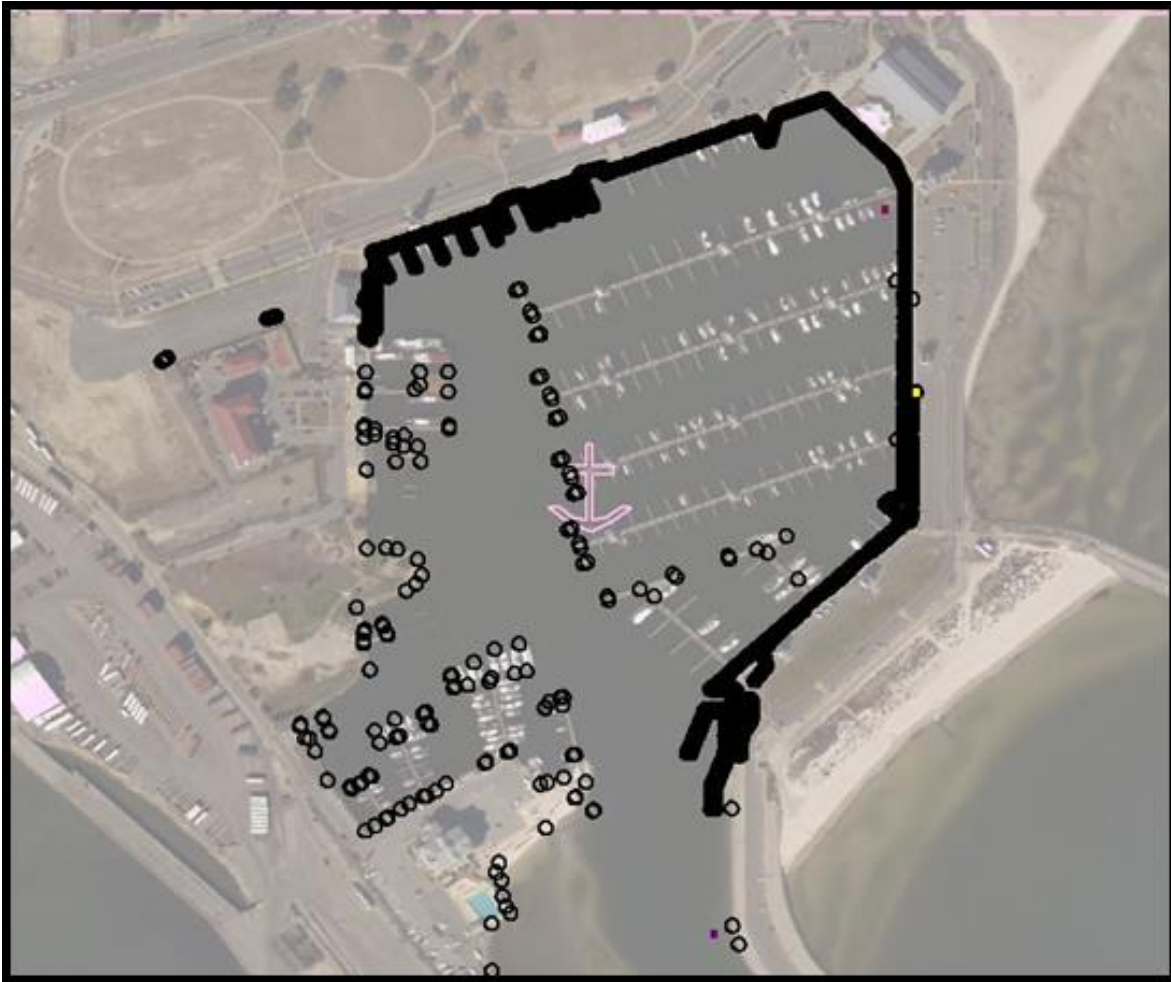
*Figure 32. RTK data overlaid on aerial photogrammetry.*

The TopCon GR-3 and GR-5 base stations were positioned over tidal BM's and programmed to serve as real-time correctors for the GR-3's and GR-5's pole-mounted/wheeled rover units to collect positioning of the shoreline. The RTK solutions were overlaid on the existing ENC data as seen in Figure 32 to provide a guide for shoreline adjustments as well as modifications to recent constructions/destruction; included were several marina piers recently built, as well as storm damage throughout the area. The aerial and satellite images were collected in 2015 and 2017

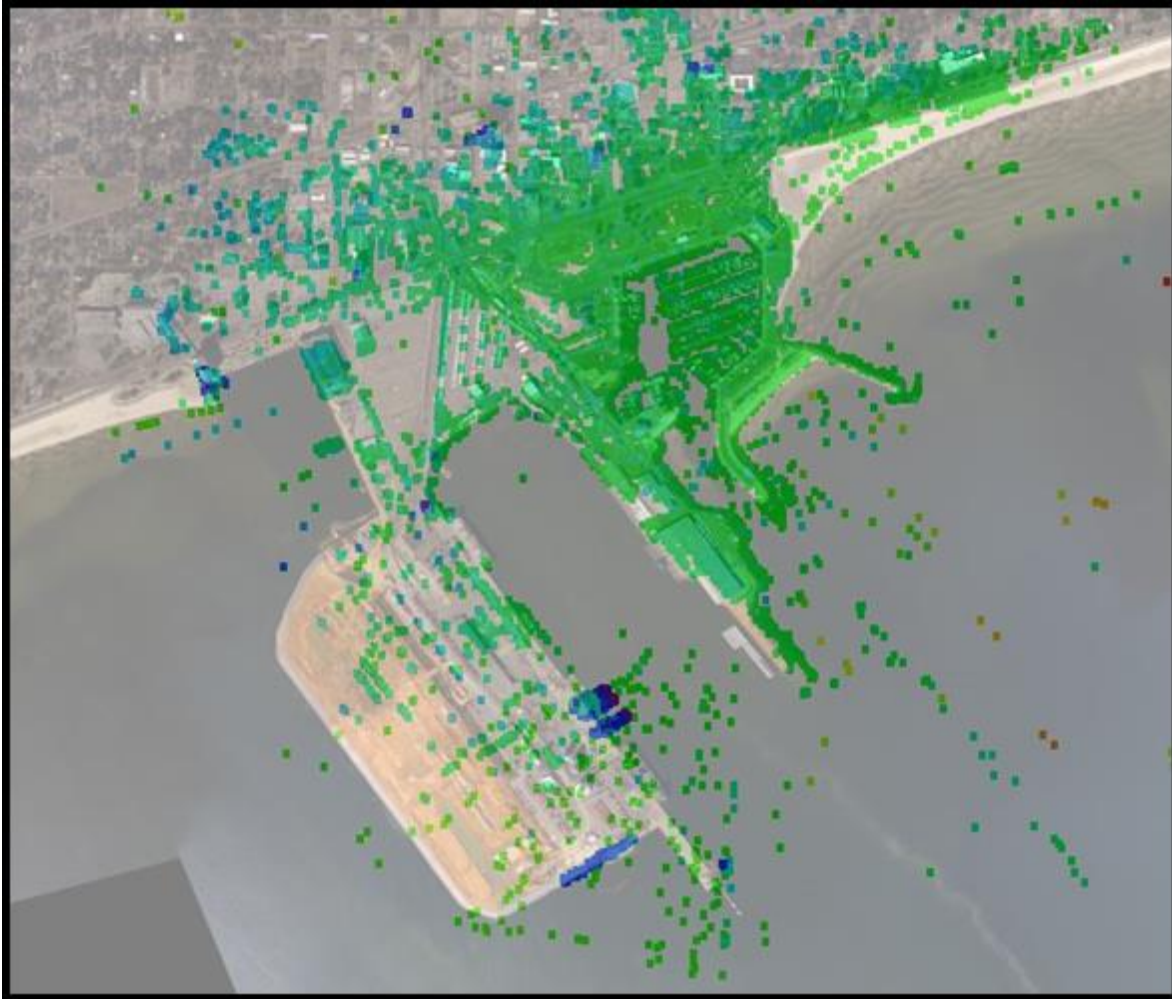
Figure 33. LIDAR data overlaid on satellite photogrammetry.

respectively and were consulted alongside the terrestrial based LIDAR point cloud, Figure 33, to further develop piers with restricted access that precluded on site GNSS data collection.
