DESCRIPTIVE REPORT

Registry Number: W00708

Saint Paul Island Harbor

Multibeam/Singlebeam Bathymetry, Mobile/Static LiDAR, and Control Survey

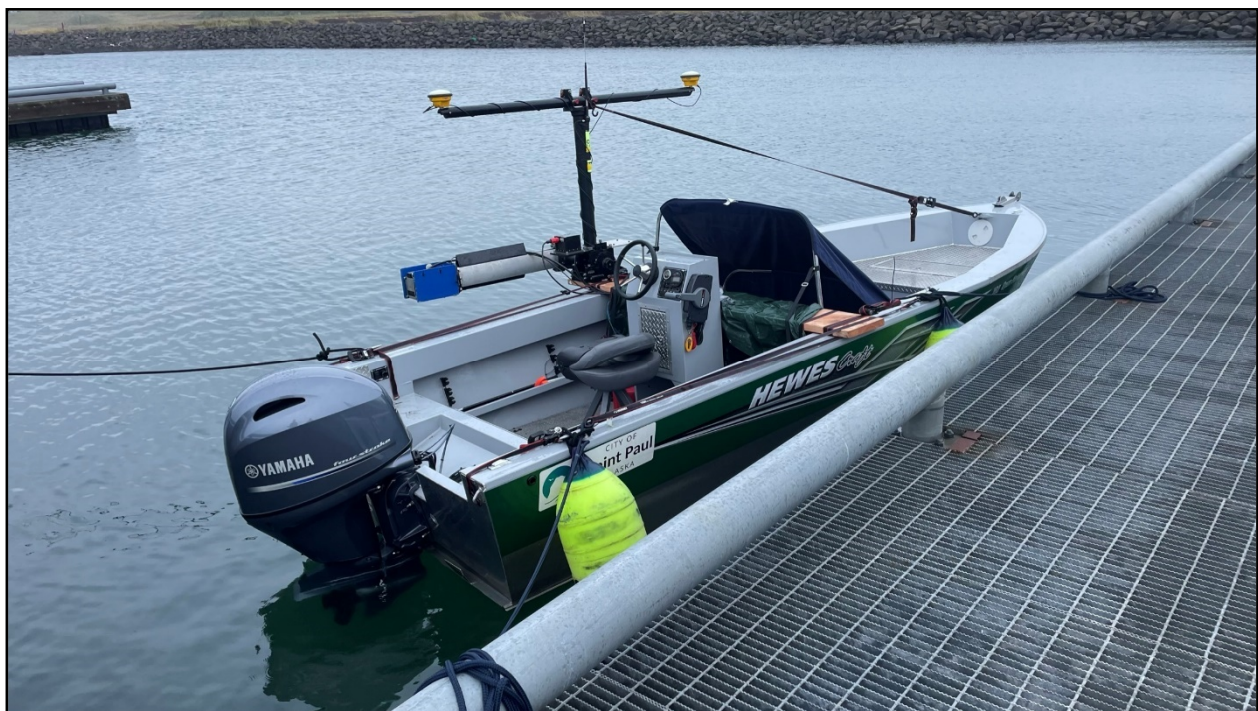
Figure 3 VOOP Vessel

All Multibeam was completed onboard a local Vessel of Opportunity (VOOP) (Figure 3). The VOOP was an open aluminum monohull vessel that was acquired and mobilized on St. Paul Island, AK. A positioning and motion detection system was installed on the vessel with a long antenna base allowing for maximum heading accuracy and better results in areas with low GNSS coverage. The VOOP had all offsets measured to ensure that measurements to and from the positioning equipment are accurate to less than 3cm.

A POS MV WaveMaster V5 was used to position the vessel during survey operations. An R2Sonic 2020 Multibeam EchoSounder (MBES) was mobilized on the vessel using the side mounted Universal Sonar Mount (USM). The mount positions the system with 100% repeatability and was specifically designed with a break-away block system that protects the sonar from damage while working in shallow water, areas with large obstructions, or waters with strong currents.

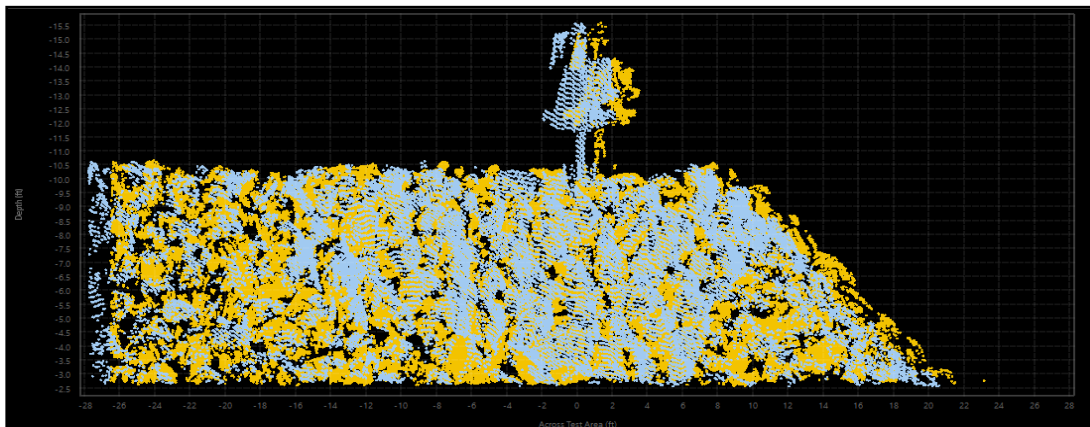
Figure 10 Example Pre-Boresight Calibration

All LiDAR data was processed in QINSy and RiScan Pro. A post-processed trajectory solution was computed using Applanix PosPac, which supplied a Post-Processed Kinematic (PPK) solution using the full 200 Hz update rate from the IMU. After initial application of the PPK trajectory, a bore-sight calibration was performed utilizing specific pairs of lines collected during calibration operations. An example of a pre- and post-calibration can be seen below in Figure 10 and Figure 11.

A bore-sight calibration quantifies and adjusts for misalignment angles between a scanner and the IMU. During the survey, specific planned lines were run along fixed objects such as piers, buildings, navigation aids, or flag poles. Based on various vessel and scanner orientations, each of the three misalignment angles (roll, pitch, and yaw) can be isolated and corrected in post processing.

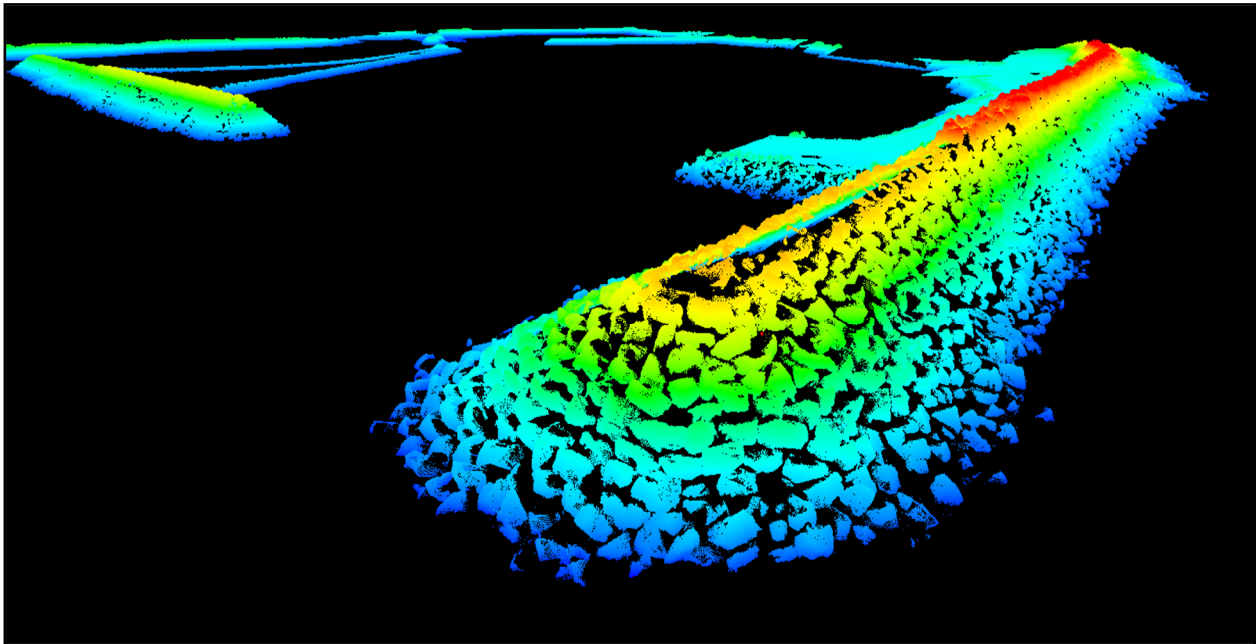
Figure 12 3D Point Cloud of LiDAR Data

LiDAR data was analyzed in a 3D point cloud environment, which shows the full sounding dataset; this gives the processor the ability to fully analyze features and environments. Geological features and manmade objects are better quantified and understood by analyzing the dataset in a 3D environment. Figure 12 shows a 3D view of the end of a breakwater.

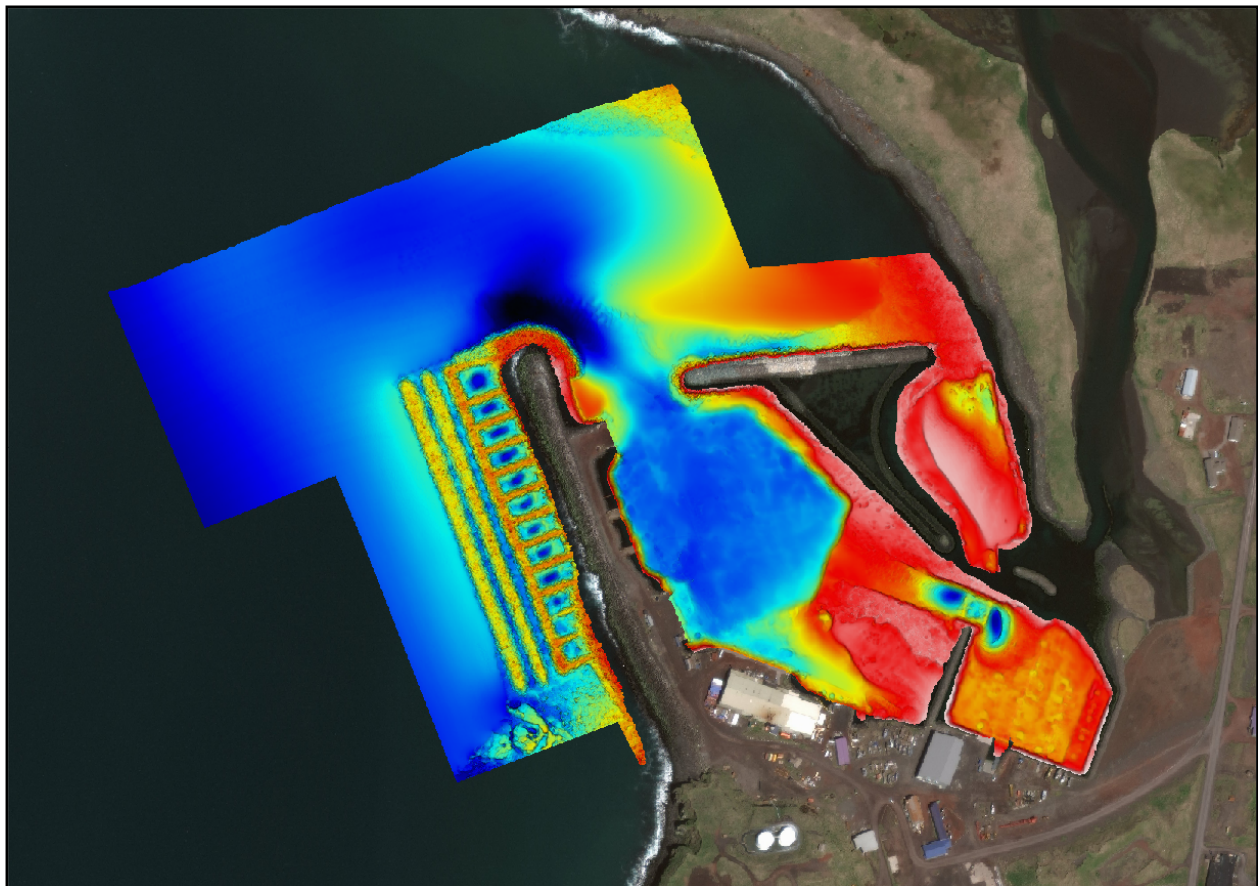
Figure 13 Overview of MBES Data in St. Paul Harbor

Multibeam data was acquired September 30th through October 9th, 2022. Singlebeam data was acquired October 12th, 15th, and 16th, 2022. All multibeam data and positioning of the vessel data was acquired in QINSy software. Vessel positioning data was logged in POSView software. Sound velocity casts were collected to account for change throughout the water column at varying depths; casts were geospatially dispersed throughout the area to account for potential influencing environmental factors. Sound velocity was also measured and monitored at the sonar head to account for rapid changes and aid in beam forming for precise depth measurements. To compliment an overlap with mobile terrestrial LiDAR data, MBES data was collected during the highest tide during the duration of the project and scan data was collected during the lowest tide in St. Paul. An overview of the data can be seen below in Figure 13.

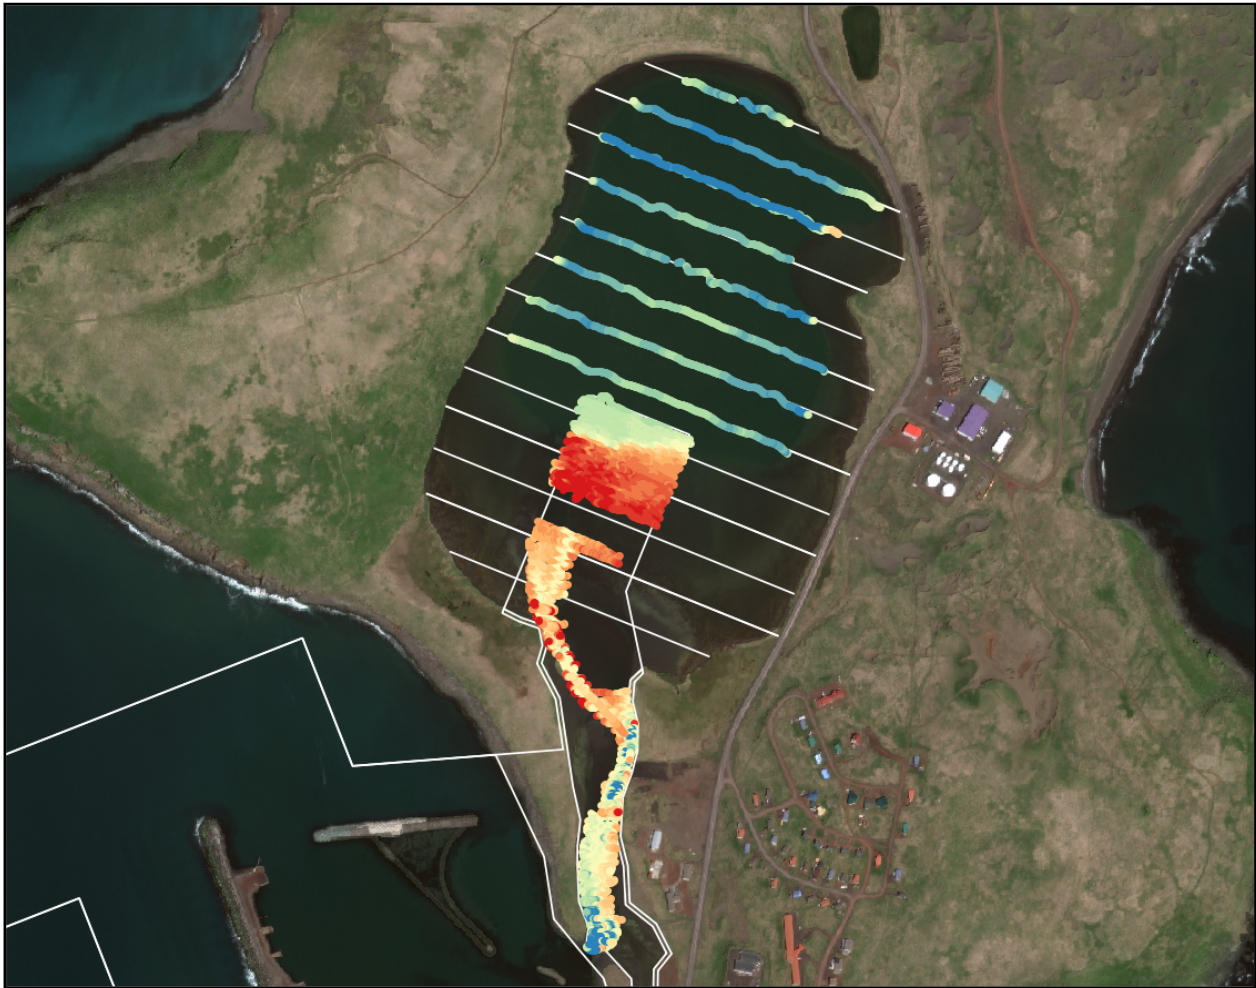
Figure 14 Overview of SBES Collection

Singlebeam and topographic data was collected within the lagoon survey area. Within the lagoon, Singlebeam data was collected along 250ft transects. An overview of the Singlebeam can be seen below in Figure 14.

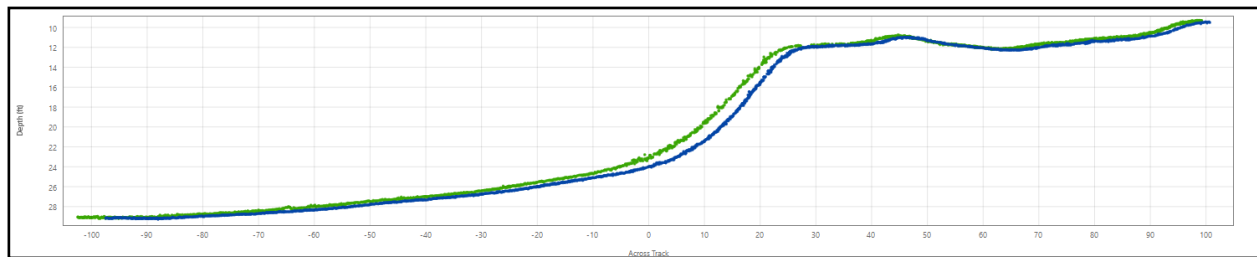
Figure 15 Example Pre-Patch Test Pitch Calibration

A patch test calibration quantifies and adjusts for misalignment angles between the multibeam sonar and the IMU. During the survey, specific planned lines were run to account for Roll, Pitch, and Yaw misalignment values.

Based on this patch test, each of the three misalignment angles can be isolated and corrected in post processing. An example of a pre and post patch test calibration can be seen below in Figure 15 and Figure 16.

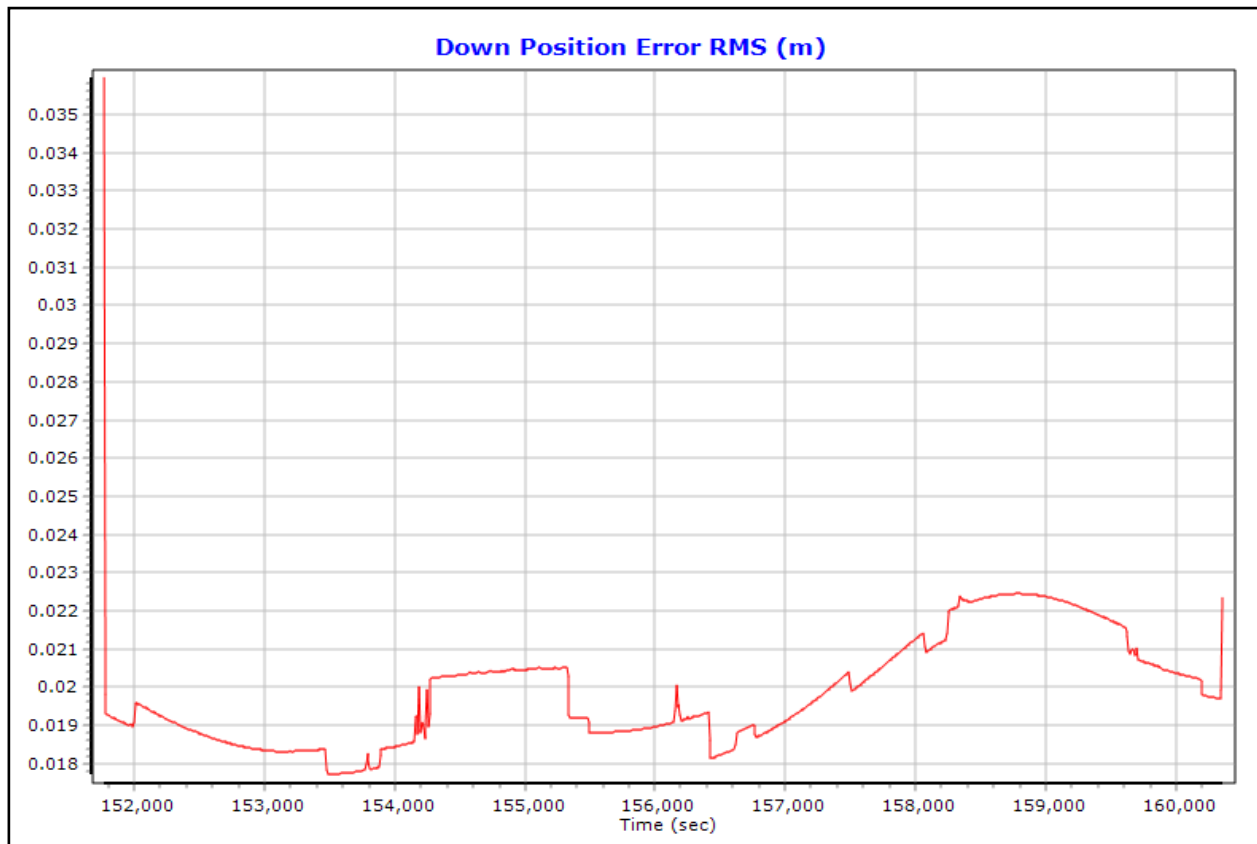
Figure 17 Example of Down Position Error for the Multibeam/LiDAR Surveys

Position data was post-processed in Applinix POSpac MMS Inertial processing software using both the vessel data file and receiver file (RINEX). This allowed for the creation of a more accurate and robust Smoothed Best Estimate of Trajectory (SBET) solution which was applied to both the Multibeam and LiDAR data for positioning corrections and horizontal and vertical control throughout the duration of the surveys. Prior to applying corrections, the SBET was analyzed for errors as seen below in Figure 17. After the data was analyzed for errors, the full motion and position solution of the SBET was applied to the MBES data to maximize overall accuracy.

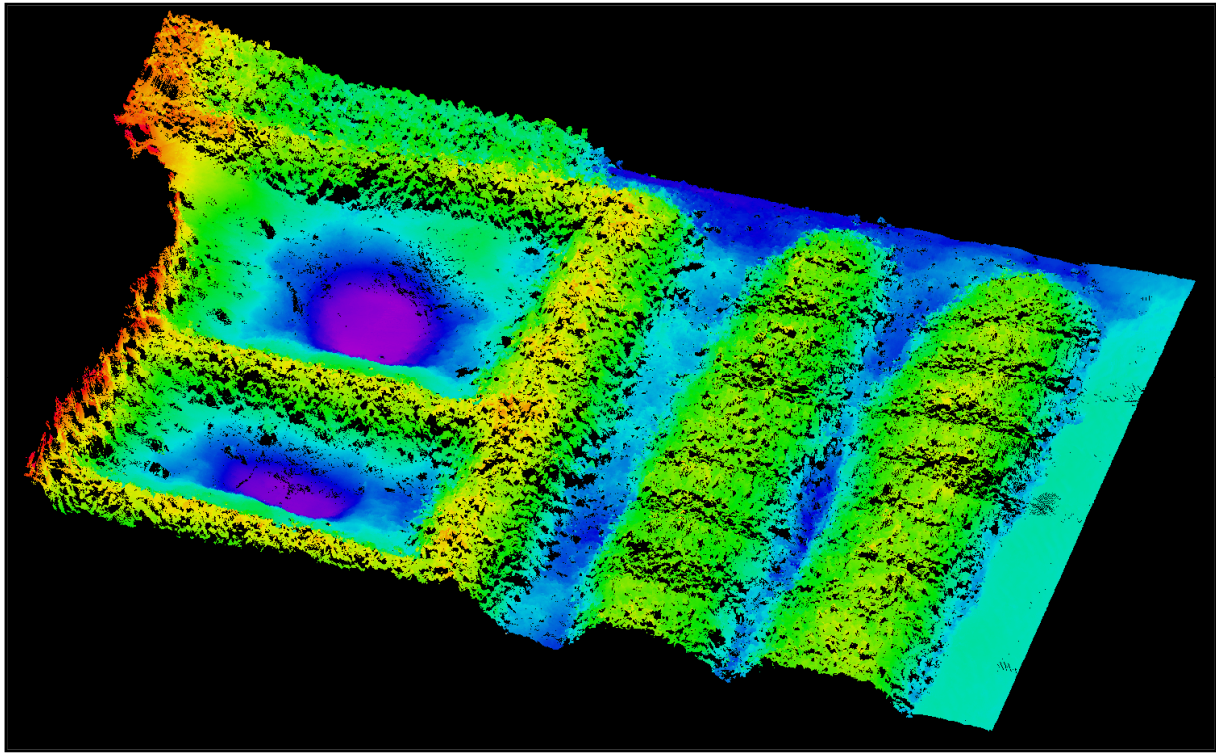
Figure 19 Point cloud of MBES data (vertical exaggeration x5)

Data was gridded at the highest resolution that the data coverage allowed. The resulting grid cell size was 1.5ft x 1.5ft. The point cloud data allows for a better understanding of object definition by viewing in 3D. A view of the point cloud data can be seen below in Figure 19.

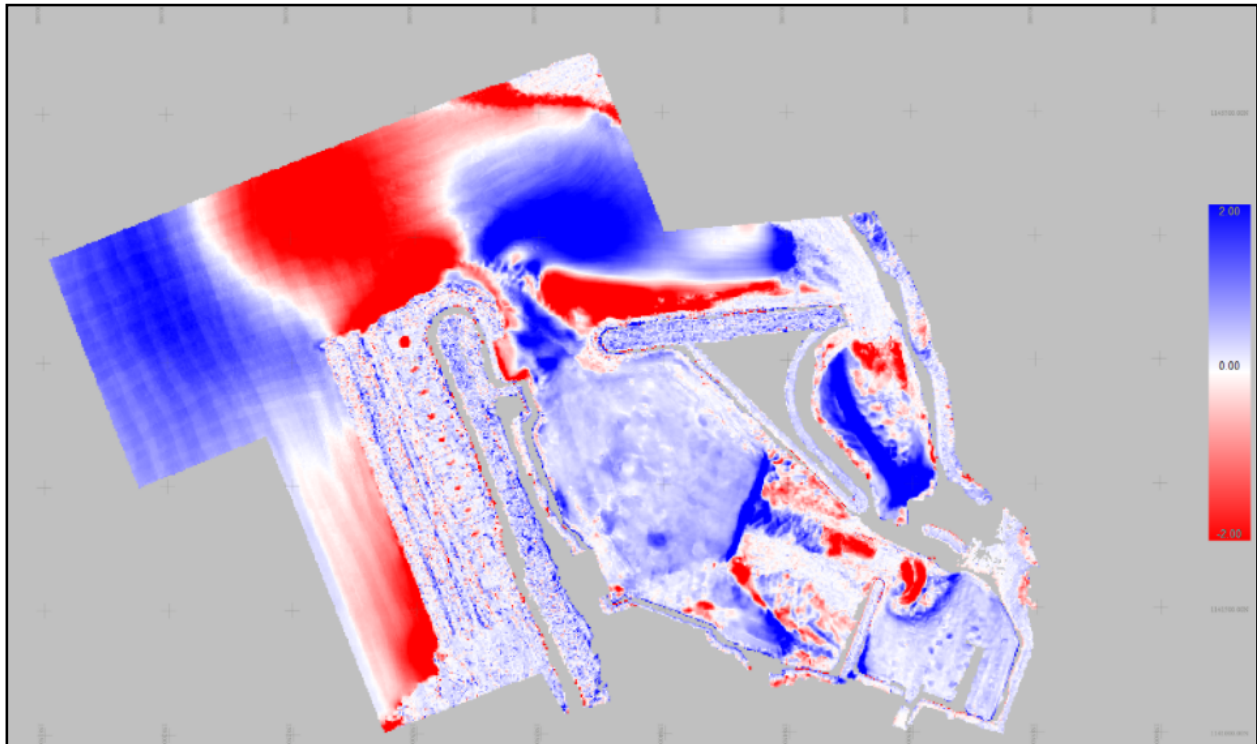
Figure 32 MBES Surface Differences October 2022 vs August 2020

Comparisons were made between the MBES and LiDAR datasets collected October 2022 and the dataset collected August 2020. Figure 32 shows an overall difference grid between the two data sets and accompanying profile views can be seen in Figure 33 through Figure 35.

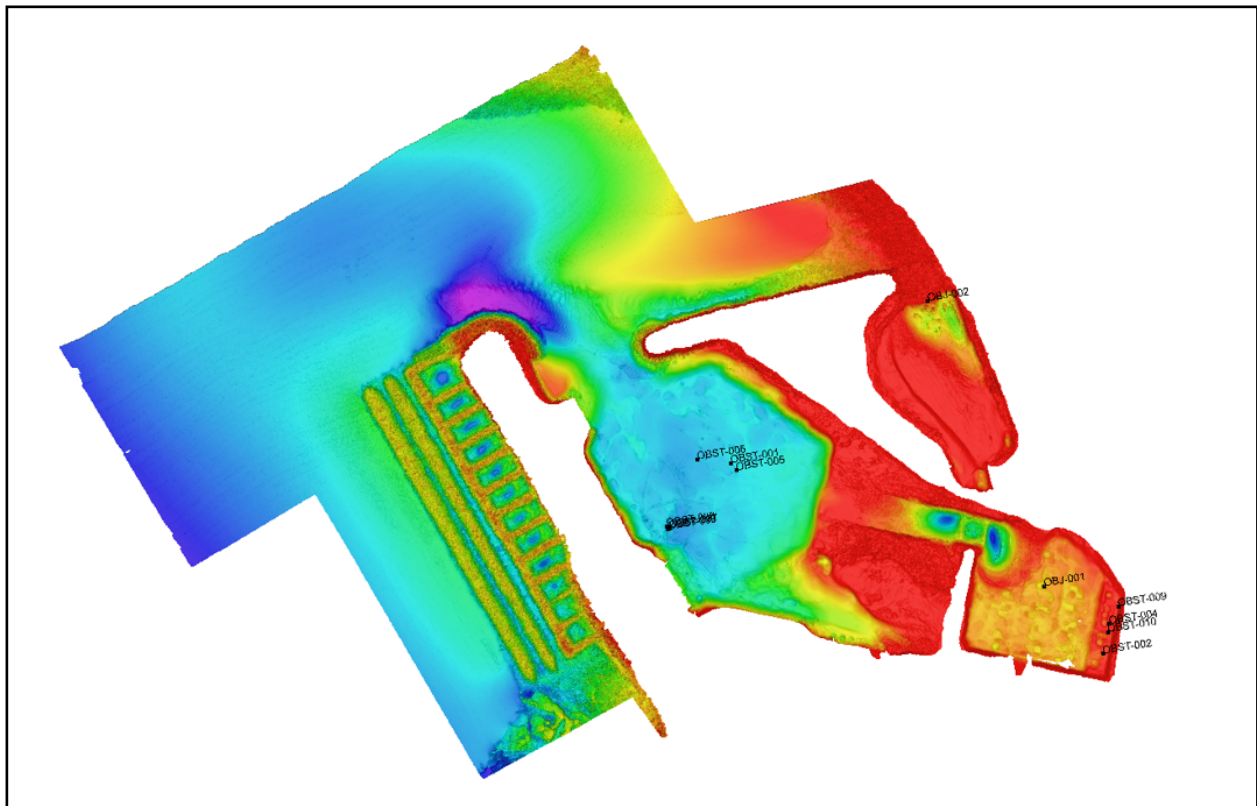
Figure 36 Location of Obstructions and Objects to Navigation within St. Paul Harbor

In St. Paul Harbor, ten (10) Obstructions to Navigation were located in the MBES data. The horizontal position, size, and shoalest depth of these objects was determined using the MBES data. Figure 36 shows an overview of the Objects and Obstructions within the survey area. Information on these objects, along with selected images, can be found below.

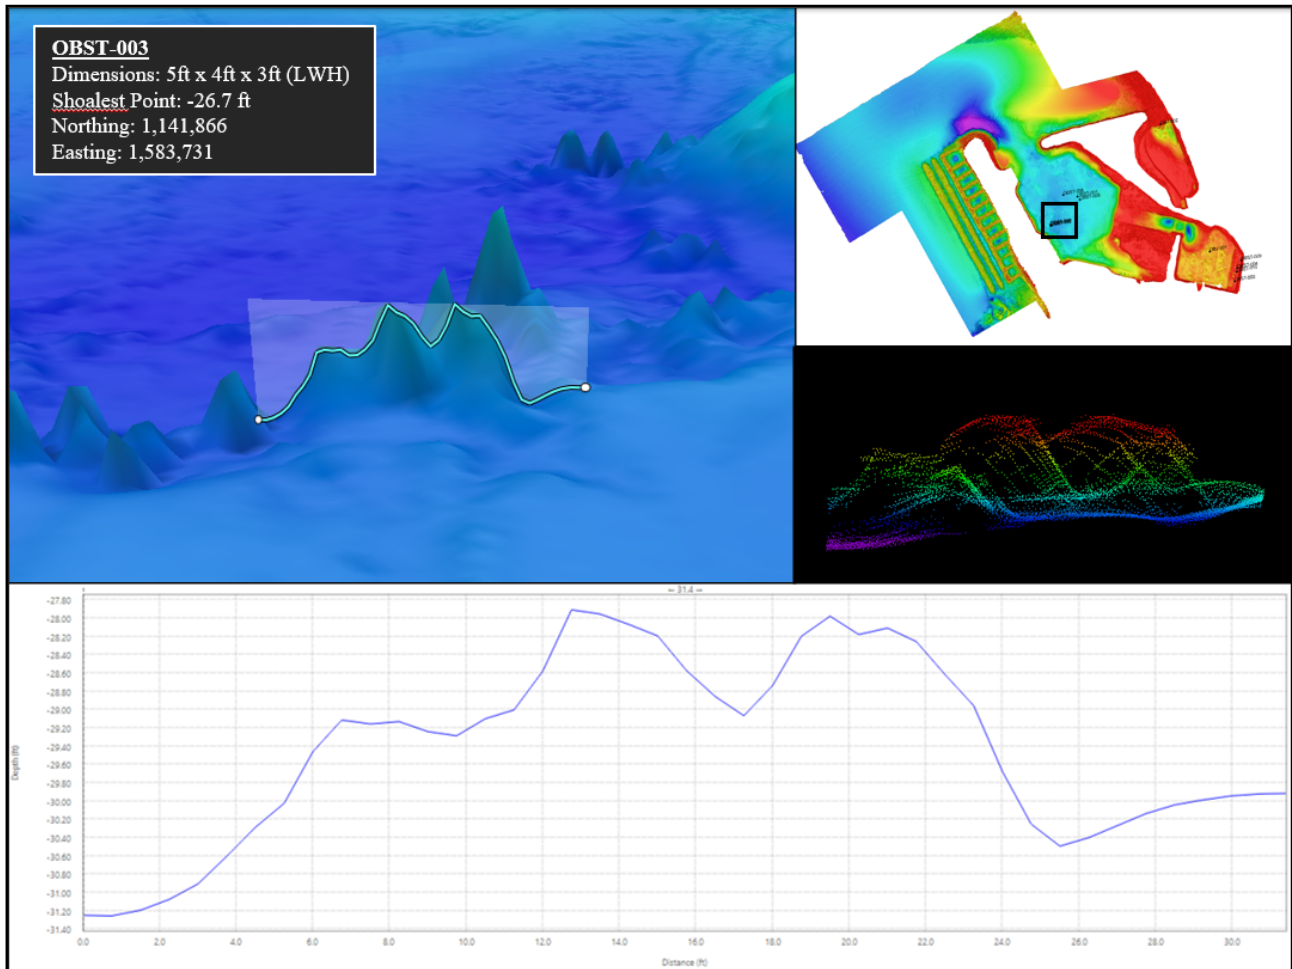
Figure 37 OBST-003: 3D, Profile, Point Cloud, and Overview

In Figure 37 above, OBST-003 is noted in detail. A 3D view, profile of bathymetry, point cloud view, and overview of object location can be seen. The obstruction has dimensions of 5ft x 4ft x 3ft and is located in the Maneuvering Area of St. Paul Harbor. With a shoalest depth of -26.7ft MLLW, it is considered an Obstruction to Navigation given its size, span, and location within the harbor.

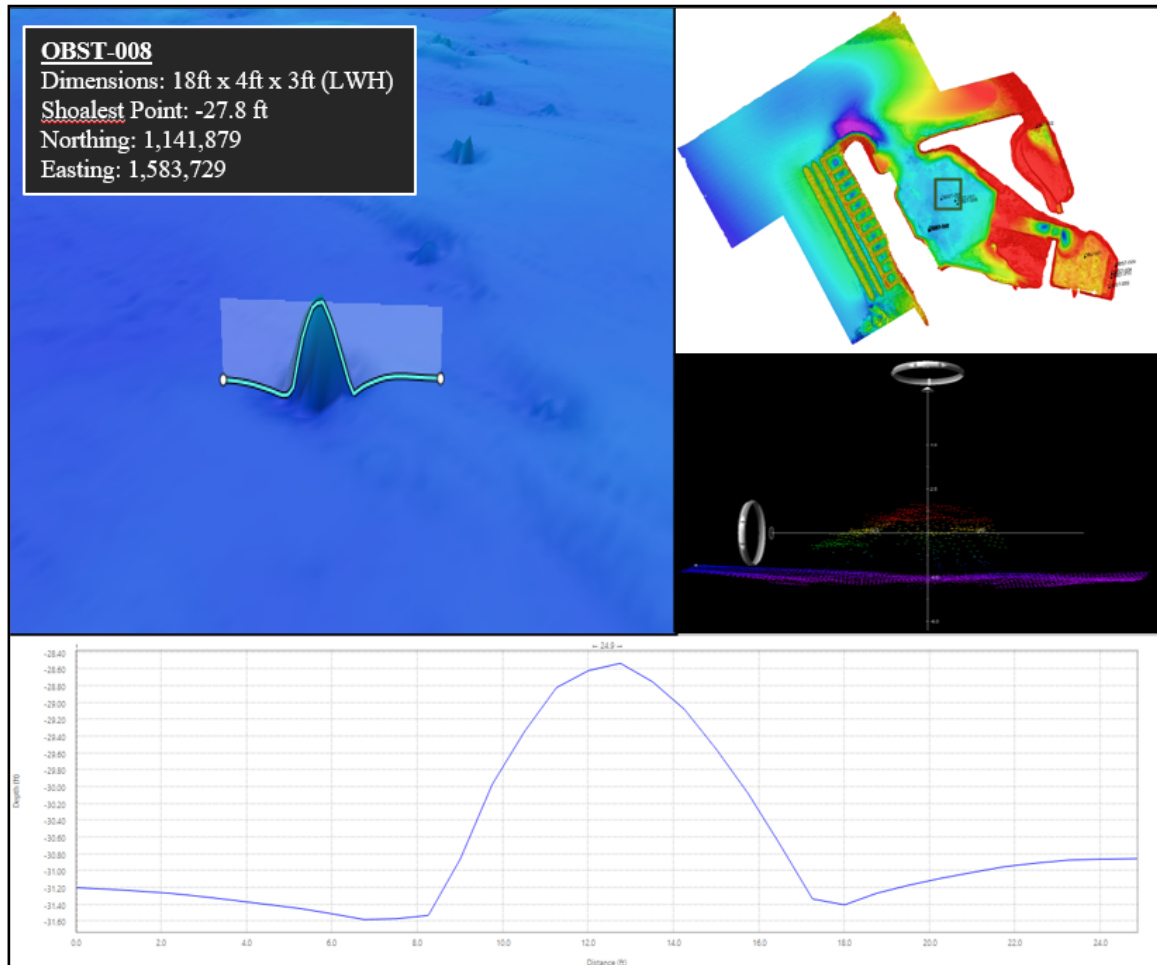
Figure 38 OBST-008: 3D, Profile, Point Cloud, and Overview

In Figure 38 above, OBST-008 is noted in detail. A 3D view, profile of bathymetry, point cloud view, and overview of object location can be seen. The obstruction has dimensions of 18ft x 4ft x 3ft and is located in the Maneuvering Area of St. Paul Harbor. With a shoalest depth of -27.8ft MLLW, it is considered an Obstruction to Navigation given its size and location.

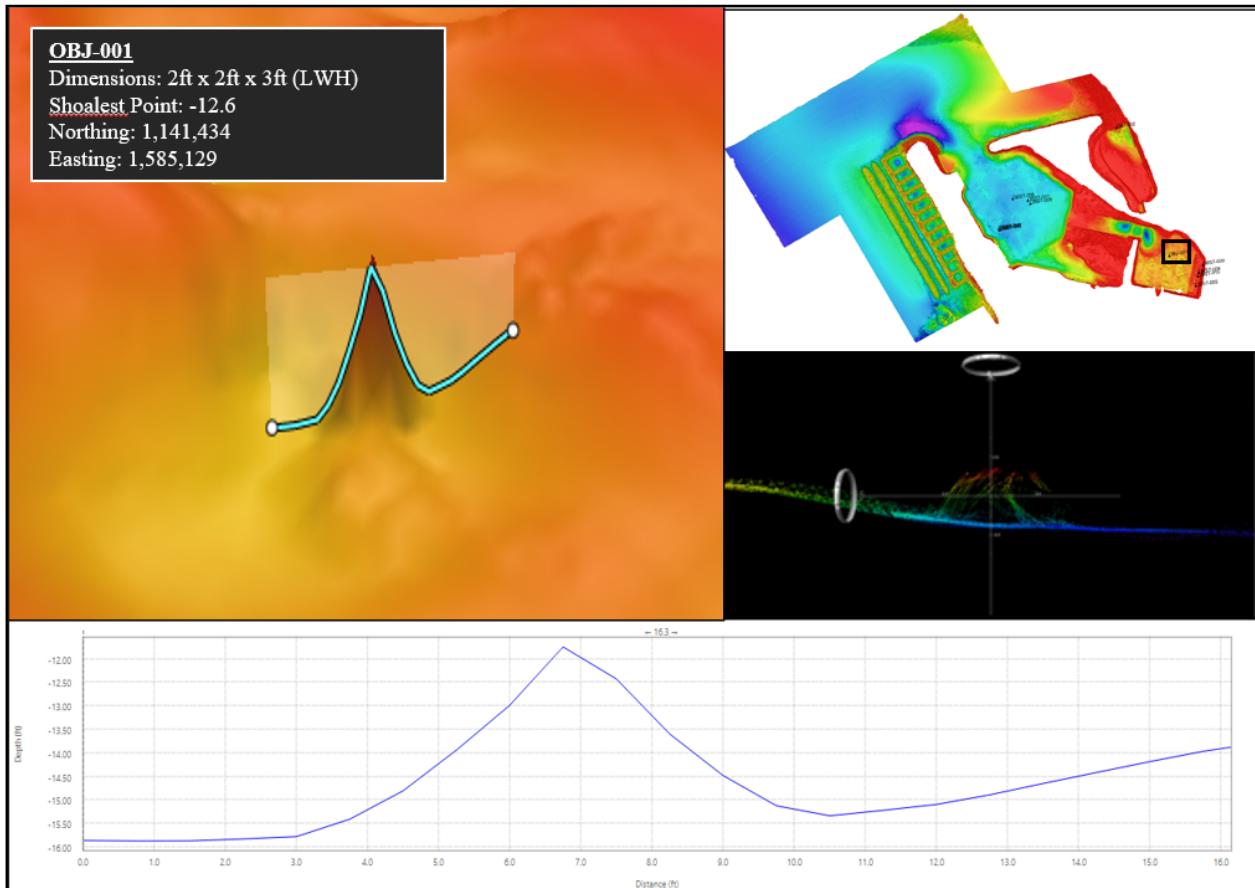
Figure 39 OBJ-001: 3D, Profile, Point Cloud, and Overview

In Figure 39 above, OBJ-001 is noted in detail. A 3D view, profile of bathymetry, point cloud view, and overview of object location can be seen. This is believed to be a large piece of debris with dimensions 2ft x 2ft x 3ft located in the Small Boat Harbor of St. Paul Harbor. With a shoalest depth of -12.6ft MLLW, it is considered an Object of Interest given its size and location within the harbor.

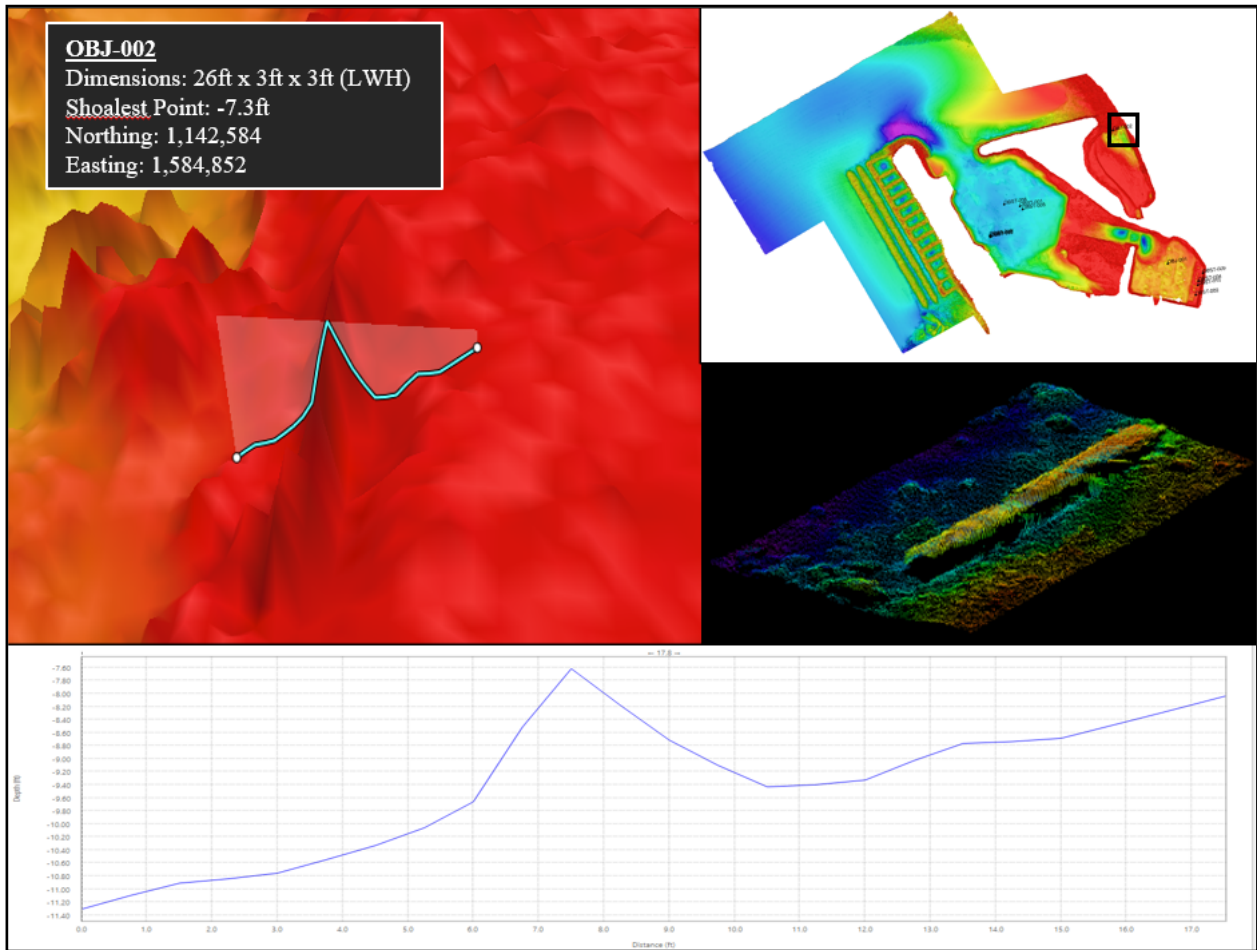
Figure 40 OBJ-002: 3D, Profile, Point Cloud, and Overview

In Figure 40 above, OBJ-002 is noted in detail. A 3D view, profile of bathymetry, point cloud view, and overview of object location can be seen. This is believed to be fishing debris with dimensions 26ft x 3ft x 3ft located in the Sediment Basin of St. Paul Harbor on the east side. With a shoalest depth of -7.3ft MLLW, it is considered an Object of Interest given its size and location.

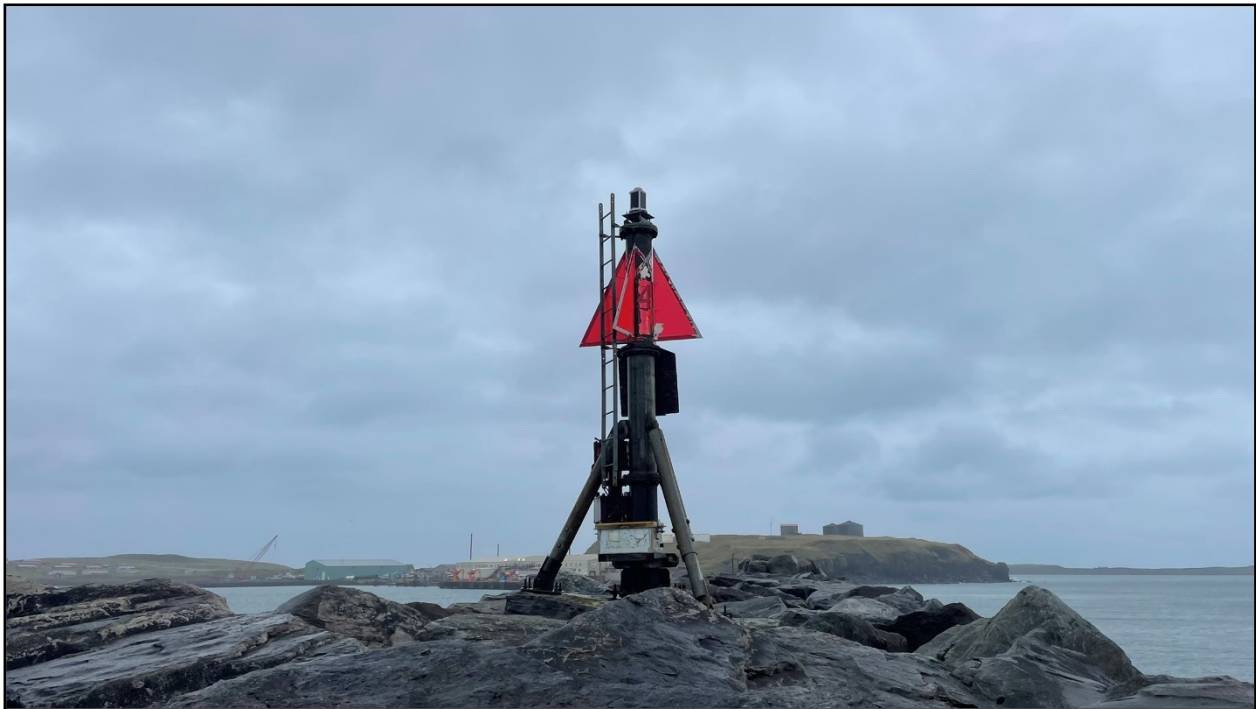
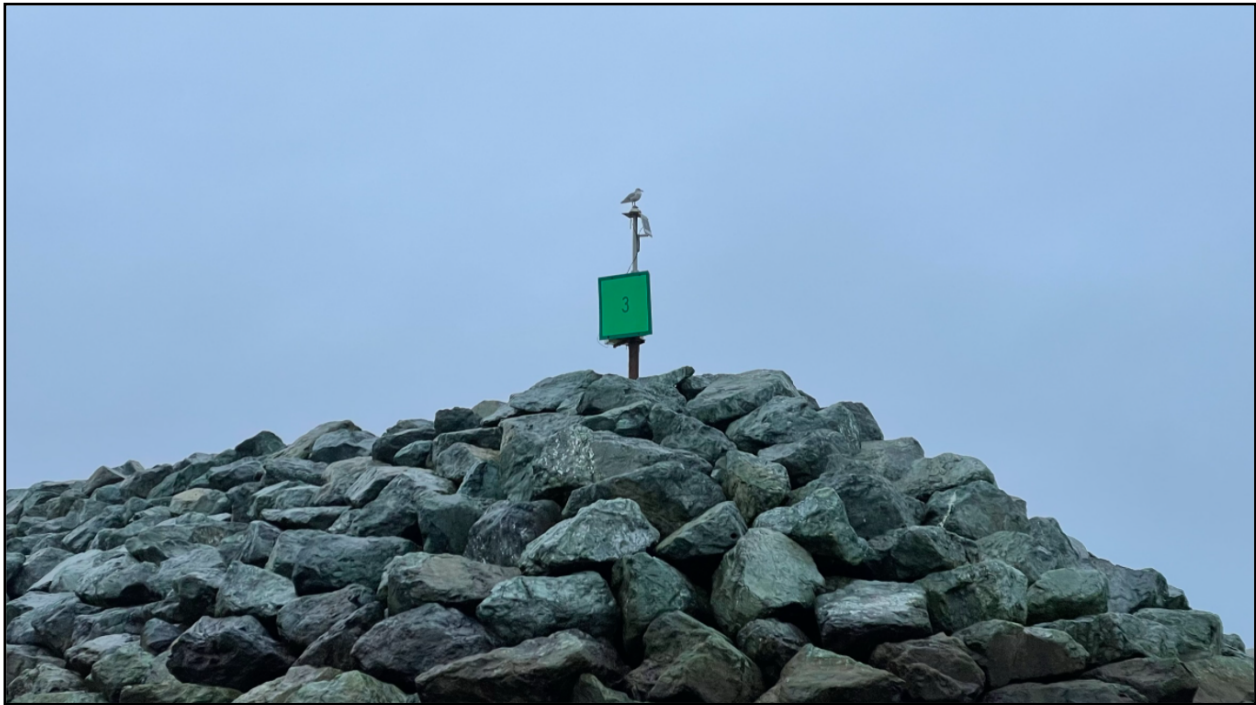
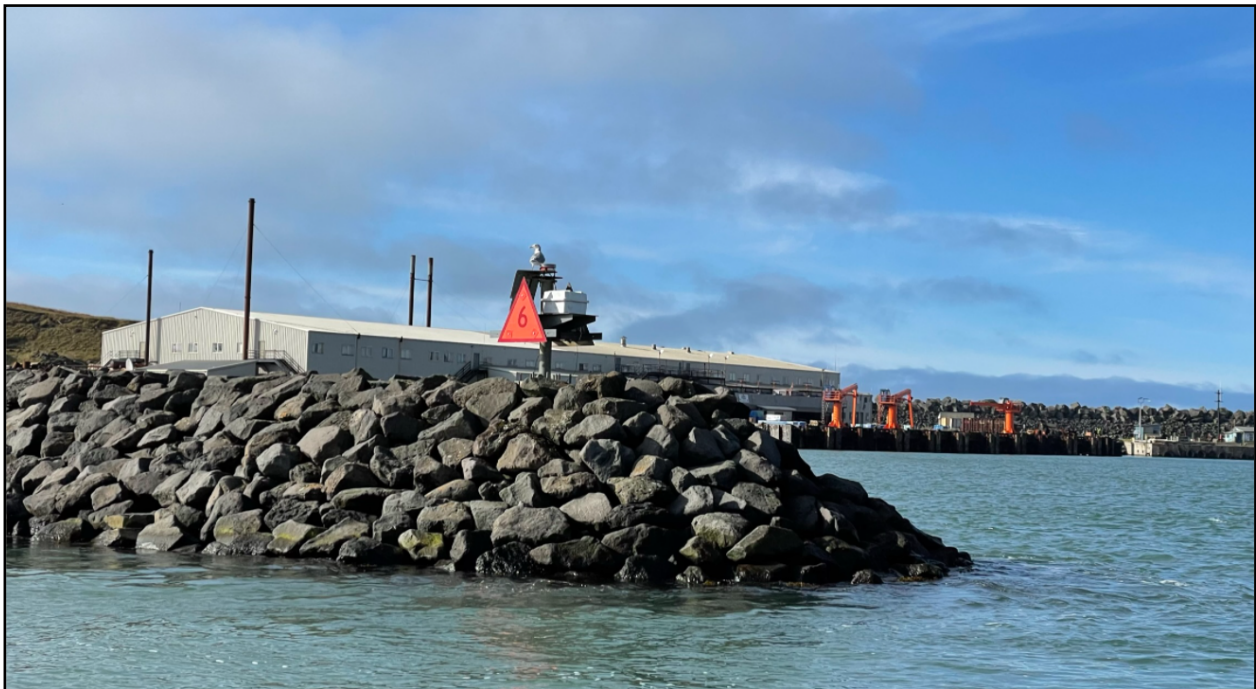
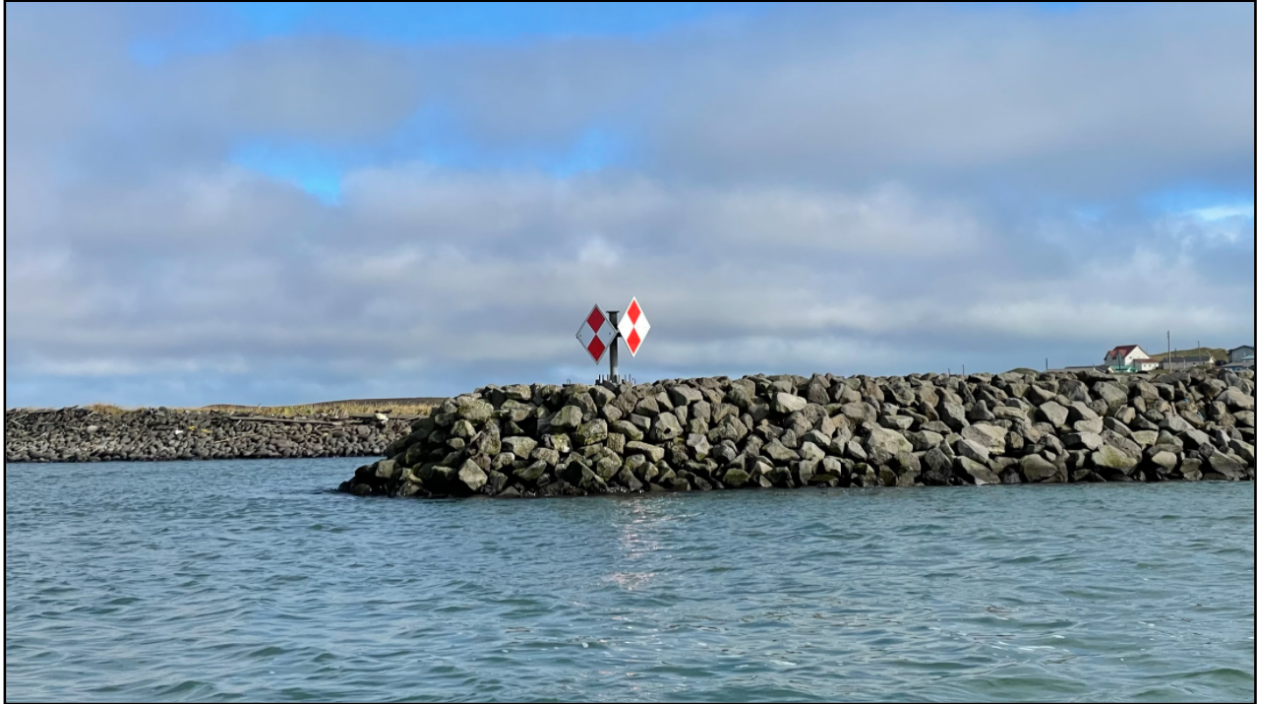
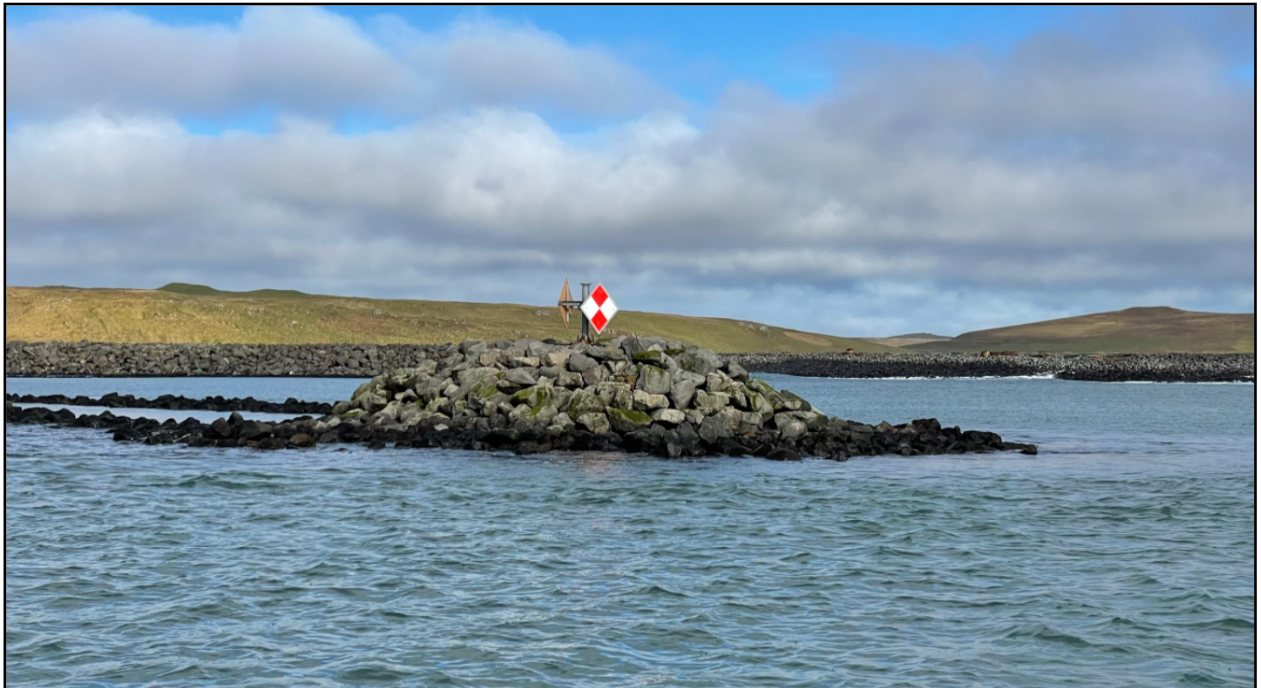
Five (5) Navigation Aids were located within the St. Paul Harbor survey area. All Navigation Aids were located within the LiDAR dataset. All Navigation Aids were found in good condition. Images of the Navigation aids are in Figures 41 through 45. Additional Photos of all Navigation Aids can be found in Deliverables; 545_Navigation Aids.

Figure 41 Navigation Aid 27830 as seen from the breakwater

Figure 42 Navigation Aid 27831 as seen from a boat

Figure 43 Navigation Aid 27832 as seen from a boat

Figure 44 Navigation Aid 27834 as seen from a boat

Figure 45 Navigation Aid 27833 as seen from a boat
