DESCRIPTIVE REPORT

Type of Survey: Reconnaissance

General Locality: Kotzebue Sound

GCI Maniilaq Fiber Project

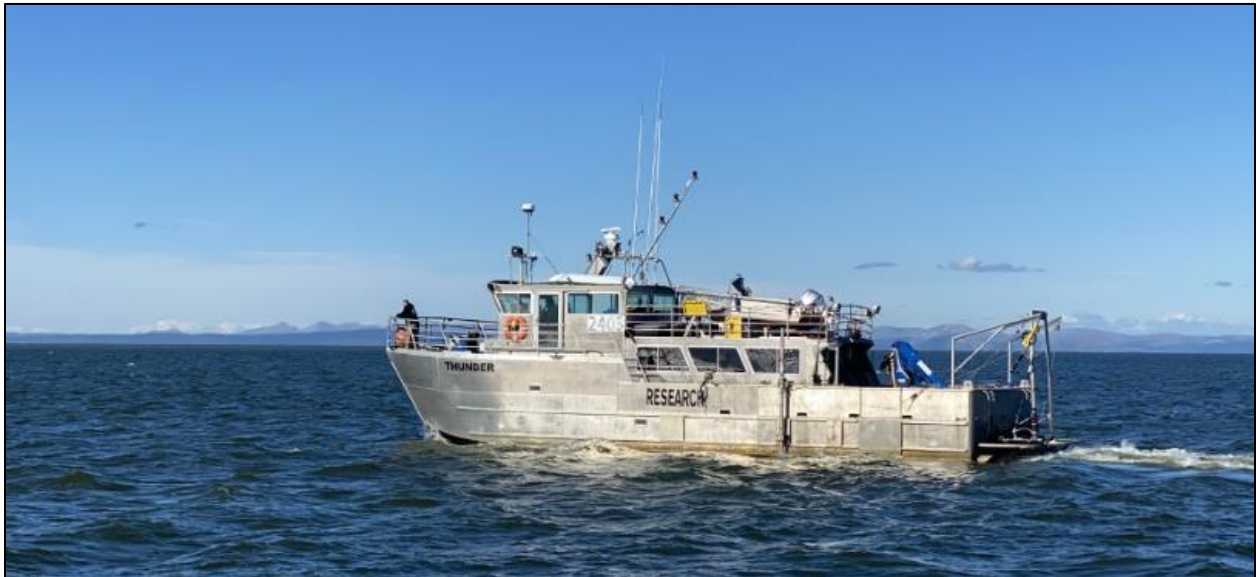
Figure 2-2. R/V Thunder in Kotzebue, AK

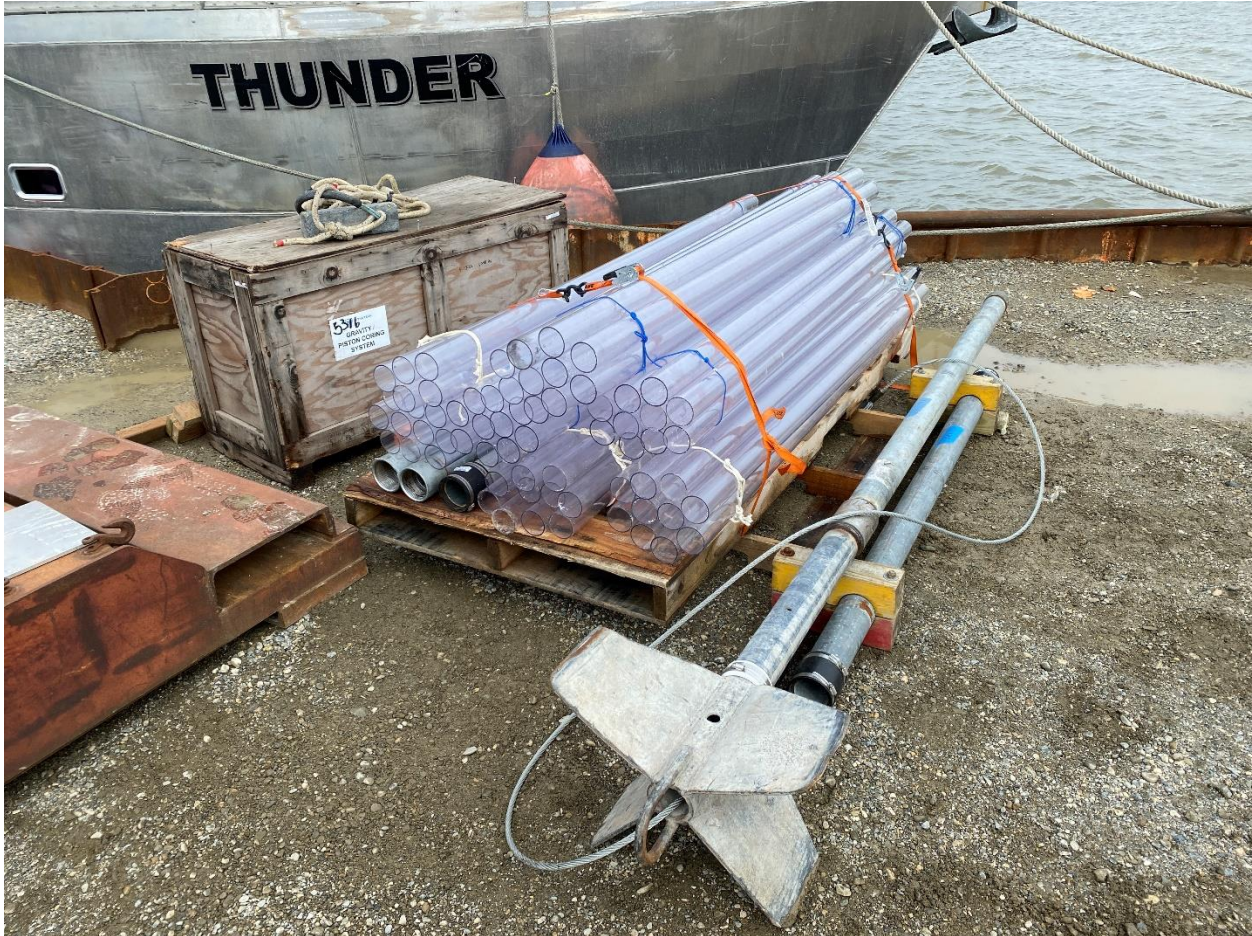
Geotechnical mobilization on the *R/V Thunder* consisted of clearing the deck of all geophysical survey equipment, assembling the piston core, trimming core liners to length, building a launch and recovery guide on deck, and setting up a core analysis station.

Figure 2-3. Piston Core and core liners ready for mobilization.

The piston core was then tested at one of the nearest stations in Zone 1. After a few cycles of launching and recovering the corer to improve the efficiency and safety of operations, geotechnical mobilization was considered complete.

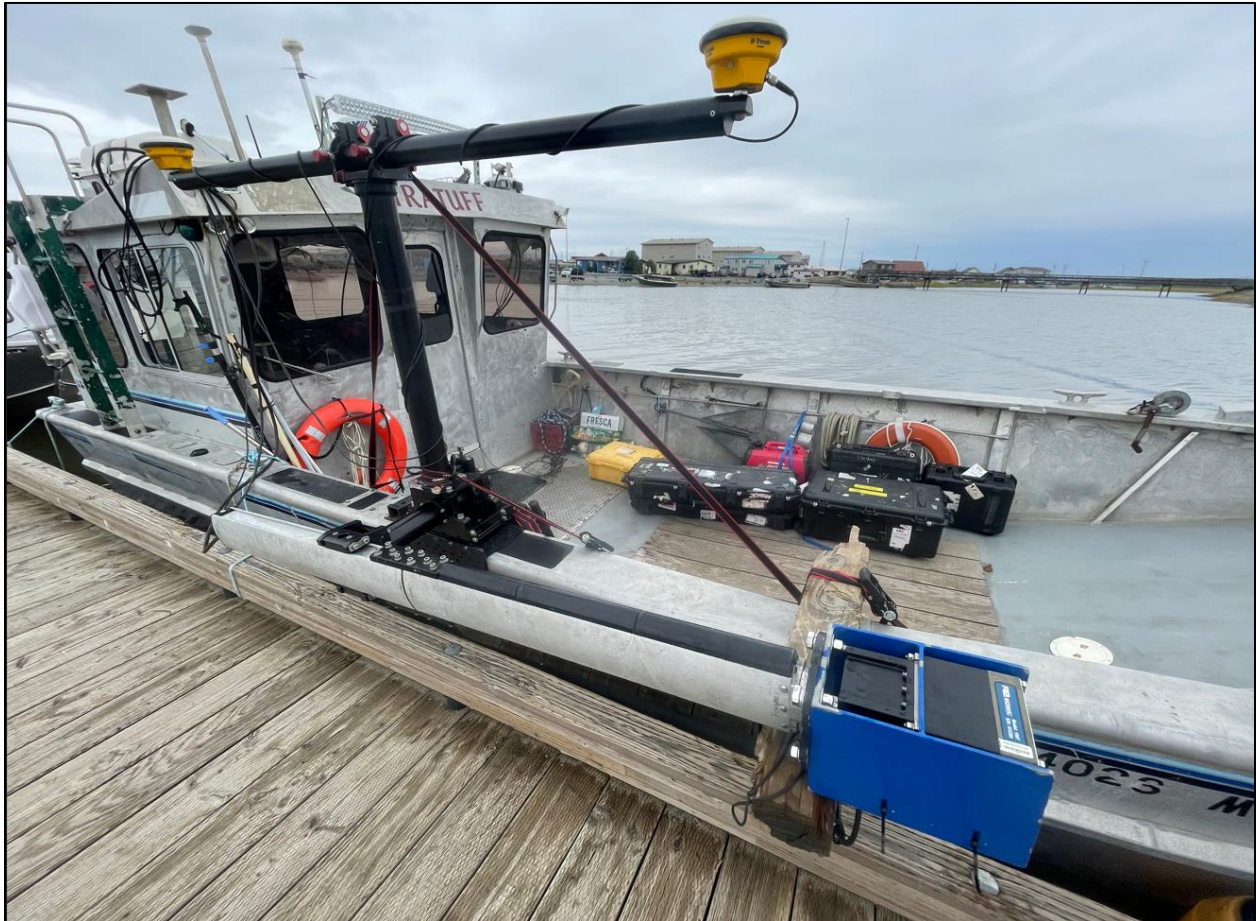
Near the entrance to the Kotzebue Channel there is a shoal that could not be safely surveyed from the R/V *Thunder*. Therefore, a local vessel of opportunity was required. The local vessel was the *Xtratuff*, an aluminum landing craft with twin 225HP outboards. The *Xtratuff* was mobilized for bathymetric survey on Aug 10th and was demobilized on August 17th.

Figure 2-4. Xtratuff mobilized for shallow water bathymetric survey.

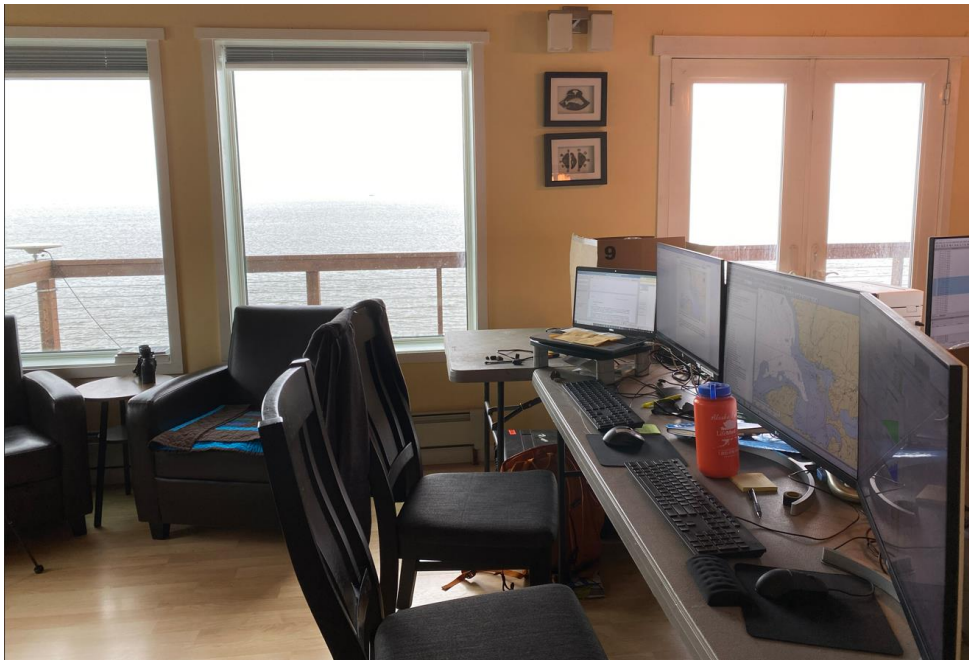
In addition to offshore survey operations, a shore side office was set up for data processing and logistical support (Figure 3-2). At the shore side office, a second RAID array data server hosted a shore side copy of the raw and processed data. A hydrographic data processor and geophysicist processed and evaluated data providing a second level of QC, and preliminary interpretation.

Figure 3-2. Data processing and analysis workstations at the shoreside support office.

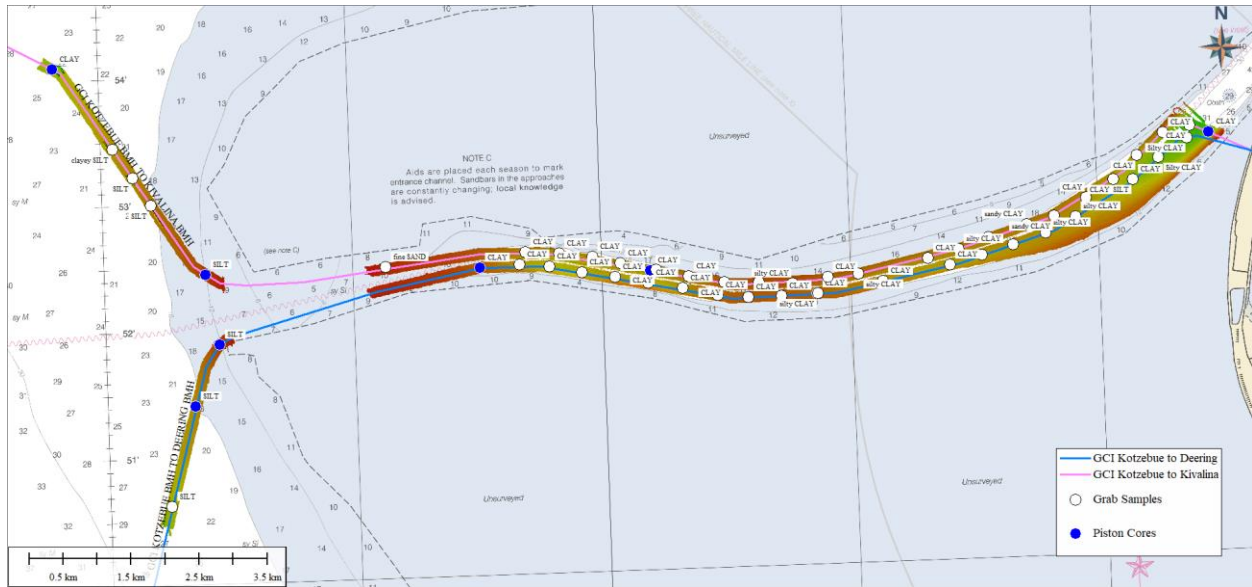
45 grab samples and 8 piston cores were collected in Zone 1 (Figure 5-13). Inside of the Kotzebue Channel the seabed sediment is predominantly composed of wet, soft to very soft clay and silty clay. Most samples were noted as having high plasticity and medium or low dilatancy. Near the shoal, fine sand was observed in one grab sample. Note that no geotechnical data was collected in water depths less than 3 m. Outside of the channel the predominant surface sediment is silt based on both the grab samples and surface sediments of the cores. Additional details are provided in Table 5-1 and Table 5-2.

Figure 5-13. Zone 1 Geotech stations

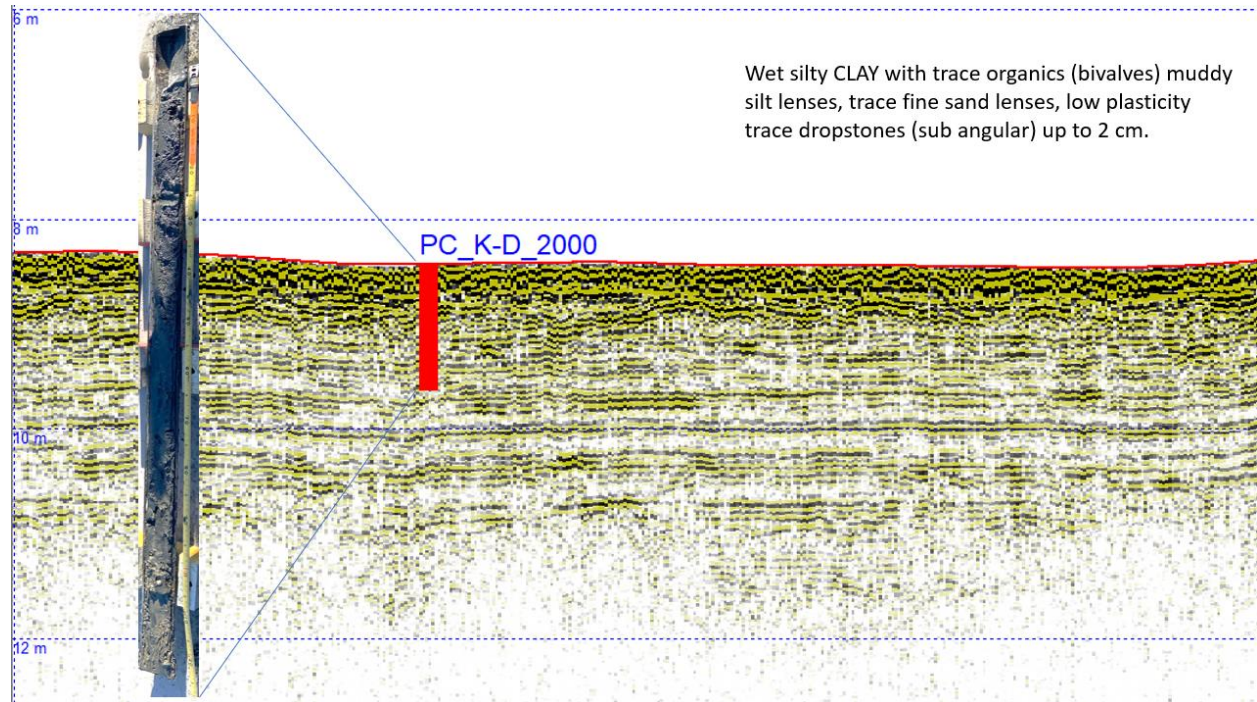
From KP 0.5 to KP 7 there is a contiguous near-horizontal bedding that follows the channel surface to a depth of 2 m or greater. A core sample collected at KP 2.0 recovered 1.2 meters of very soft, wet silty clay with muddy silt lenses, and trace fine sand lenses (Figure 5-18).

Figure 5-18. Sub-bottom and core records from K-D_2000

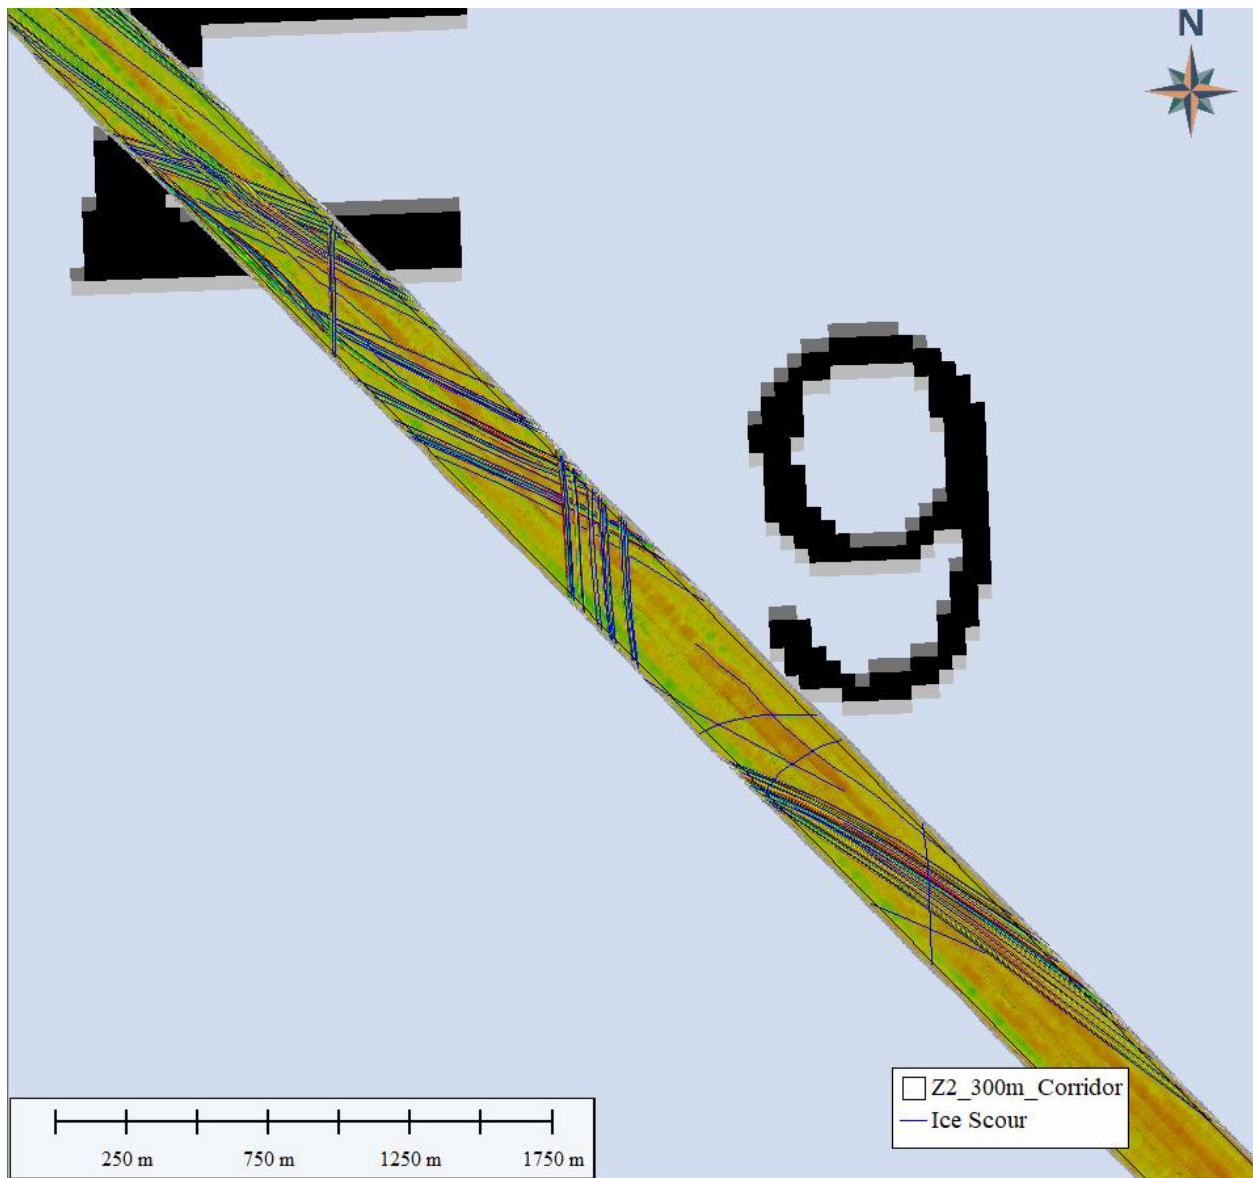
Figure 5-24. Ice scour concentration between KP 42 and KP 61 on the K-D route.

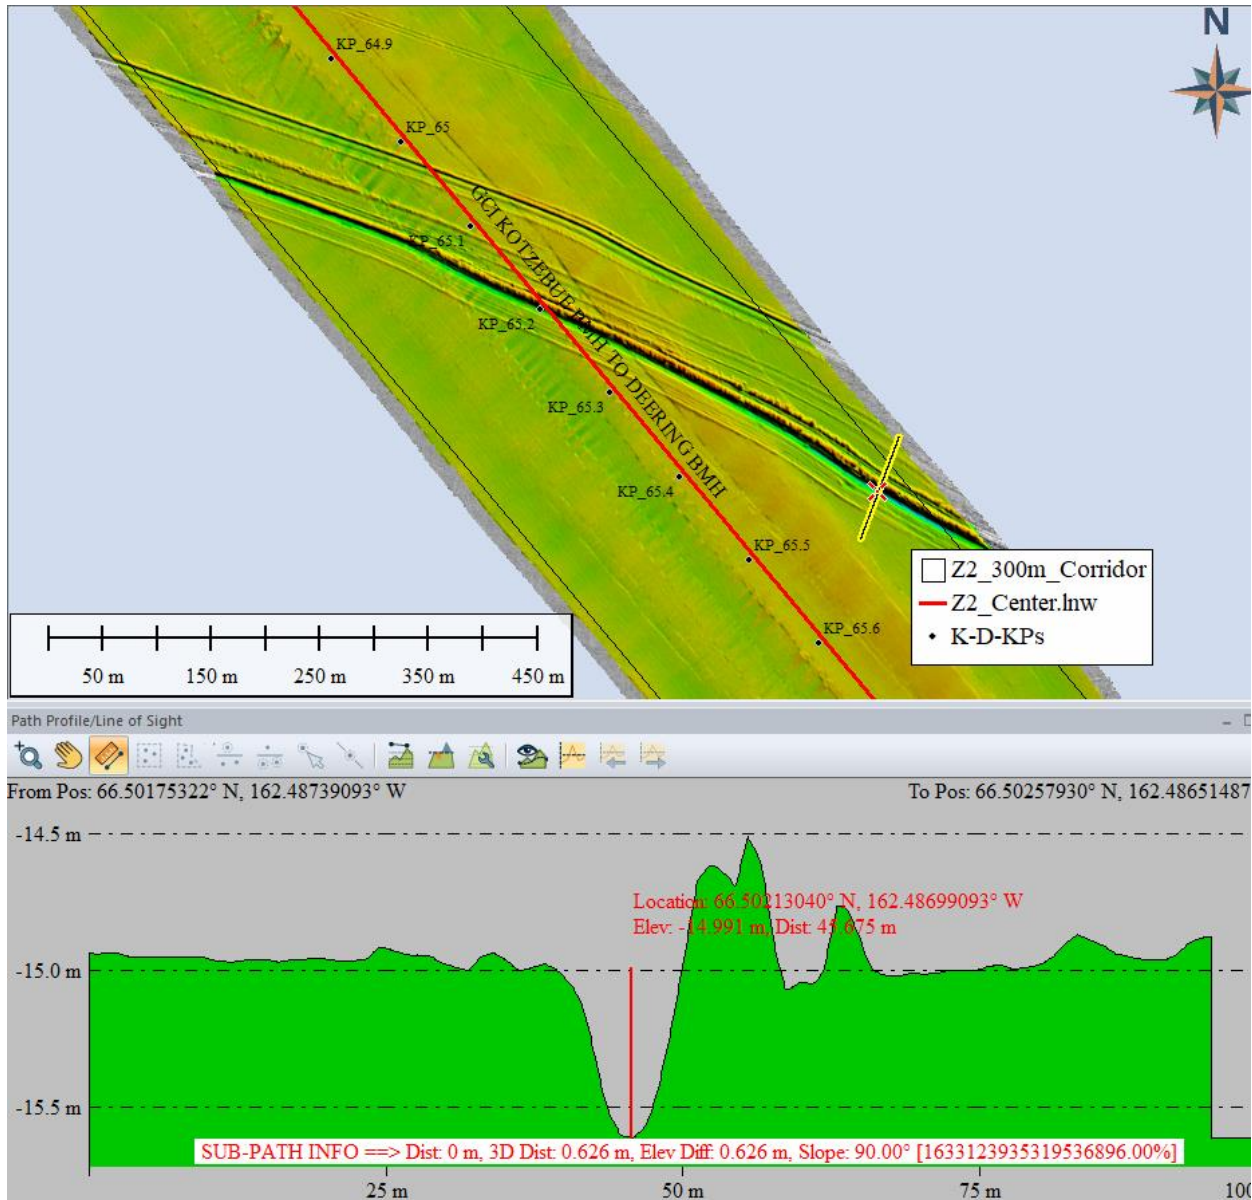
Typical ice scour depths are 0.1 to 0.2 m below the surrounding seabed. Furrows are typically of equal or slightly greater height above the surrounding seabed. However, the maximum scour depth observed in Zone 2 was 0.6 m (Figure 5-25) and the maximum furrow height observed was 0.6 m.

Figure 5-25. Deep ice scour example from Zone 2 near KP 65.5.

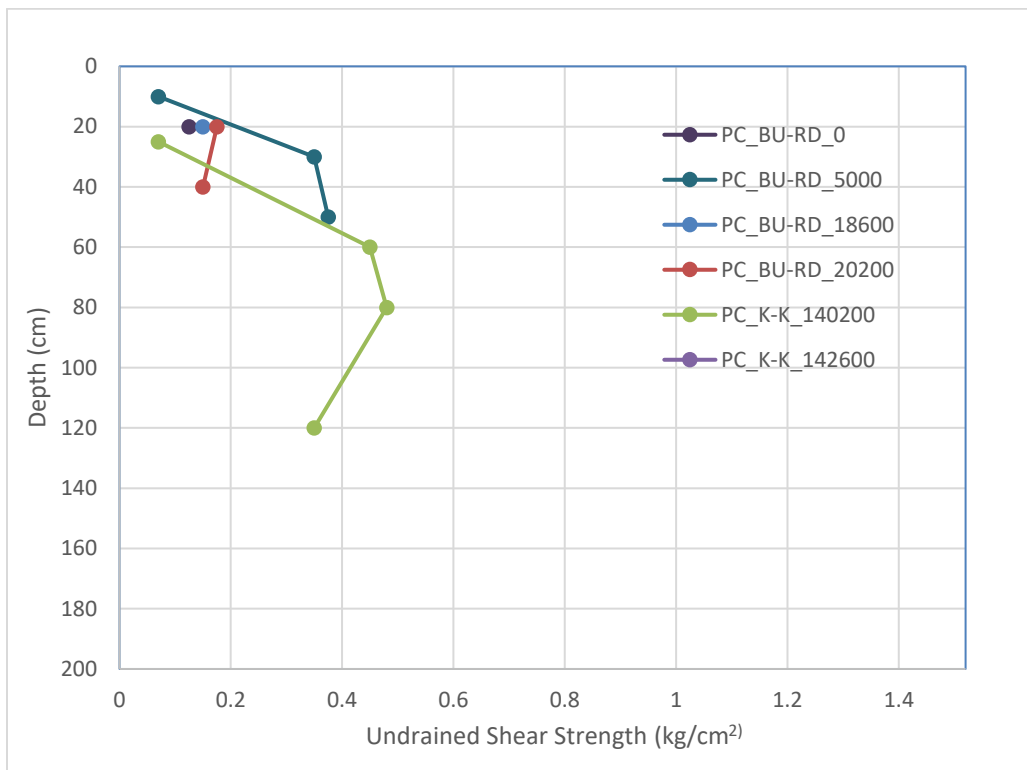
Shear strength tests in Zone 6 were performed on most cores. 15 measurements of shear strength revealed very soft to stiff sediment (Figure 5-84). Based on 21 unconfined compressive strength tests the sediment is very soft to hard. However, hard sediment was only found in K-K_142600 at a depth of 50 cm (Figure 5-85).

Figure 5-84. Zone 6 Undrained shear strength
