**HORIZONTAL AND VERTICAL CONTROL
REPORT**

Type of Survey Navigable Area
Project No. OPR-R302-KR-22
Time Frame June – August, 2022

Horizontal and Vertical Control Report

Nunivak, AK

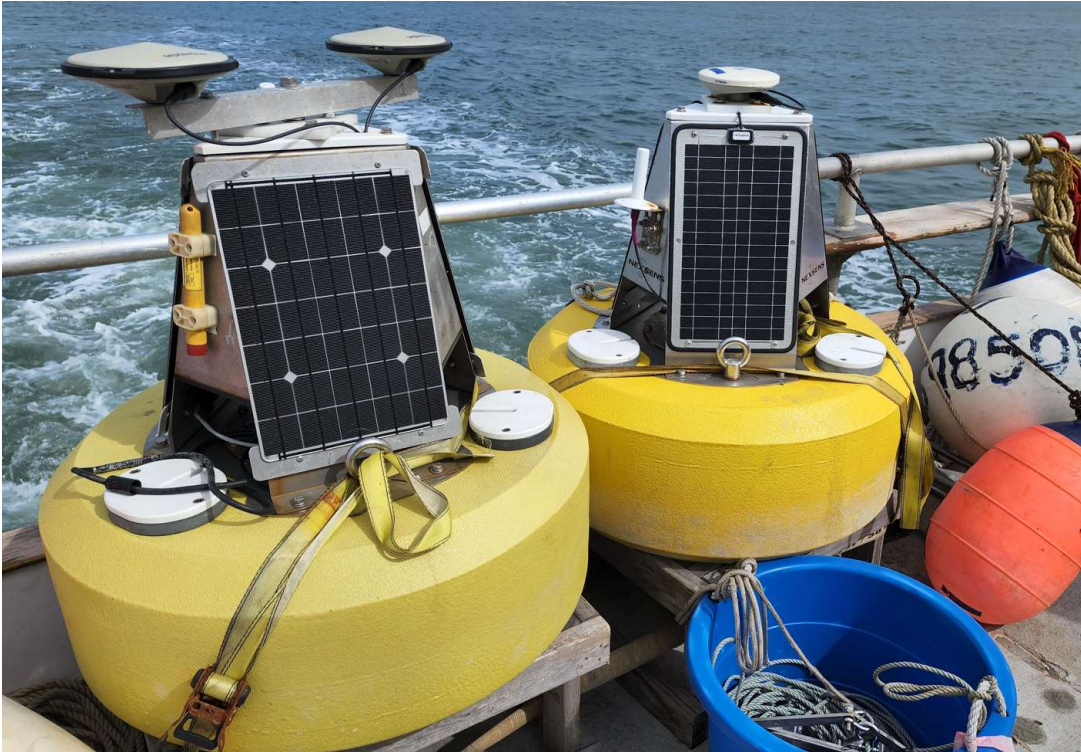
Figure 2 – The two project GNSS tide buoys after retrieval. The Southwest Nunivak buoy is on the left, while the Northwest Nunivak buoy is on the right.

The Northwest Nunivak GNSS tide buoy experienced issues on this survey, especially regarding GNSS tracking. The buoy was initially deployed on 6/24/22 but was pulled for troubleshooting on 7/2/22. Issues were addressed and the buoy was redeployed at the same location on 7/15/22, but stopped tracking satellites again and was retrieved a final time on 8/13/22. It was able to log approximately 19 days of data, which was short of the 30 required.

The Southwest Nunivak GNSS tide buoy did not experience any significant issues and was able to complete approximately 37 days of logging.

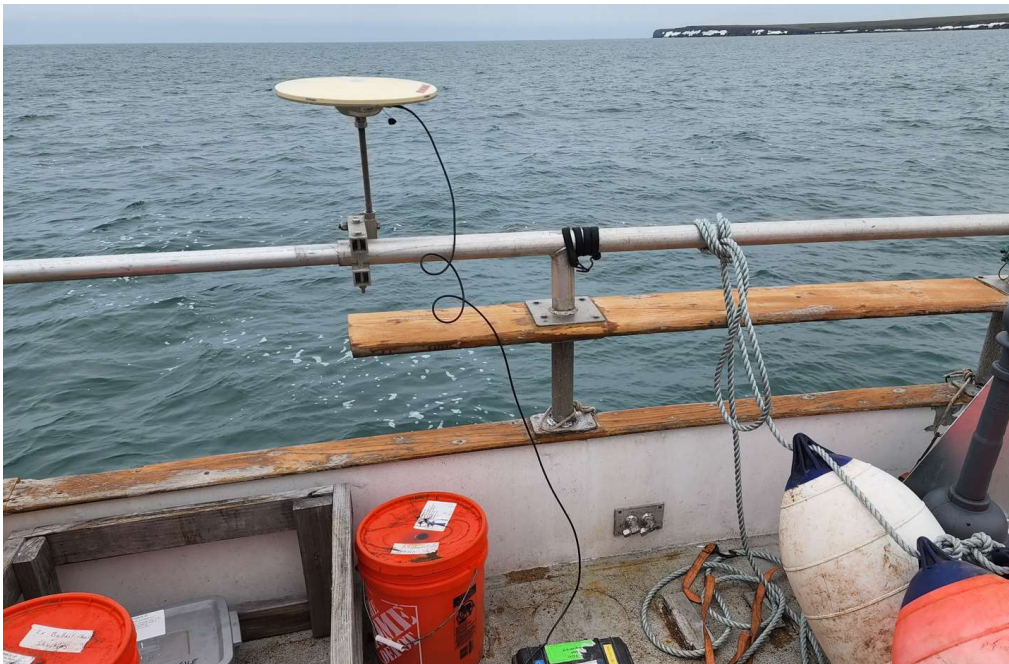
Figure 3 – Trimble 5700 GNSS antenna on the back deck of the survey vessel used for comparisons with the buoy data. Vessel POSMV data was also used.

TerraSond contracted JOA Surveys, LLC (JOA) for tide support. JOA provided the GNSS Tide Buoys as well as services relating to processing of the tide data, datum computations, tide analysis, and tide report compilation. TerraSond’s tasks included the on-site recovery and deployment of the buoys and completion of static floats with the survey vessels for vessel versus buoy water line comparisons.
