**DESCRIPTIVE REPORT**

Type of Survey Wire Drag  
Field No. R/H-20-1-78  
Registry No. F00222

State Virginia-Maryland  
General Locality Chesapeake Bay  
Sublocality Chesapeake Channel to  
Cove Point  
1978  
CHIEF OF PARTY  
R.V. Smart

Project No. OPR-E609-RU/HE-78

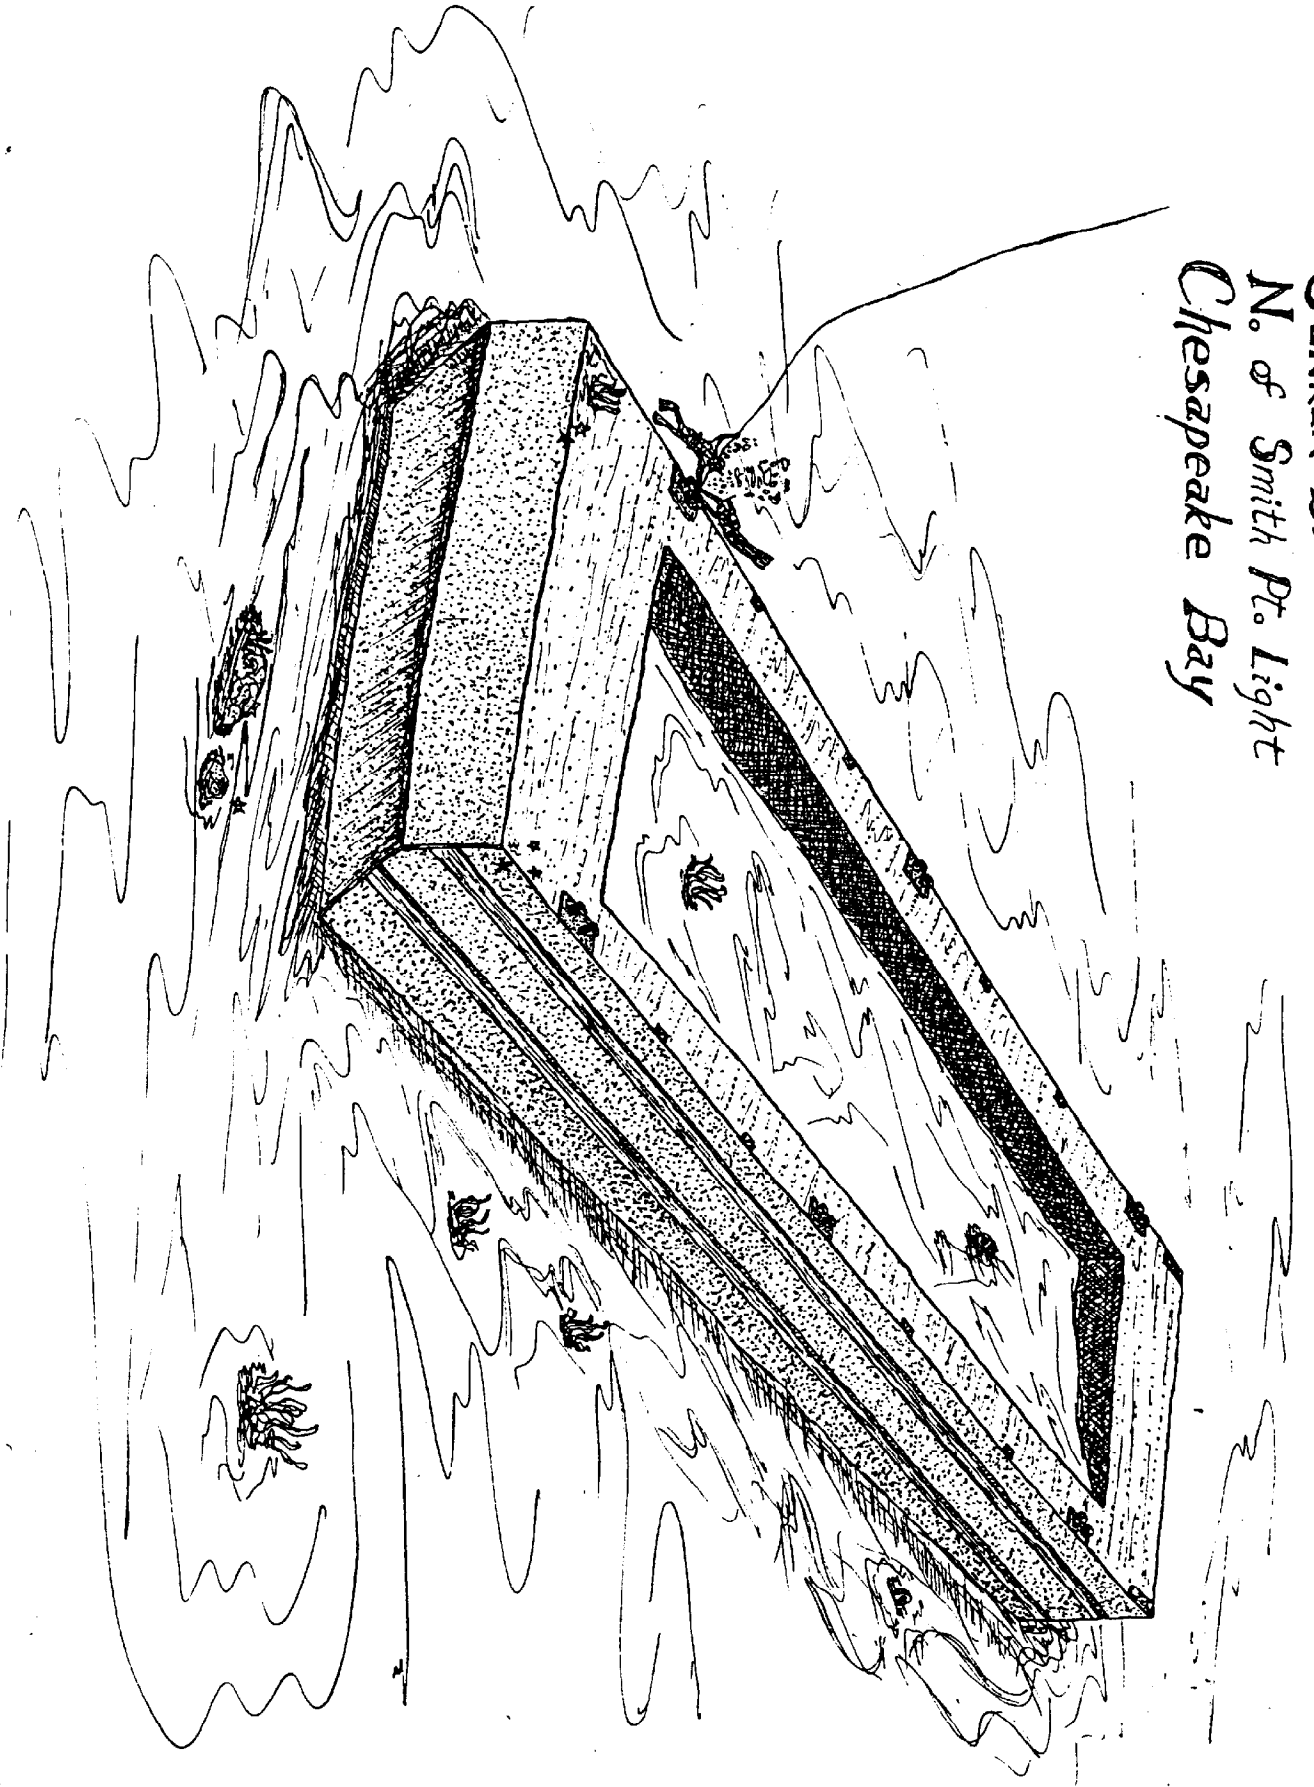
SUNKEN BARGE  
No. of Smith Pt. Light  
Chesapeake Bay

WEATHER CONDITIONS AT TIME OF SINKING: wind Southeast 40 knots, seas rough,  
heavy rain

CONDITION OF WRECK AT PRESENT (VERIFIED BY DIVING SURVEY):

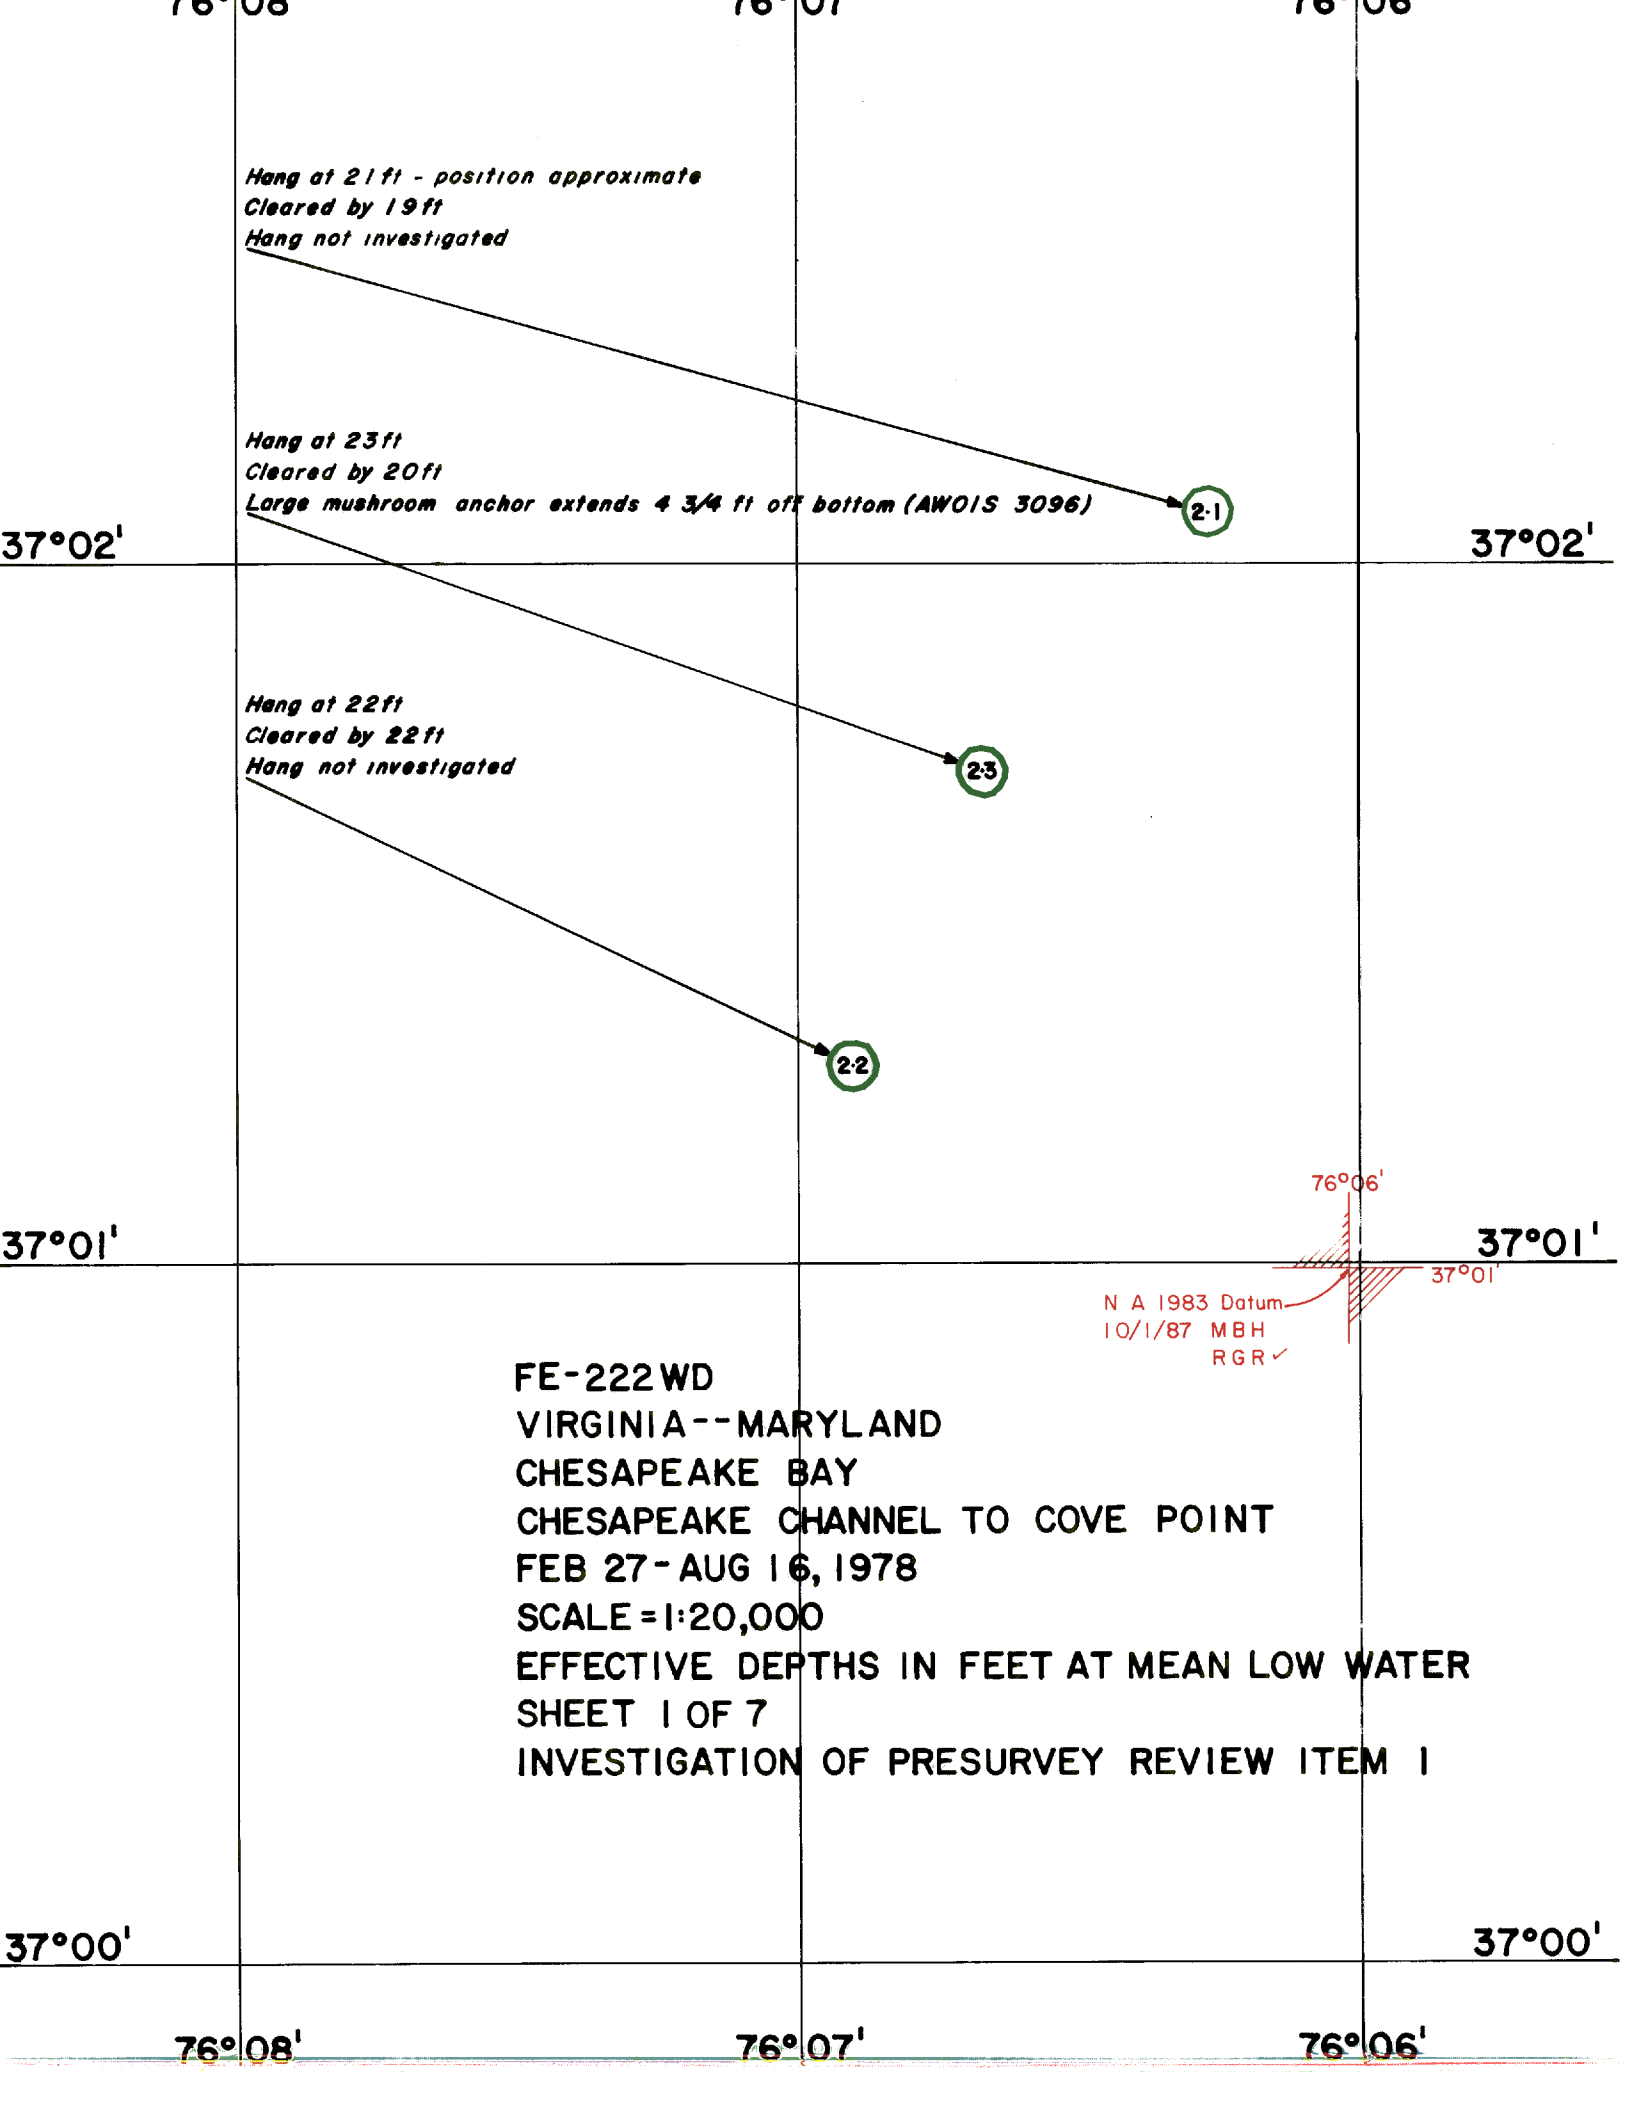
FE-222WD  
VIRGINIA--MARYLAND  
CHESAPEAKE BAY  
CHESAPEAKE CHANNEL TO COVE POINT  
FEB 27-AUG 16, 1978  
SCALE=1:20,000  
EFFECTIVE DEPTHS IN FEET AT MEAN LOW WATER  
SHEET 1 OF 7  
INVESTIGATION OF PRESURVEY REVIEW ITEM 1

Prior survey H-7750 is common to the entire area of investigation of Presurvey Review Item #1 (AWOIS #923). Present effective clearance depths range from 2 to 21 feet shoaler than prior depths within the common area. However, present clearance depths are generally 5 to 10 feet shoaler than the prior hydrography. Charting recommendations for Presurvey Review Item #1 (AWOIS #923) are made in section 7. of this report. No conflicts exist between present clearance depths and prior hydrography except three hangs and two groundings on the present survey which are addressed as follows:

A present survey hang occurred at 21 feet in the vicinity of Latitude 37°02'04.4"N, Longitude 76°06'16.1"W, position approximate (+1,000 feet). This hang was cleared in one direction by 20 feet and an opposing direction by 19 feet. This hang lies in prior depths of 29 feet and subsequent survey (H-10116) depths of 29 to 30 feet. This hang was not investigated. It is recommended that this hang be charted in the approximate position determined by the present survey as a dangerous submerged obstruction, position approximate, with a label in parentheses: (cleared 19 feet). Additional field work is recommended to either prove and more precisely locate the obstruction or disprove the existence of an obstruction at the approximate position of this present survey hang. A strong possibility exists that this hang may be AWOIS #917, a dangerous sunken wreck, position approximate, charted in Latitude 37°02'N, Longitude 76°06'W (see section 7.a.3) of this report).

as no investigation was made and the hang is 4 to 6 feet shoaler than current depths, it is considered a probable hang on an obstruction. It is recommended that this hang be charted in the position determined by the present survey as a dangerous submerged obstruction with a label in parentheses: (cleared 22 feet). Additional field work is recommended to either prove or disprove the existence of an obstruction at the position of this present survey hang. A possibility exists that this hang may be AWOIS #916, see section 7.a.2) of this report. Wire drag is not an effective search method to resolve this hang due to the large sand waves throughout this area. It is recommended that this hang be resolved by side-scan sonar investigations.
