FE-232 W.D.

DESCRIPTIVE REPORT

Type of Survey ..Wire Drag.....
Field No.R/H-5-1-80.W.D.....
Office No.....FE 232 W.D.....

State New York-New Jersey
General Locality ..New York Harbor
Locality Upper and Lower Bays

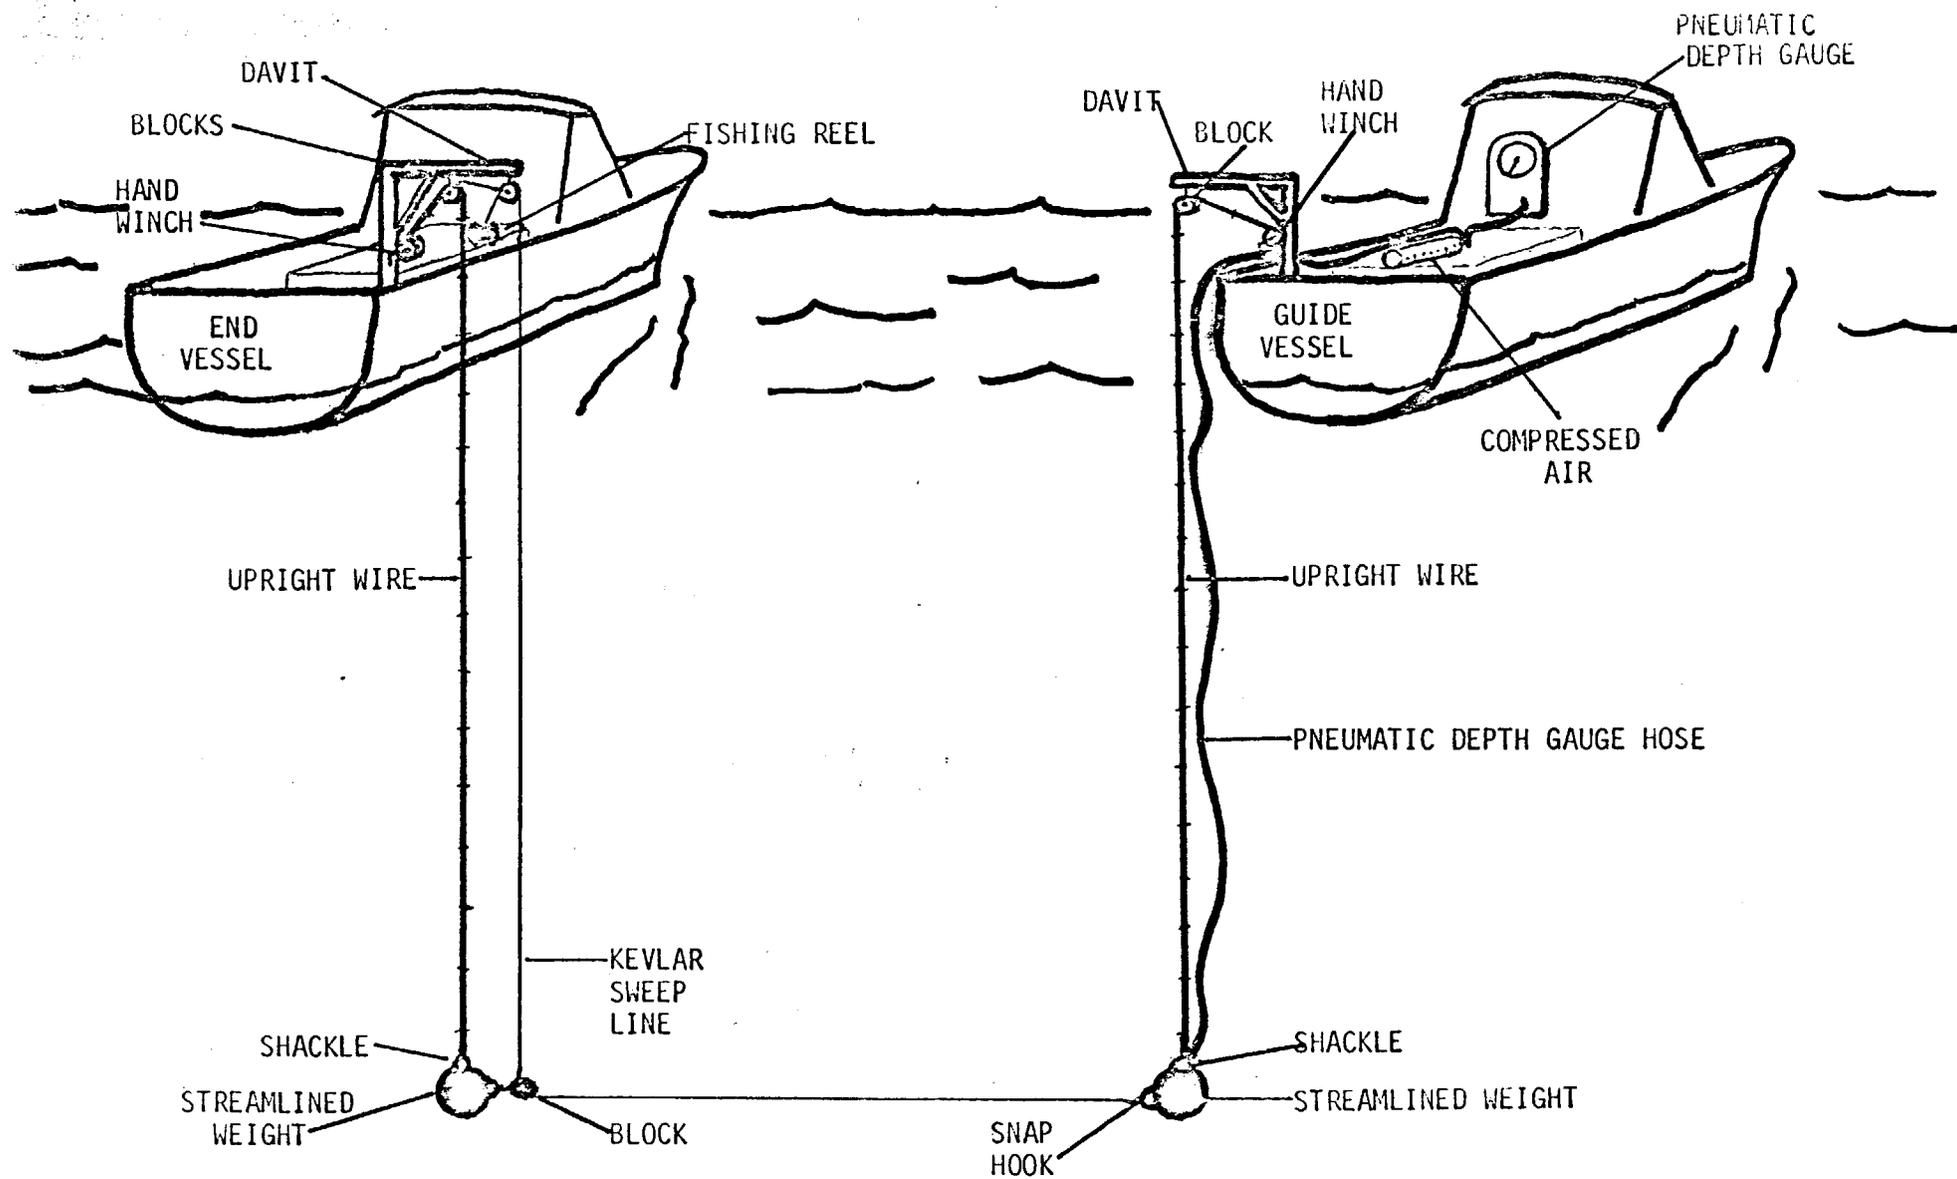
FIGURE 1

NOAA Launches 1274 and 1275 were used as towing vessels for all the remaining drags during this survey project. The technique used was a modification of the "drift sweep", adequately described in the Admiralty Manual of Hydrographic Surveying (1969), Volume II, Chapter 4, Part 3, and employs the concept of constant tension. The configuration of equipment necessary for this drag technique is illustrated in Figure I.
