WIRE DRAG

DESCRIPTIVE REPORT

Type of Survey Wire Drag
Field No. R/H-20-1-83
Office No..... FE-243WD

State Louisiana
General Locality Gulf of Mexico
Locality Approach to Calcasieu Pass

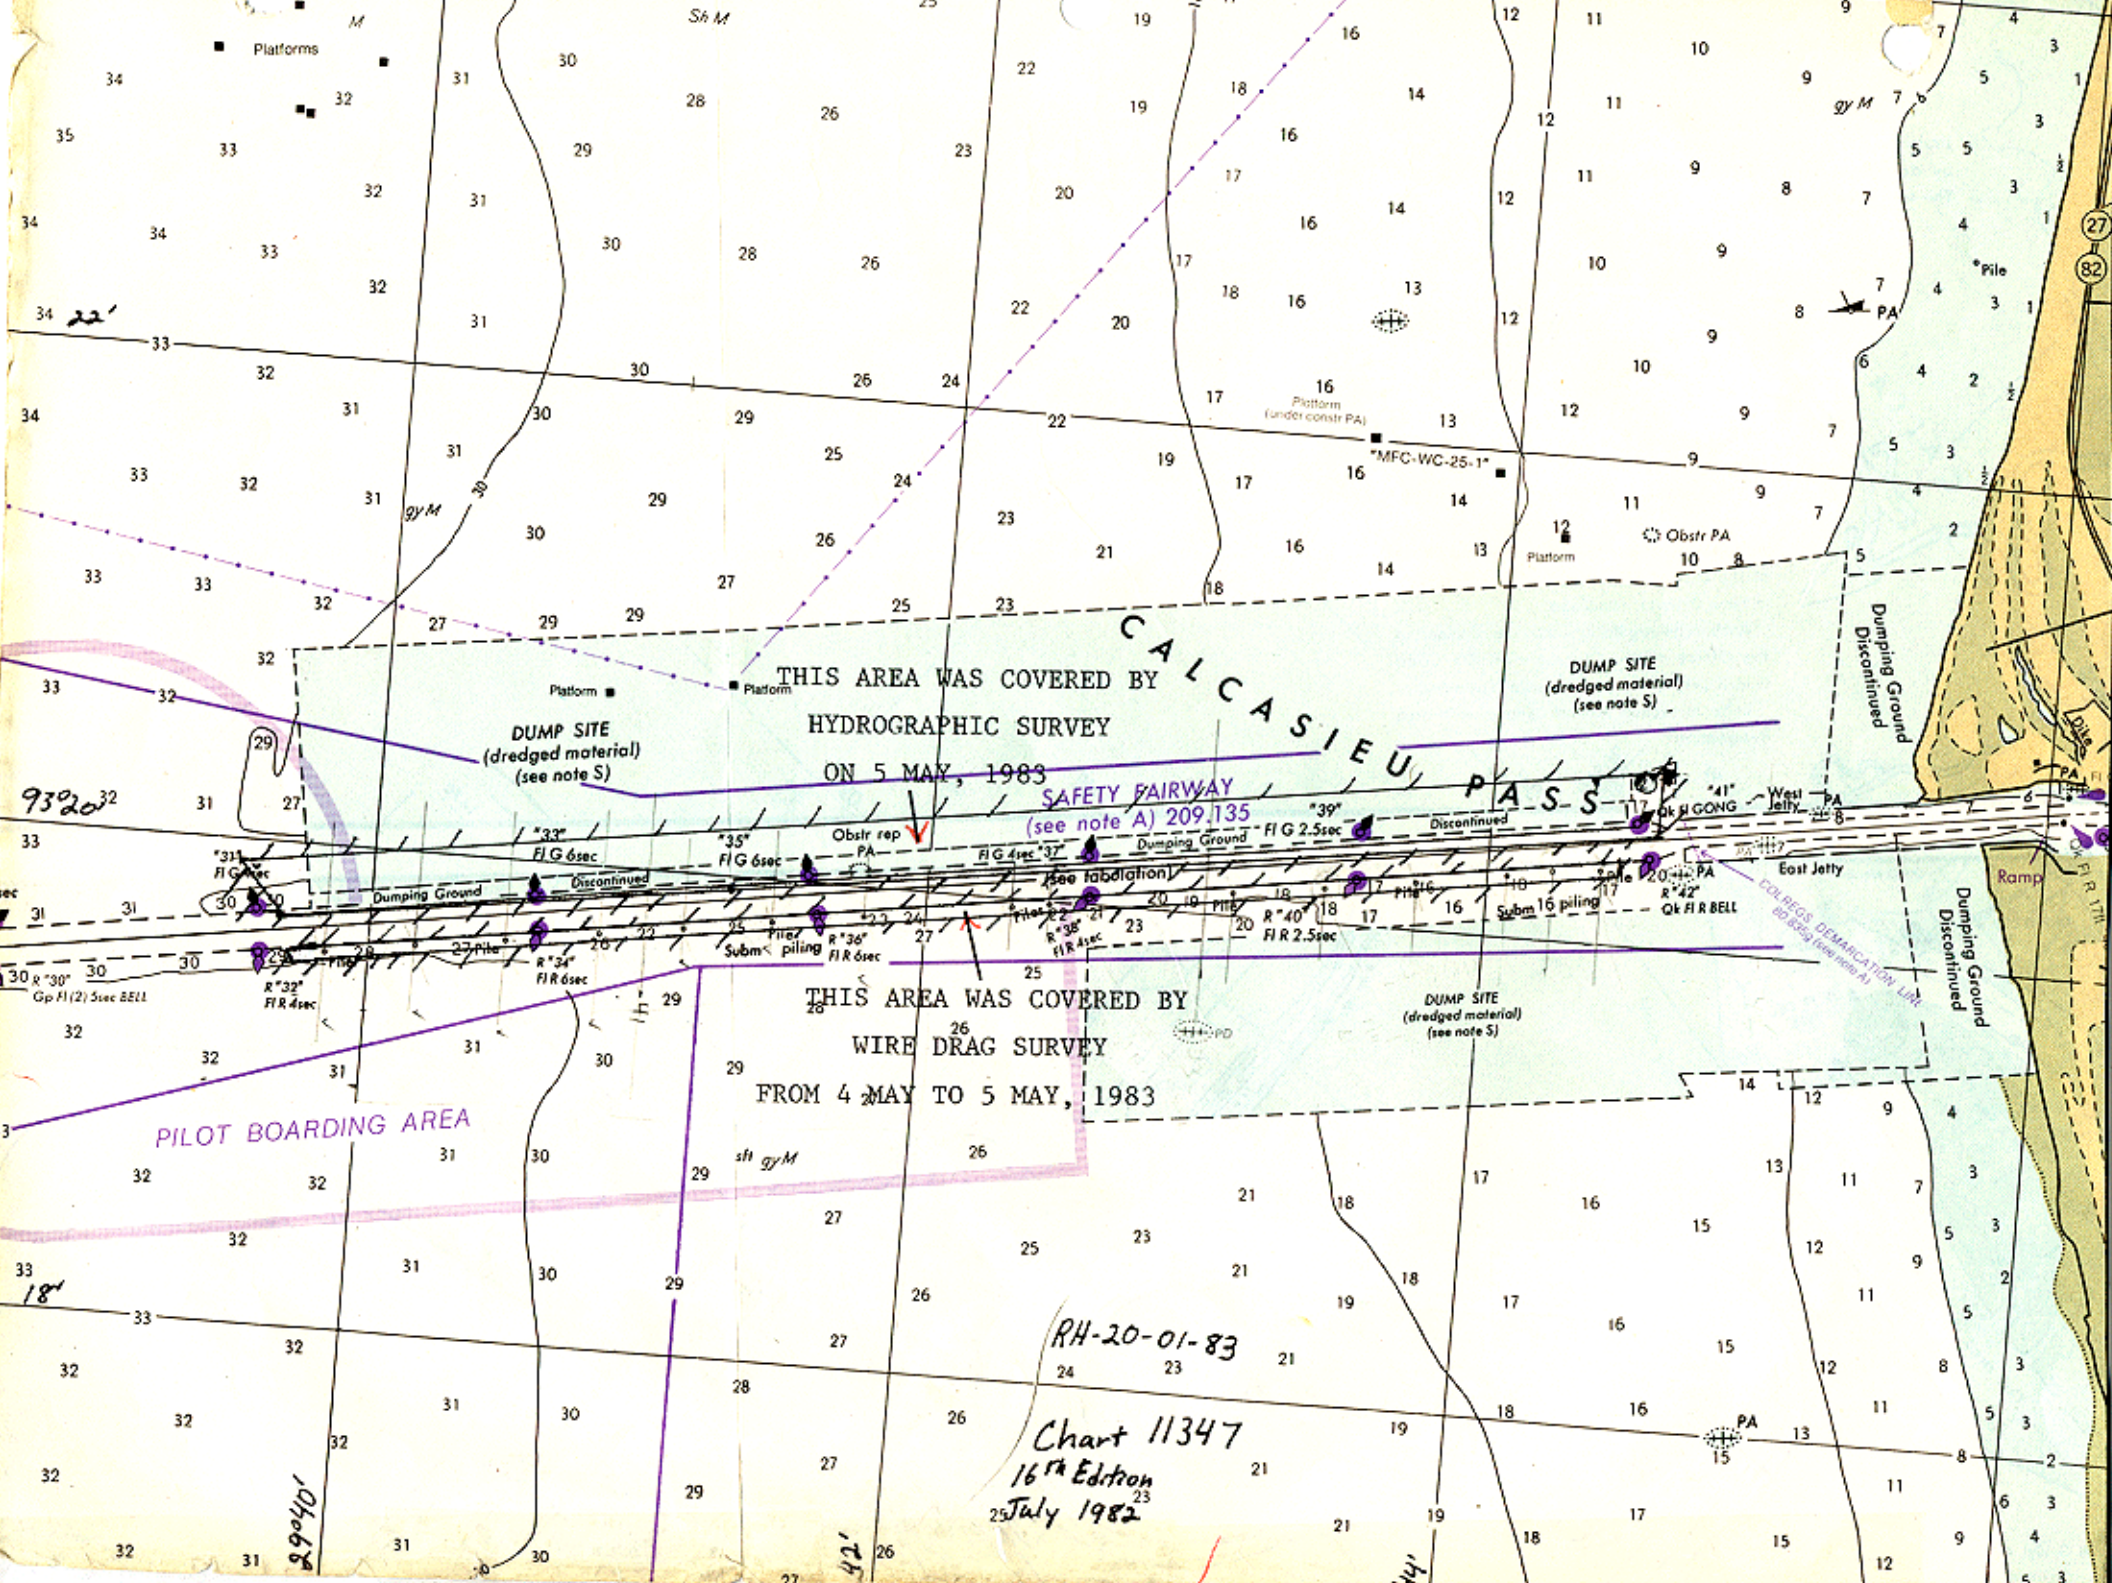
THIS AREA WAS COVERED BY
HYDROGRAPHIC SURVEY
ON 5 MAY, 1983

THIS AREA WAS COVERED BY
WIRE DRAG SURVEY
FROM 4 MAY TO 5 MAY, 1983
