DESCRIPTIVE REPORT

Type of Survey ... Field Examination
Field No. RU-10-6-91
Registry No. FE-365SS

State Rhode Island
General Locality .. Rhode Island Sound
Sublocality Zero Point Five to Eleven
..... NM East of Block Island
.....
..... 1991
.....
CHIEF OF PARTY
..... LCDR N.E. Perugini

Locality Zero Point Five to Eleven Nautical Miles East of Block Island

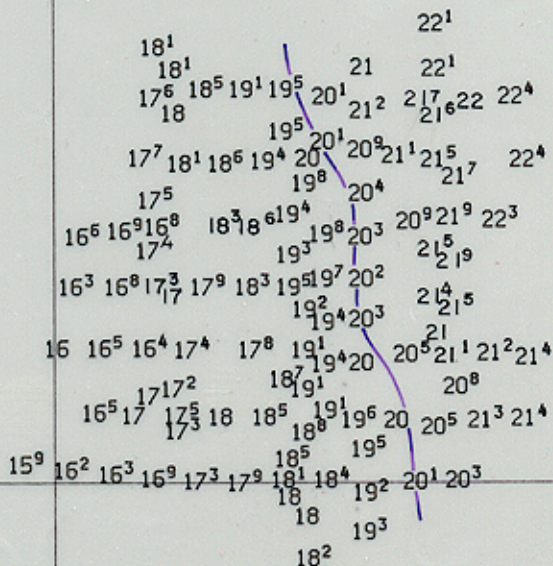
FE-365SS
RHODE ISLAND
RHODE ISLAND SOUND
0.5 TO 11 NM EAST OF BLOCK ISLAND
DATE OF SURVEY: 5 SEP 1991
SCALE: 1:10000
SOUNDINGS IN METERS AT MLLW
HORIZONTAL DATUM: NAD 1983
SHEET 2 OF 5
AVOIS ITEM NUMBER 1819

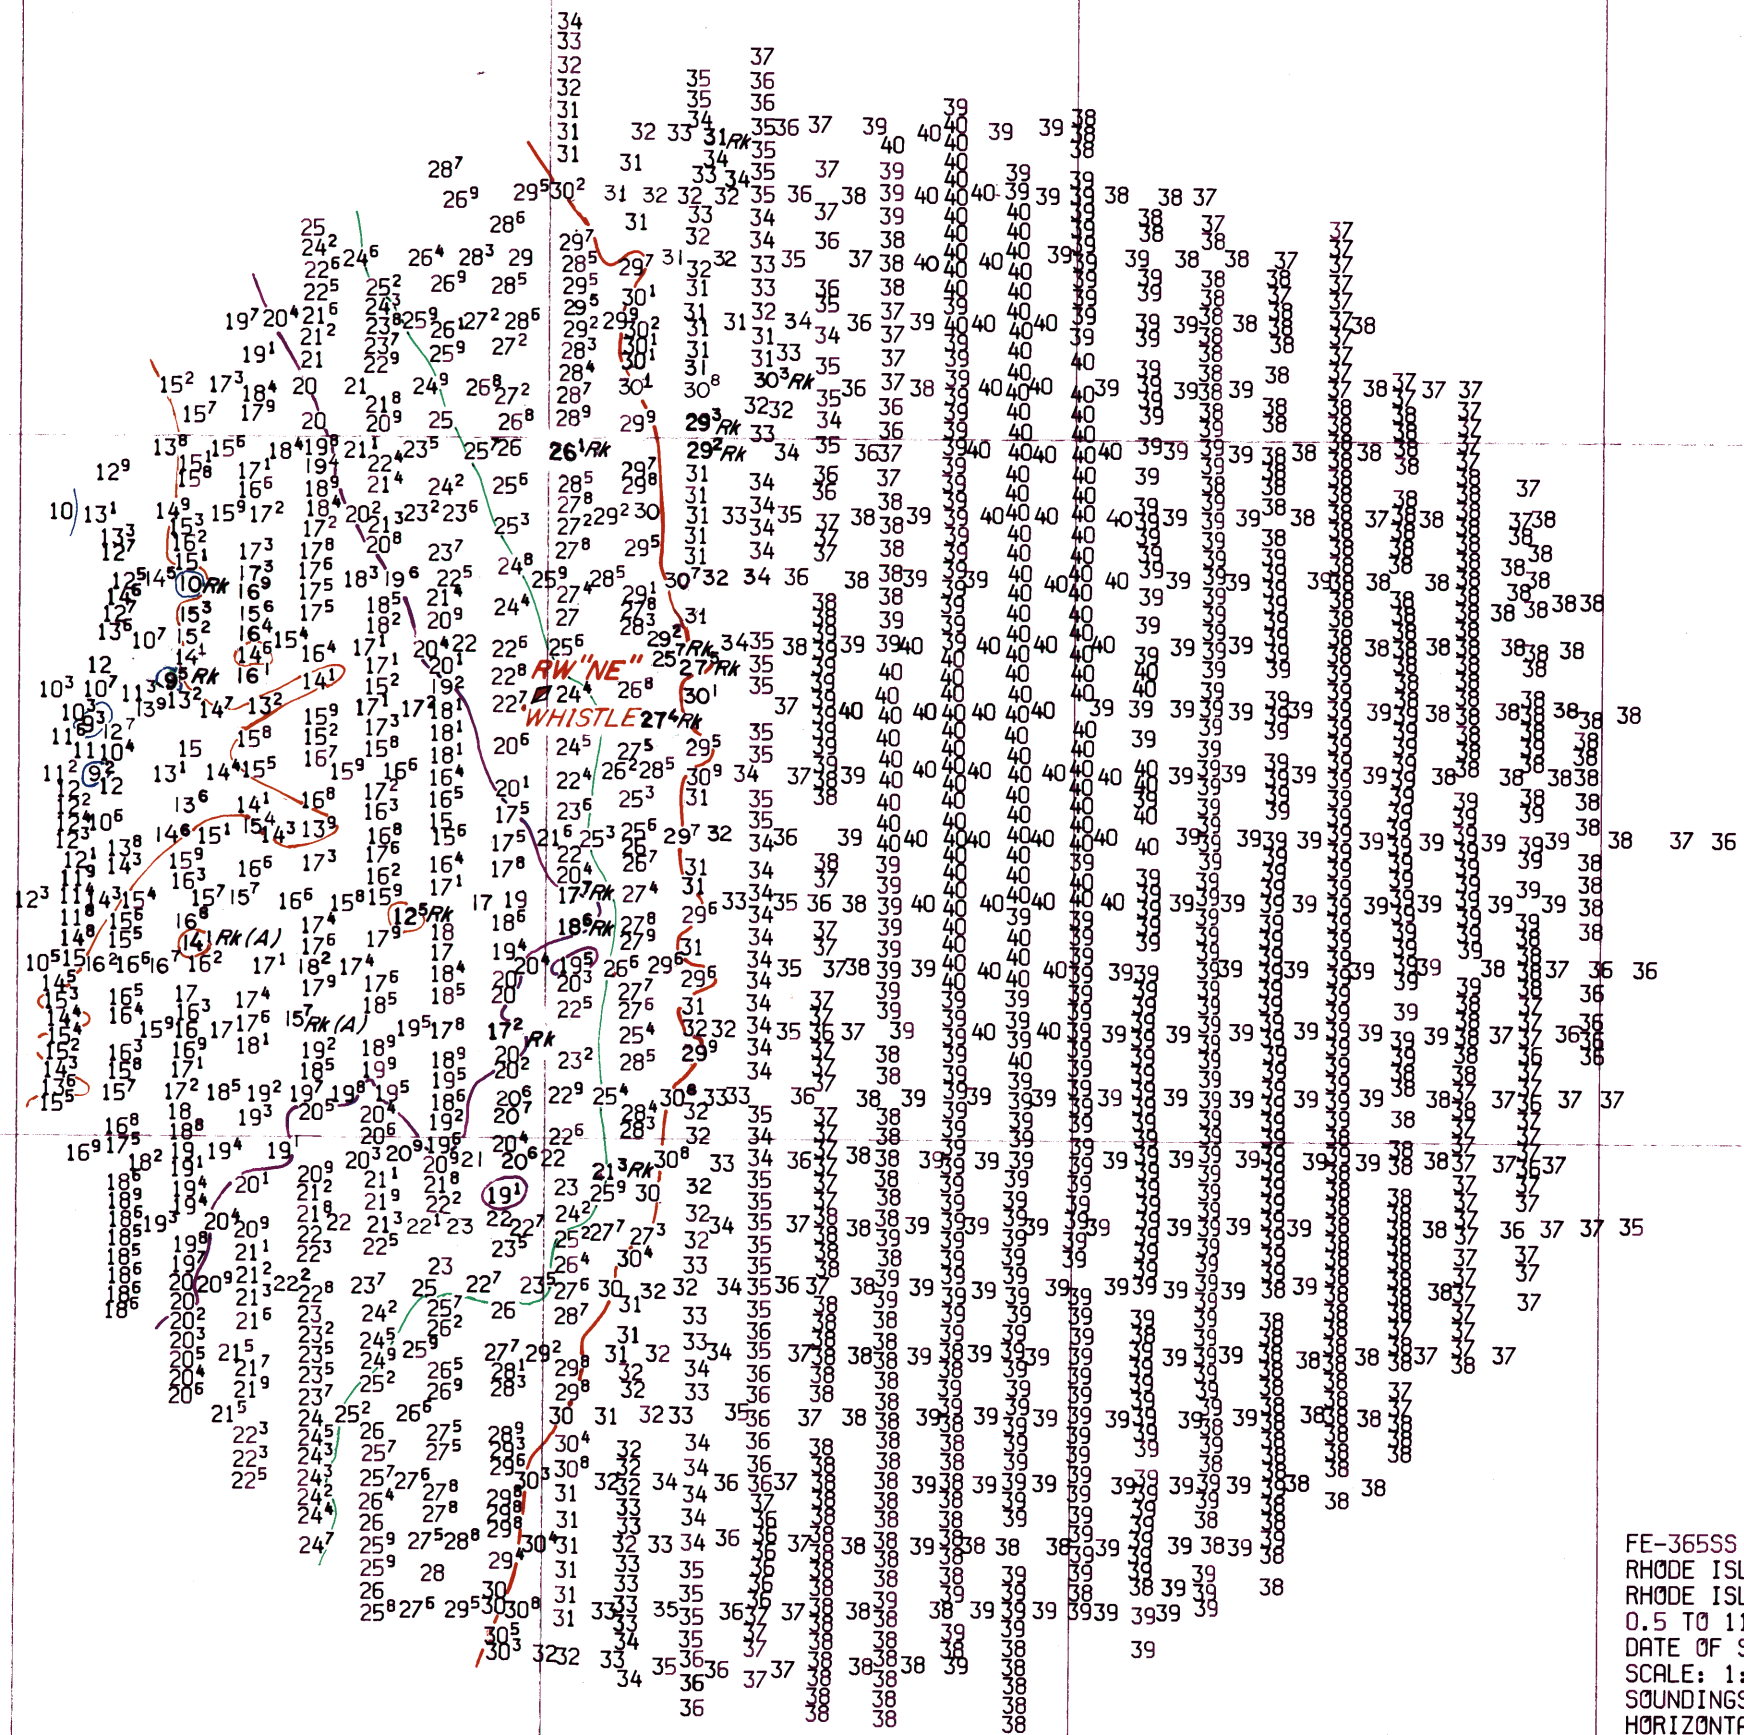
FE-365SS
 RHODE ISLAND
 RHODE ISLAND SOUND
 0.5 TO 11 NM EAST OF BLOCK ISLAND
 DATE OF SURVEY: 5 SEP 1991 TO 19 SEP 1991
 SCALE: 1:20000
 SOUNDINGS IN METERS AT MLLW
 HORIZONTAL DATUM: NAD 1983
 SHEET 3 OF 5
 AWOIS ITEM NUMBER 1826
 (A) Depths on these obstructions were estimated by scaling heights off the bottom from side scan sonar records. Positions were determined by computing offsets from the vessels track.
