DESCRIPTIVE REPORT

Registry No. **F00505**

General Locality Baltimore Harbor

Sub-locality Sparrows Point to Locust Point

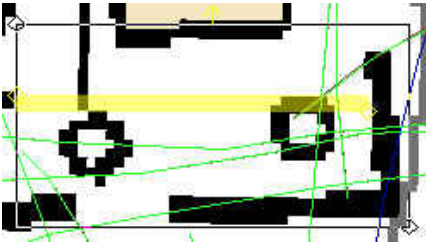
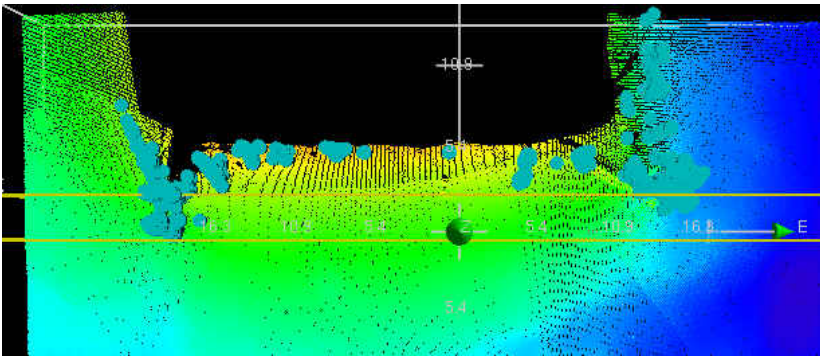
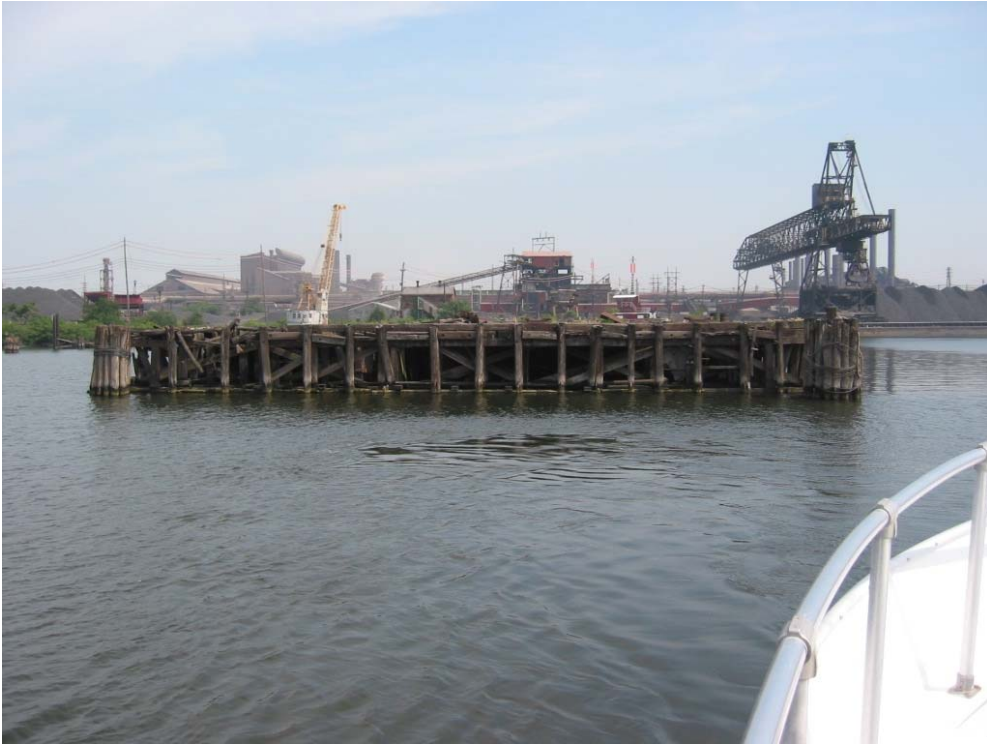
The Hydrographer recommends revising the pier and repositioning the two obstructions against the pier face; centering the DOLS at:

LAT 39-12-34.43N, LONG 076-29-04.04W (NAD83)

Concur. Retain the two dolphins as charted. Defer to Marine Charting Division (MCD) Update Service Branch for revision of the pier and shoreline.

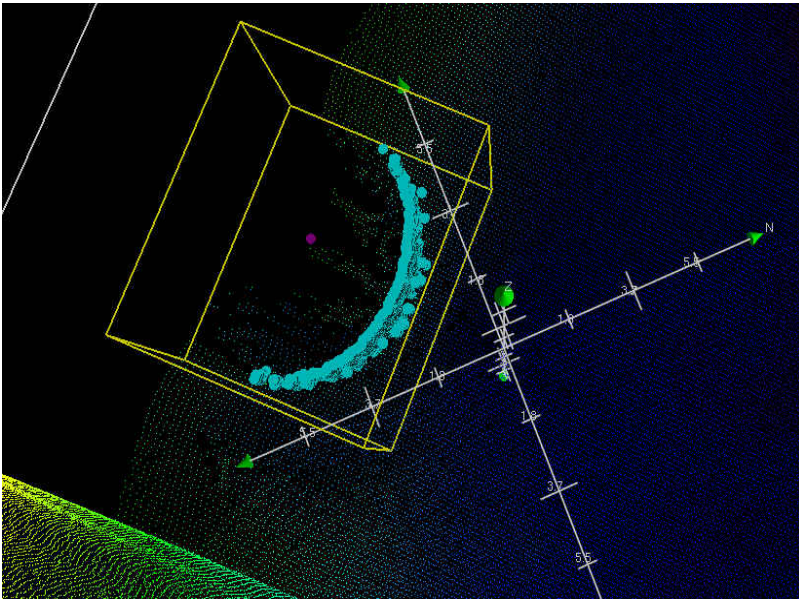
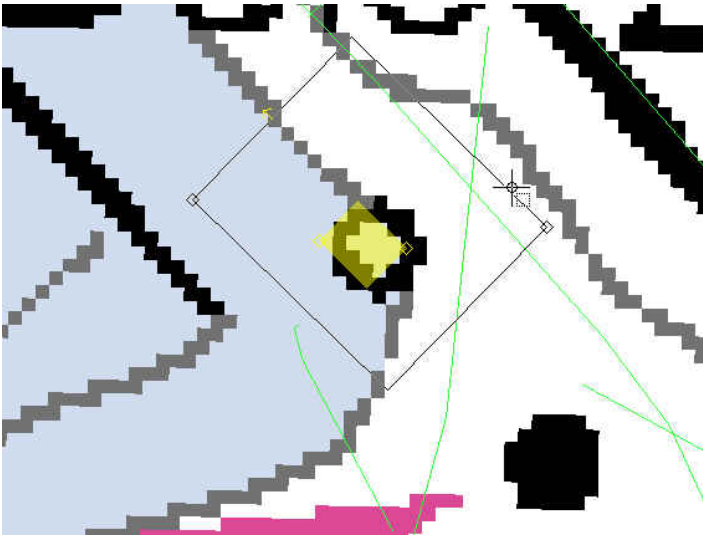
The Hydrographer recommends retaining the position of the charted obstruction.

Concur. Retain the dolphin as charted.
