U.S. Department of Commerce National Oceanic and Atmospheric Administration National Ocean Service		
1	DESCRIPTIVE REPORT	
Type of Survey:	Navigable Area	
Registry Number:	F00734	
	LOCALITY	
State(s):	Texas	
General Locality:	Port Lavaca, TX	
Sub-locality:	Matagorda Bay	
	2019	
	CHIEF OF PARTY Andrew Orthmann	
	LIBRARY & ARCHIVES	
Date:

Descriptive Report to Accompany Survey F00734

Project: OPR-K376-KR-18 Locality: Port Lavaca, TX Sublocality: Matagorda Bay Scale: 1:20000 August 2018 - February 2019 **Terrasond, Ltd.**

Chief of Party: Andrew Orthmann

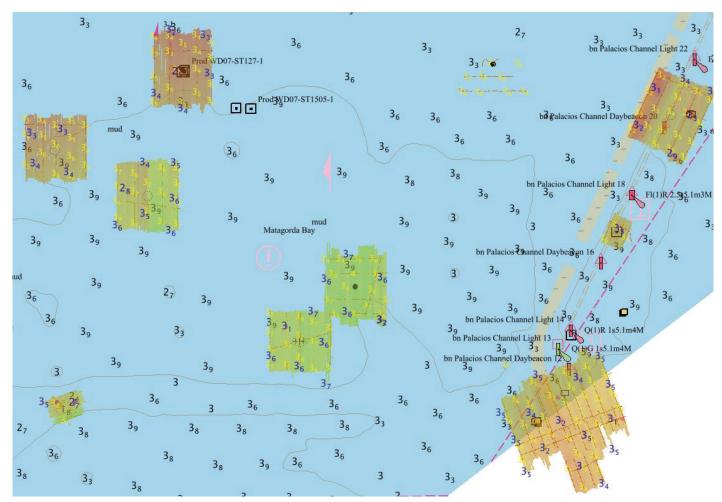
Figure 12: Soundings from this survey (blue from MBES, yellow from SBES) overlaid on US5TX32M (black). Soundings in meters. NE part of survey area.

The northern part of this survey intersects chart US5TX32M. General sounding agreement is excellent, with all soundings comparing to 0.5 m or better, and most soundings agreeing to 0.2 m or better. There are no discernible trends in shoaling or deepening. The images below show soundings from this survey overlaid on this chart.

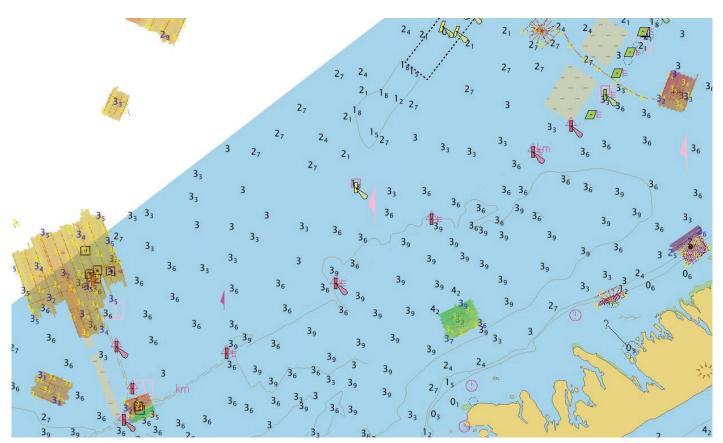
Figure 14: Soundings from this survey (blue from MBES, yellow from SBES) overlaid on US5TX33M (black). Soundings in meters. SE part of survey area.

The southern part of this survey intersects chart US5TX33M. General sounding agreement is excellent, with most soundings comparing to 0.5 m or better, and many agreeing to 0.2 m or better. An exception is the area immediately inside the bay after approaching through the pass, which appears to have deepened by up to 2 meters outside of the channel.
