DESCRIPTIVE REPORT

Type of Survey:	Support USCG			
Registry Number:	F00796			
	LOCALITY			
State(s):	Texas			
General Locality:	Galveston Bay, TX			
Sub-locality:	San Jacinto River at the I-10 bridge			
2019				
CHIEF OF PARTY				
	Dan Jacobs			
LIBRARY & ARCHIVES				
Date:

Sub-Locality: San Jacinto River at the I-10 bridge

Project Number: S-K924-NRT4-19

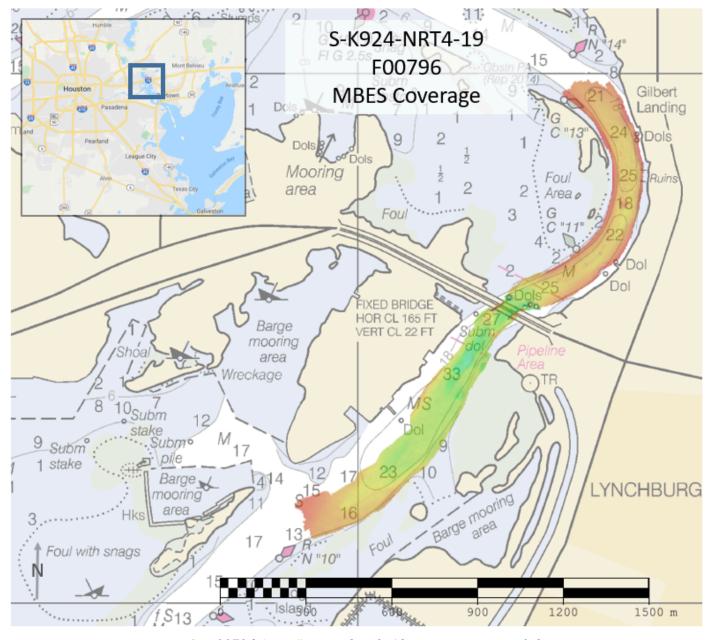
Figure 1: F00796 Area Surveyed with Object Detection Multibeam.

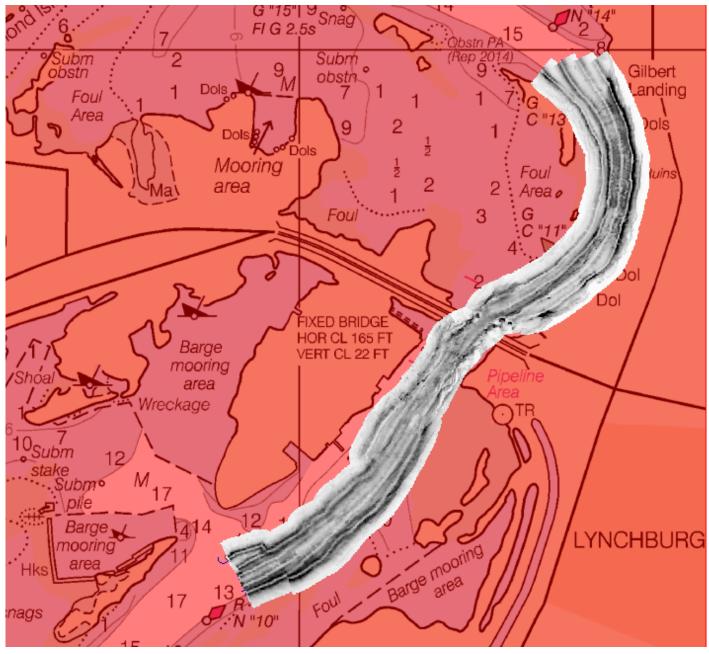
Figure 3: 200% Side Scan Imagery (50m Range Scale) was collected concurrently with Multibeam for this Object Detection Survey.

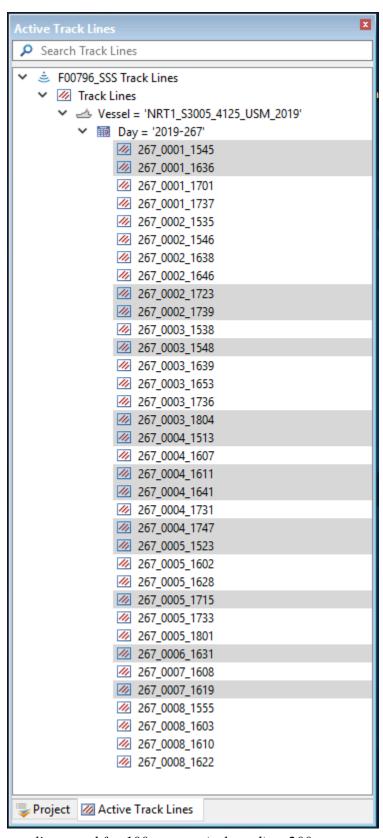
F00796 100 percent and 200 percent side scan mosaics were created at a resolution of 1 meter. Bridge fendering aside, no significant contacts were noted in this imagery. The mosaics are included in the Surfaces_Mosaics folder. In the graphic below, side scan lines are highlighted/selected in CARIS denoting their use in the creation of the 100 percent mosaic.

Figure 6: Side scan lines used for 100 percent (selected) vs 200 percent coverage mosaics

SAR: The field states incorrectly that no significant contacts were noted in the imagery beside the bridge fendering. During review, the survey bathyemtry and imagery revealed 13 additional uncharted features in the surveyed extents: 12 OBSTRN objects and one WRECKS object.

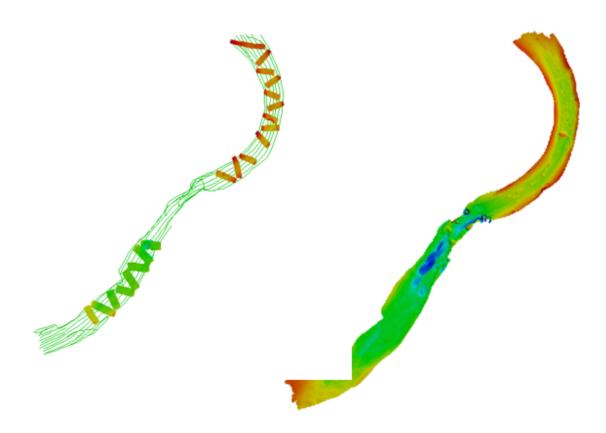
Figure 7: 50cm crossline surface compared to 50cm mainscheme surface, F00796.

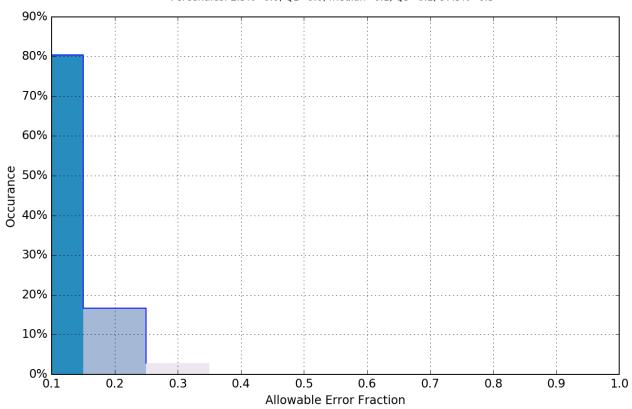
99.5+% nodes pass (252959), min=0.0, mode=0.1 mean=0.1 max=11.3

Figure 8: Comparison distribution between crosslines and mainscheme lines invoking Pydro's Compare Surfaces utility.

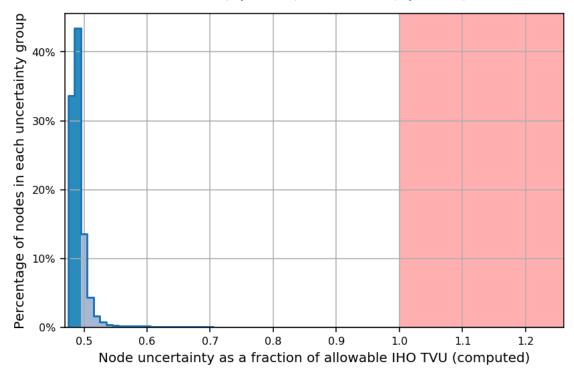
99.5+% pass (992,472 of 992,542 nodes), min=0.47, mode=0.49, max=1.92 Percentiles: 2.5%=0.48, Q1=0.48, median=0.49, Q3=0.49, 97.5%=0.54

Figure 9: F00796 Finalized 50cm Surface, TVU Compliance

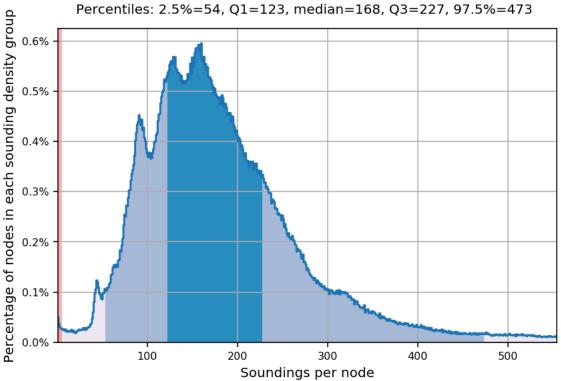
99.5+% pass (999,245 of 1,000,708 nodes), min=1.0, mode=160, max=5618.0

Figure 10: F00796 Finalized 50cm Surface, Density Compliance

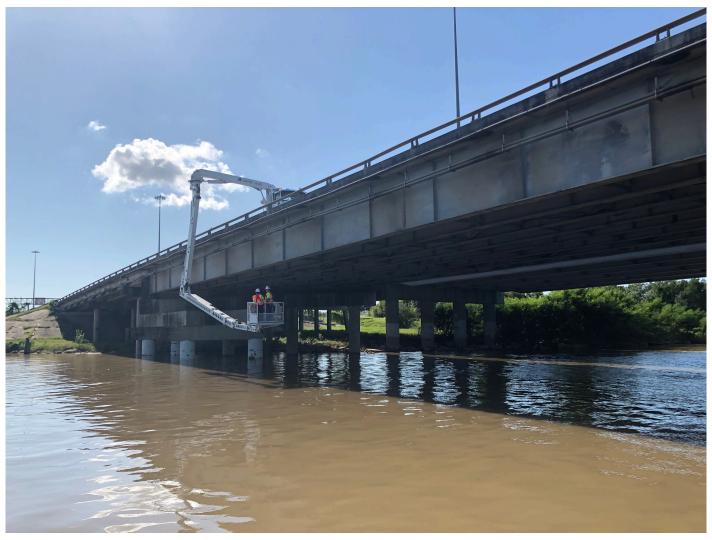
Figure 16: Department of Trans portion Inspectors, Interstate 10 Bridge, Westbound Segment. Picture facing Southeast.

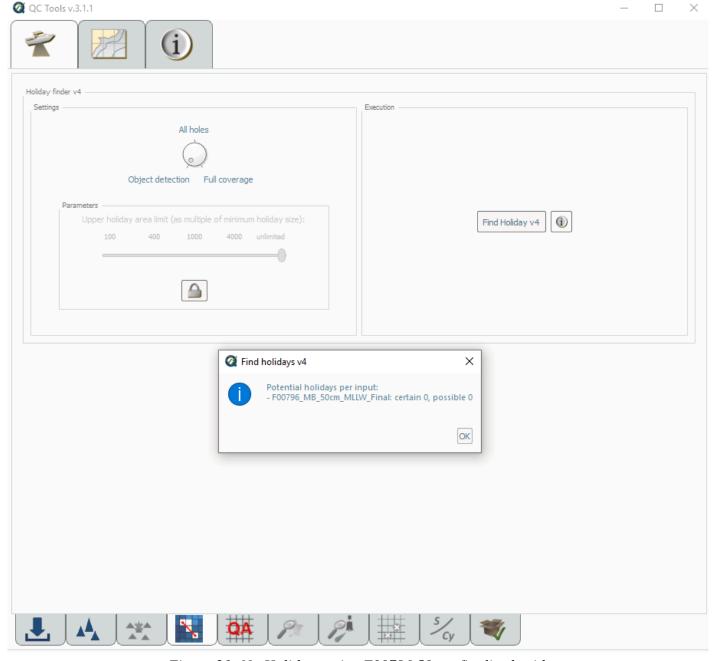
Figure 21: No Holidays exist, F00796 50 cm finalized grid.
