DESCRIPTIVE REPORT

Sheet No. 1-6350

Southern coast of Cape Cod.

Nantucket Sound

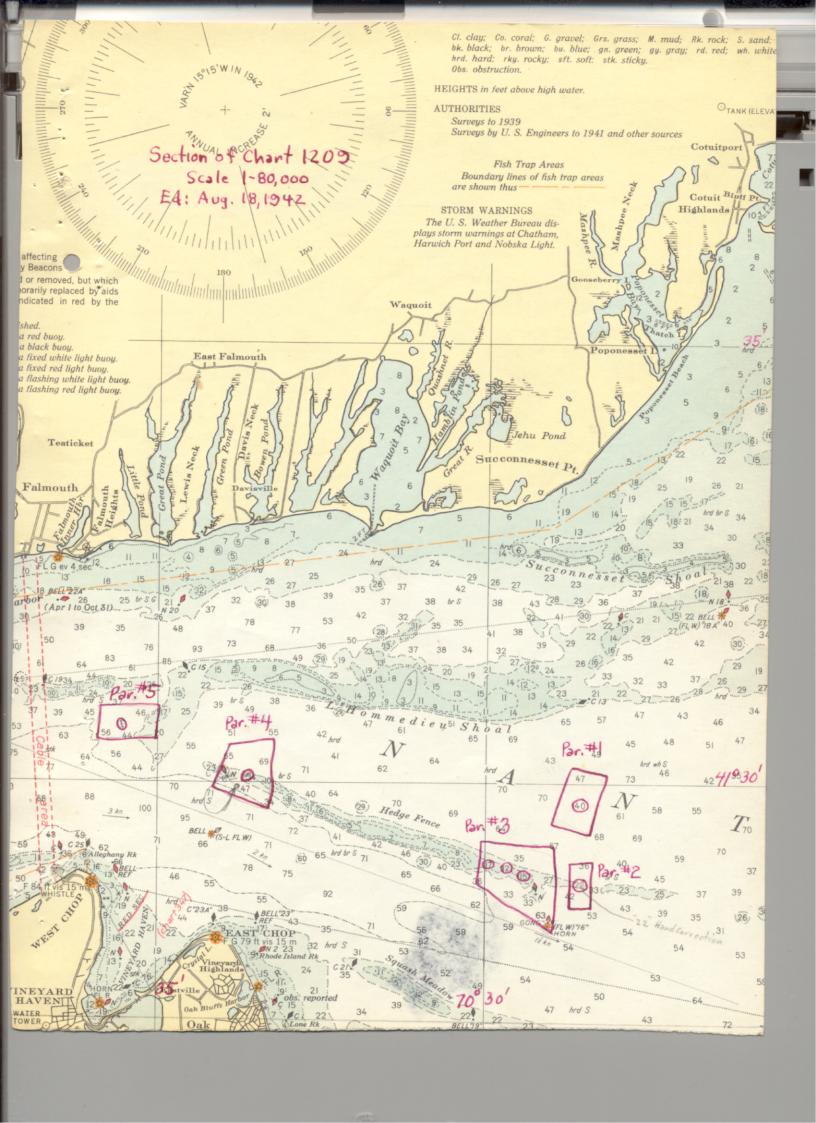
Overlay tracing showing sounding lines in immediate vicinity of 40 and 44 foot depths

Sounding lines spaced 10m. apart and one drag strip (900 feet wide) with an effective depth of 35 feet (10-15 feet off the bottom) failed to reveal any evidence of the wreck which as plotted appears to lie in depths of 55 feet. Enlargement of the dragged area was prevented by an increasing easterly current.

The fact that the schooner is reported to lie in depths of 40 feet whereas the position as plotted is actually 55 feet implies that one or both of the reported bearings may be slightly inaccurate. The discovery of a 36-ft. lump about 180m. ESE of the wreck (outside dragged limit) may represent a shoal covering the wreck but since this lump lines up with a group of 15-18 foot shoal spots to the northeast, the lump in turn may represent a resistant part of an old ridge which has been partly worn away.

The field examination is considered adequate to definitely disprove the wreck in the position as reported. However, since the wreck may conceivably lie outside the actual dragged limits, it is recommended that the wreck symbol be retained on the chart but marked "Position Doubtful" so as to caution navigators to give this area a wide berth.
