DESCRIPTIVE REPORT

Type of Survey ... Hydrographic
Field No. ... HSB-10-1-82
Registry No. ... H-9995

State ... Florida
General Locality ... Pensacola Bay
Sublocality ... Fort McRee to Bayou Chico

DESCRIPTIVE REPORT
TO ACCOMPANY
HYDROGRAPHIC SURVEY H-9995
HSB-10-1-82

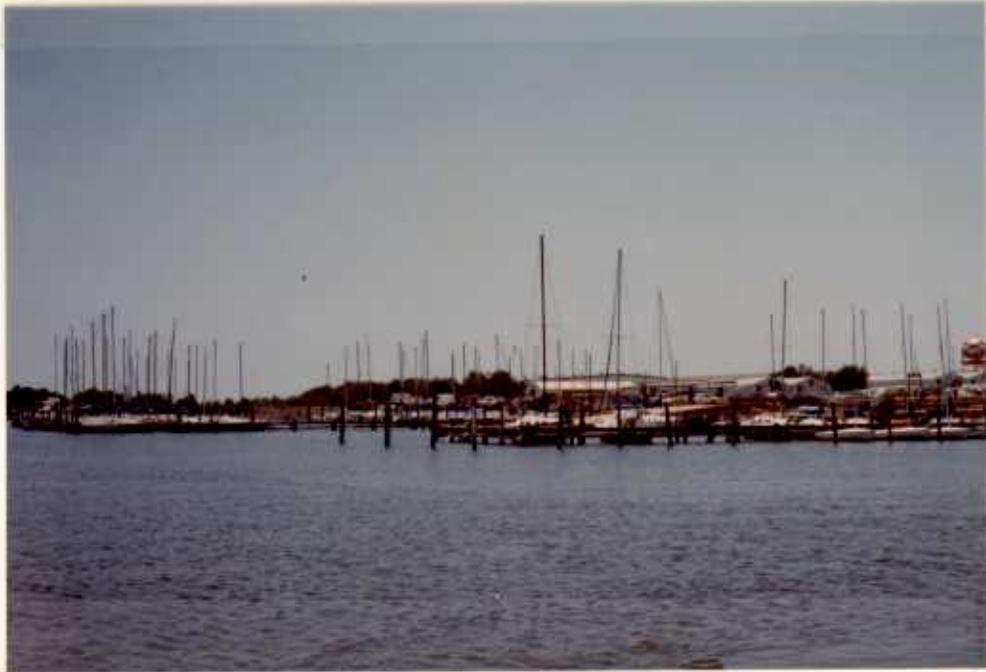
PSR # 329 NAVY SAILING FACILITY IN BAYOU GRANDE

In Bayou Grande the formation of a new entrance channel and the sailing facility has caused that area to be much different than the shoreline shown on H-2026, 1889. However comparison of the present survey with the rest of the Bayou was surprisingly good, with 83% of the soundings in agreement to within one foot, and 98% within 2-3 feet. The major difference was in the vicinity of the Naval Sailing Facility which was built after the 1889 survey.
