DESCRIPTIVE REPORT

Type of Survey . . . Navigable Area Hydrographic . . .

Registry No. . . . H-10282

Sublocality Sweeper Cove

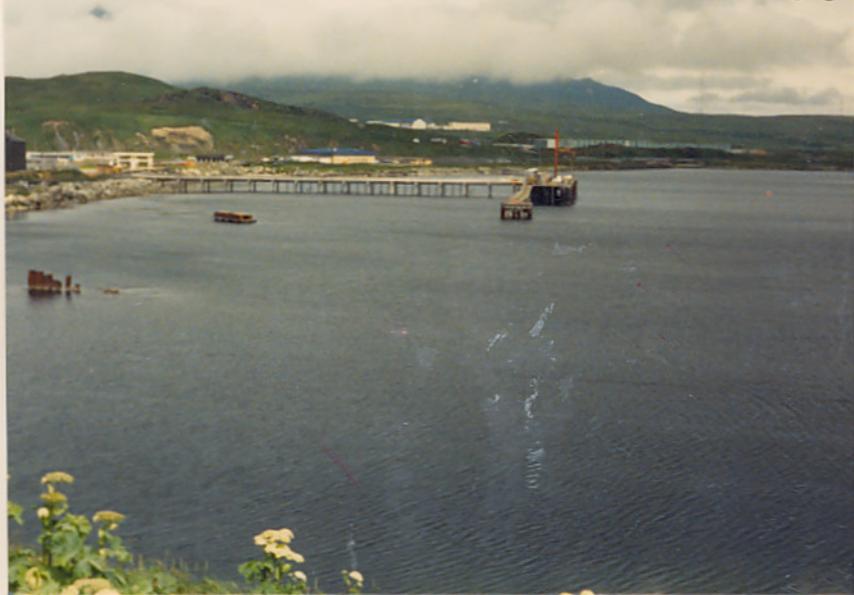
Fuel Pier, Looking NW FROM STATION HAPPY,
1988

The fuel pier position was verified by sextant fixes. Position fixes 3024-3029 verified the position of the seaward face within 5 meters of the charted position. There did not appear to be any new construction or pier modifications since the original construction. DAVIDSON recommends that the fuel pier remain as charted.
