DESCRIPTIVE REPORT

Type of Survey HYDROGRAPHIC
Field No. AHP-10-1-95
Registry No. H-10588

State TEXAS
General Locality GALVESTON BAY
Sublocality RED FISH BAR TO
..... EAGLE POINT
..... 19 96
..... CHIEF OF PARTY
..... LT. K. N. HARRISON, NOAA

Project No. OPR-K204

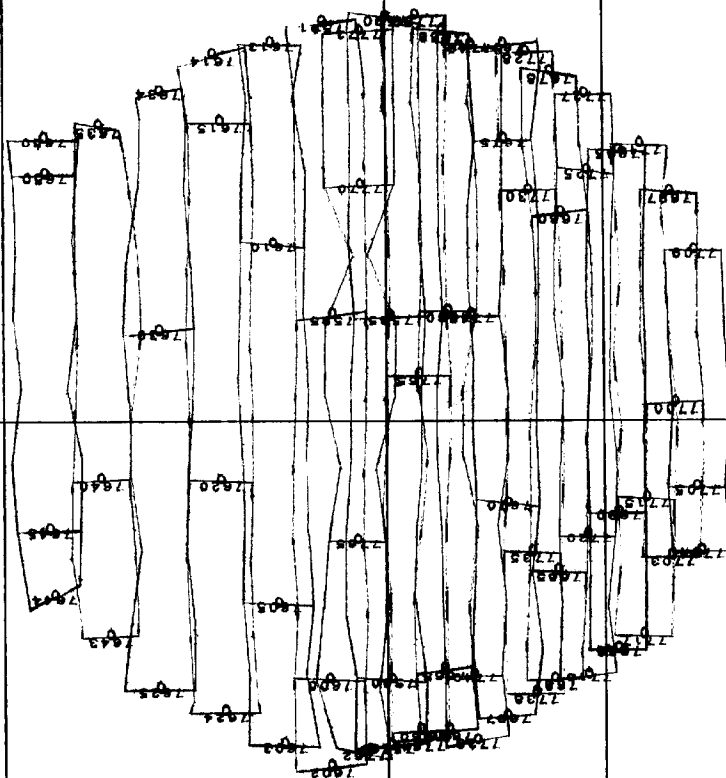
AWOIS NO: 9359

Item Description: Obstruction (Pole)

Investigation Summary: AHP divers conducted a 50-meter circle search around the AWOIS target center. No contacts were found.

The hydrographer recommends that the pole be deleted from the chart.
