DESCRIPTIVE REPORT

Type of Survey ... Field Examination

Registry No. FE-289

General Locality Kodiak Island

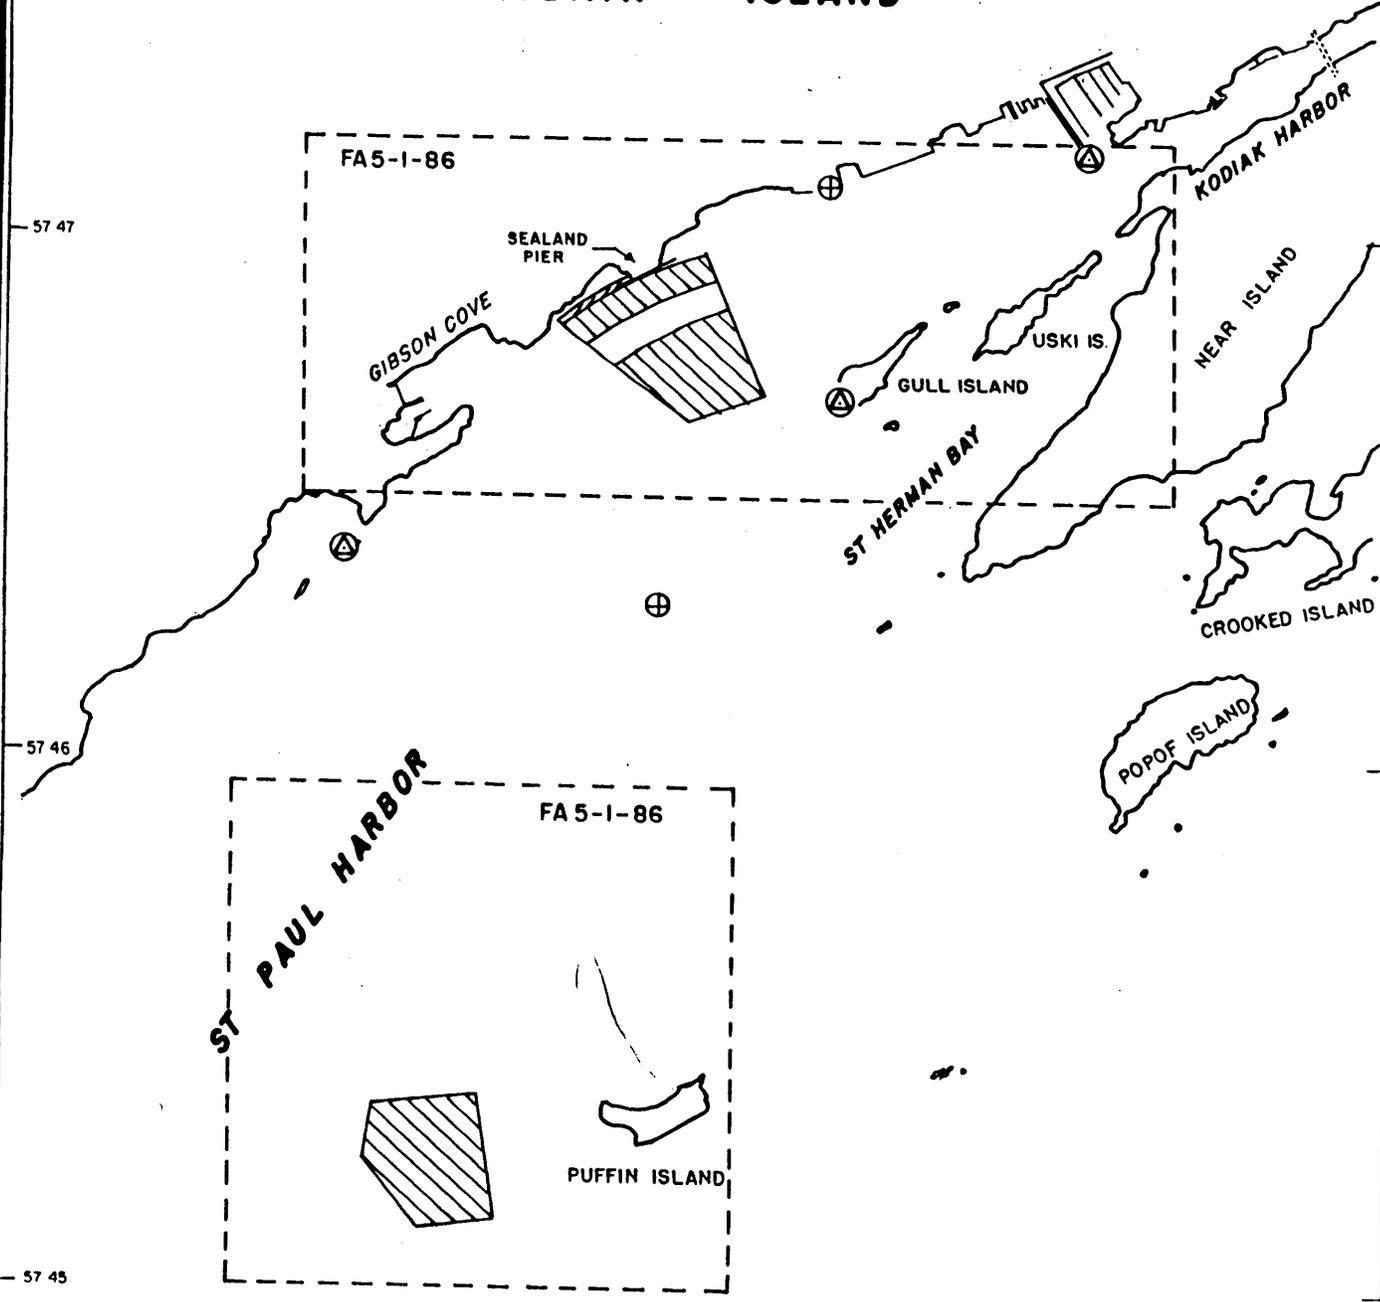
JUNE JULY	
SO NM SOUNDING LINE	1-2	0
LNM SOUNDING LINE	10-1	0-3
BOTTOM SAMPLE	6	0
HYDRO CONTROL STATIONS	3	0
SV/D-NANSEN CAST	1-1	1-0
WATER SAMPLES ANALYZED	3	0
HYDROGRAPHY	[Hatched Box]

- ⊗ STATIONS RECOVERED
- ⊕ SV/D NANSEN CAST

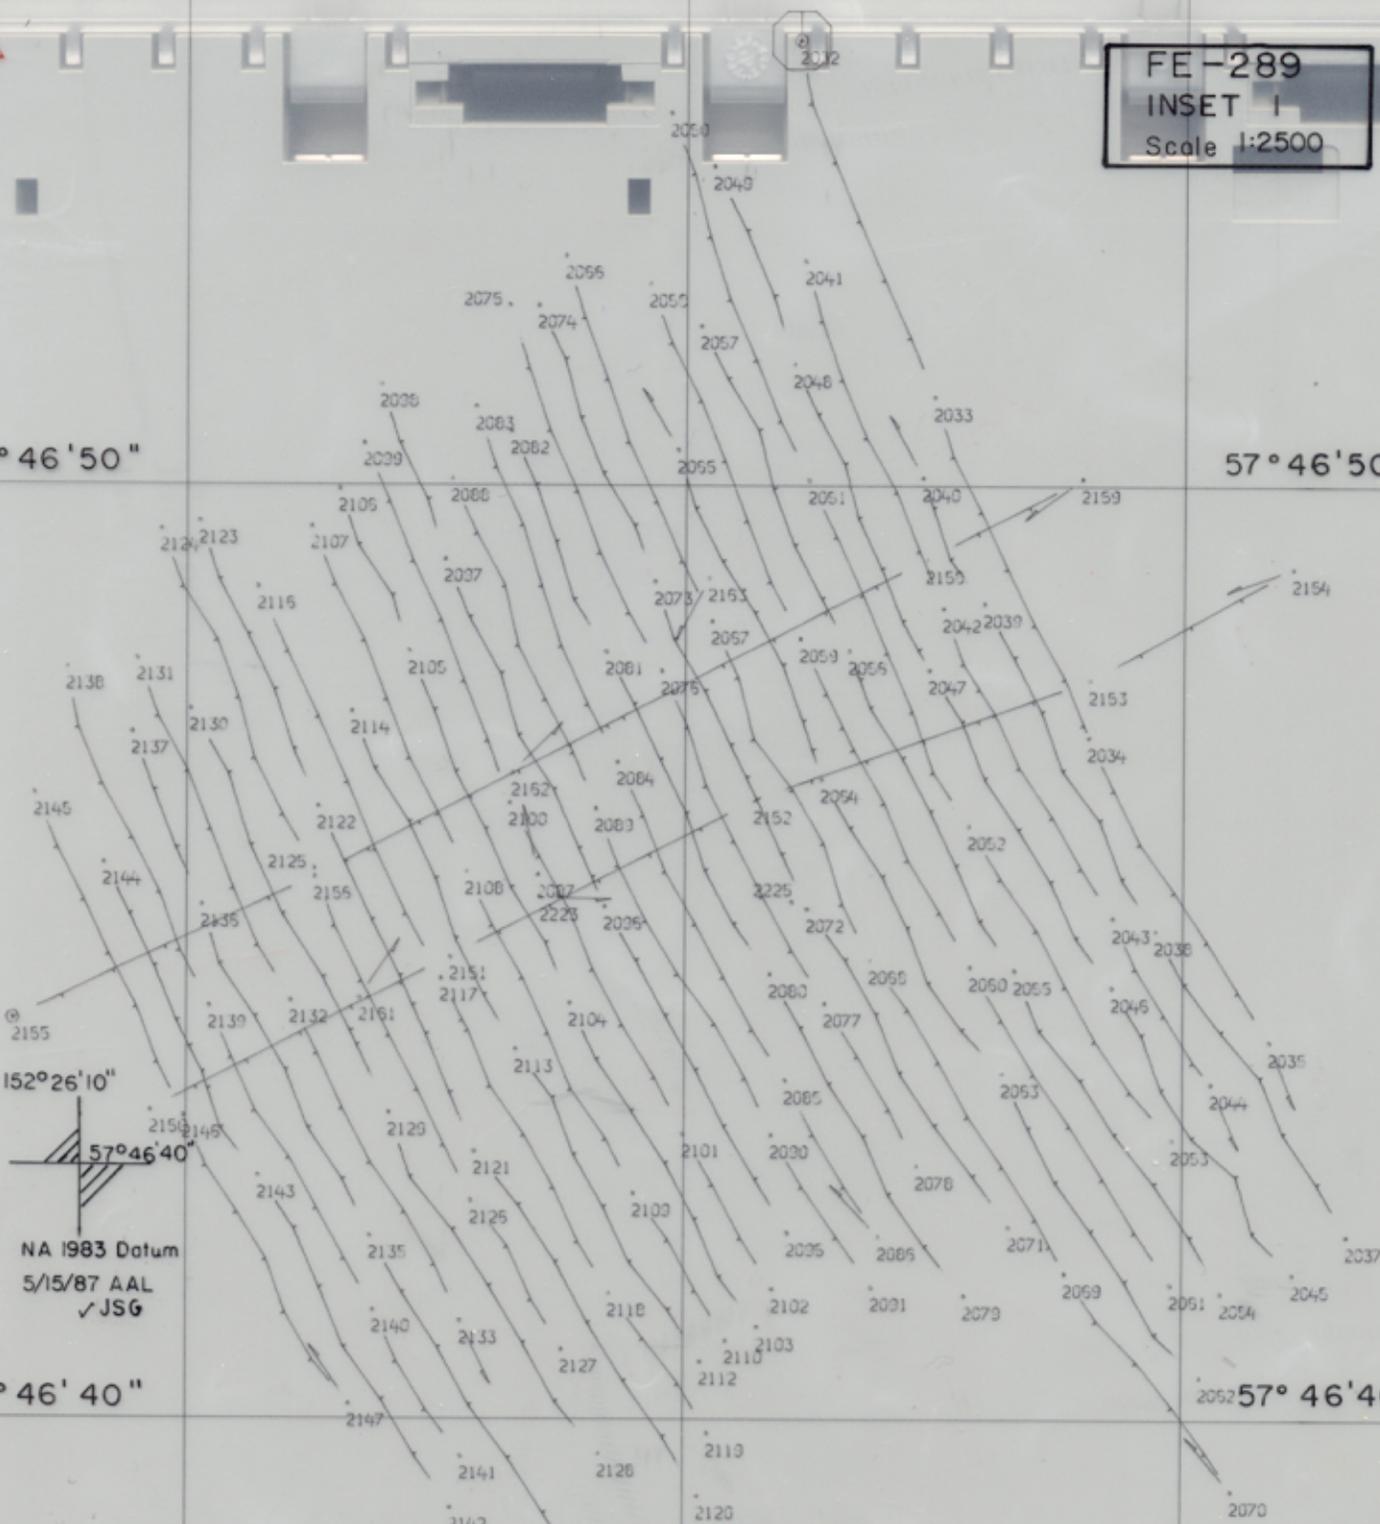
FE-289
 INSET 2
 Scale 1:2500

- CONTAINER TERMINAL PIER EAST LIGHT (dolphin)
- 901 CONTAINER TERMINAL PIER 3 OUTER EAST LIGHT
- 950 CONTAINER TERMINAL PIER 3 INNER EAST LIGHT
- 700 CONTAINER TERMINAL PIER 3 INNER WEST LIGHT
- 900 CONTAINER TERMINAL PIER 3 OUTER WEST LIGHT

The area in the vicinity of latitude 57/46/53N, longitude 152/26/10W, was investigated for signs of the submerged rock reported by Sea Land Services, Inc. personnel as being near shore and 300 feet west of Pier 3. Two sets of lines approximately 20-degrees offset from each other were run over this area. Both sets of lines were run with 12-meter line spacing. Hydrography agreed with H-10032 to within 1 foot. No indications of a dangerous submerged rock were found. The only significant feature on the echograms was determined by diver investigation (position 2246 at latitude 57/46/51.5N, longitude 152/26/11.0W) to be a 3-ft x 5-ft x 6-ft crab pot
