DESCRIPTIVE REPORT.

Hydrographic Sheet No. 3774

*Approaches to
Assateague Anchorage*

APPROACHES TO ASSATEAGUE ANCHORAGE, VA.

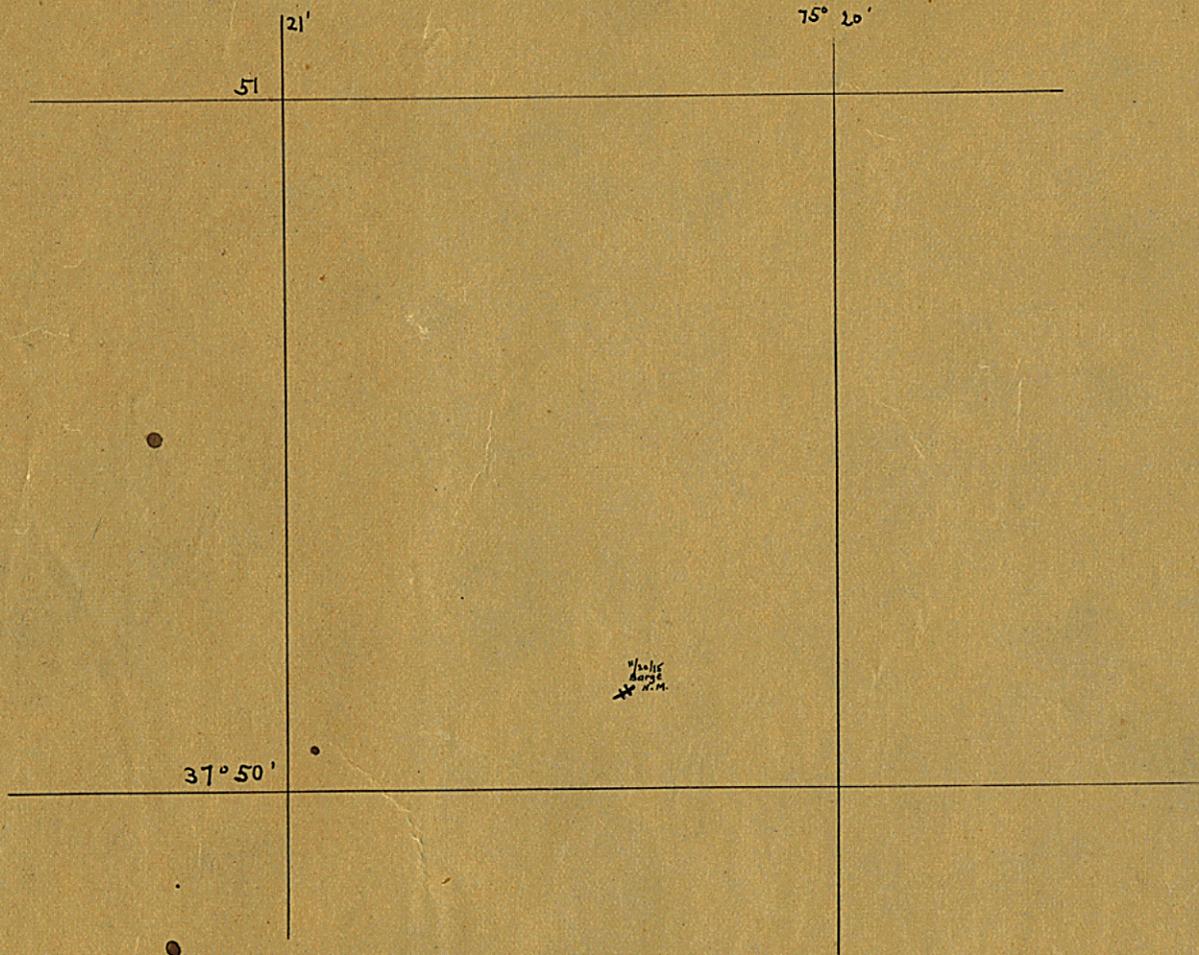
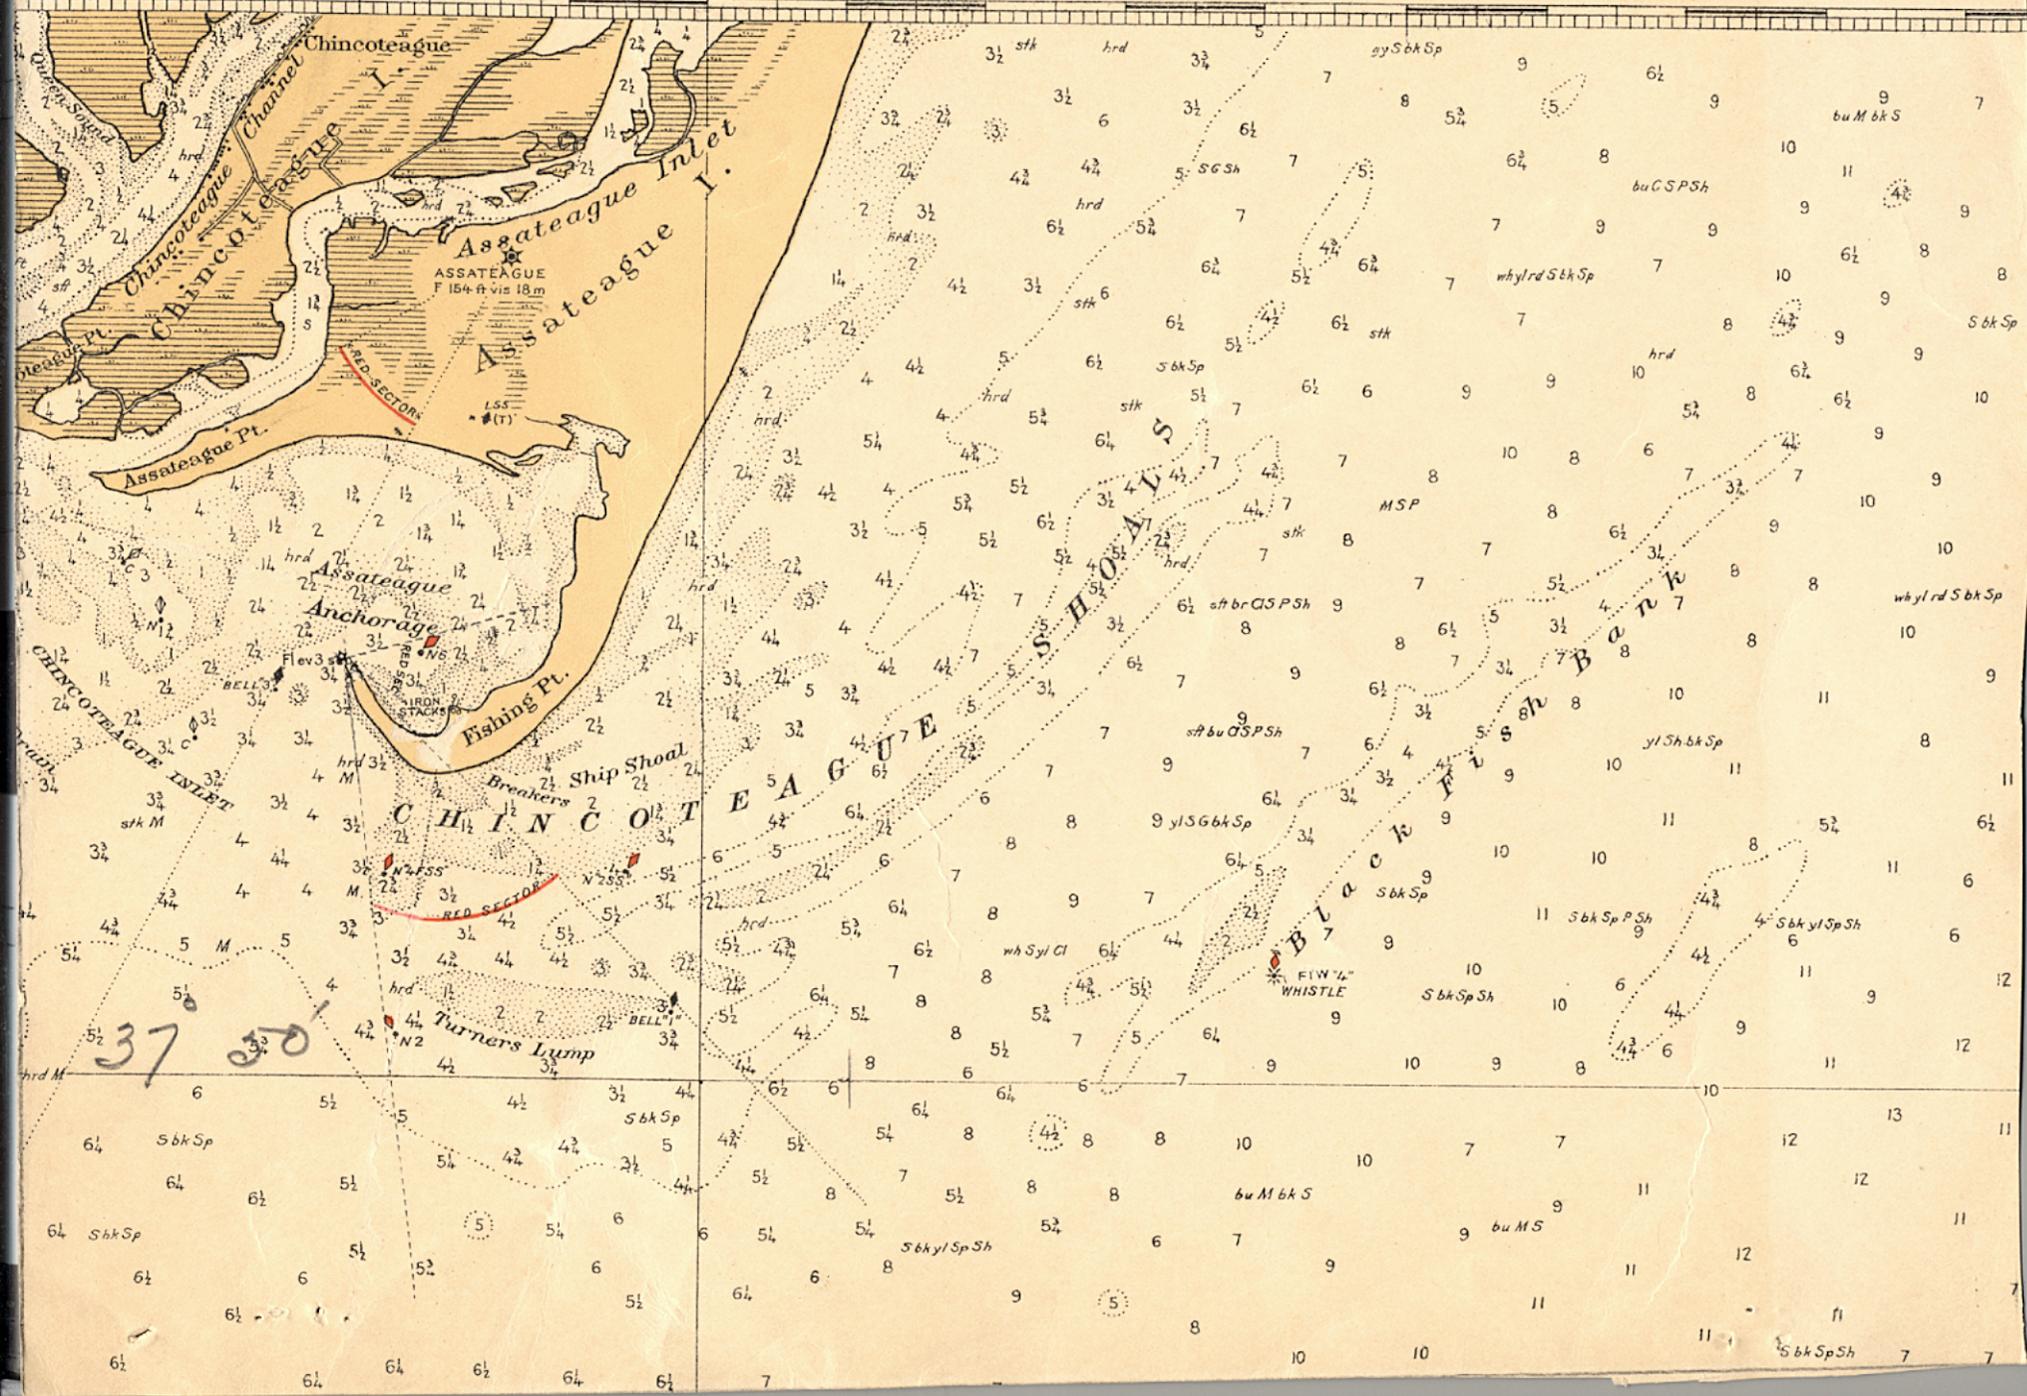
Approach to Assateague Anchorage, Va.

Scale 1:20,000

no reference to which could be found in the records.
This symbol has been removed as per instructions and
explanations attached to the Descriptive Report.

Several other inaccuracies of minor importance have
been found and corrected.
