## DESCRIPTIVE REPORT

Type of Survey HYDROGRAPHIC

Field No. ECFP-1256 Office No. H-8365

Locality ST. HELENA SOUND

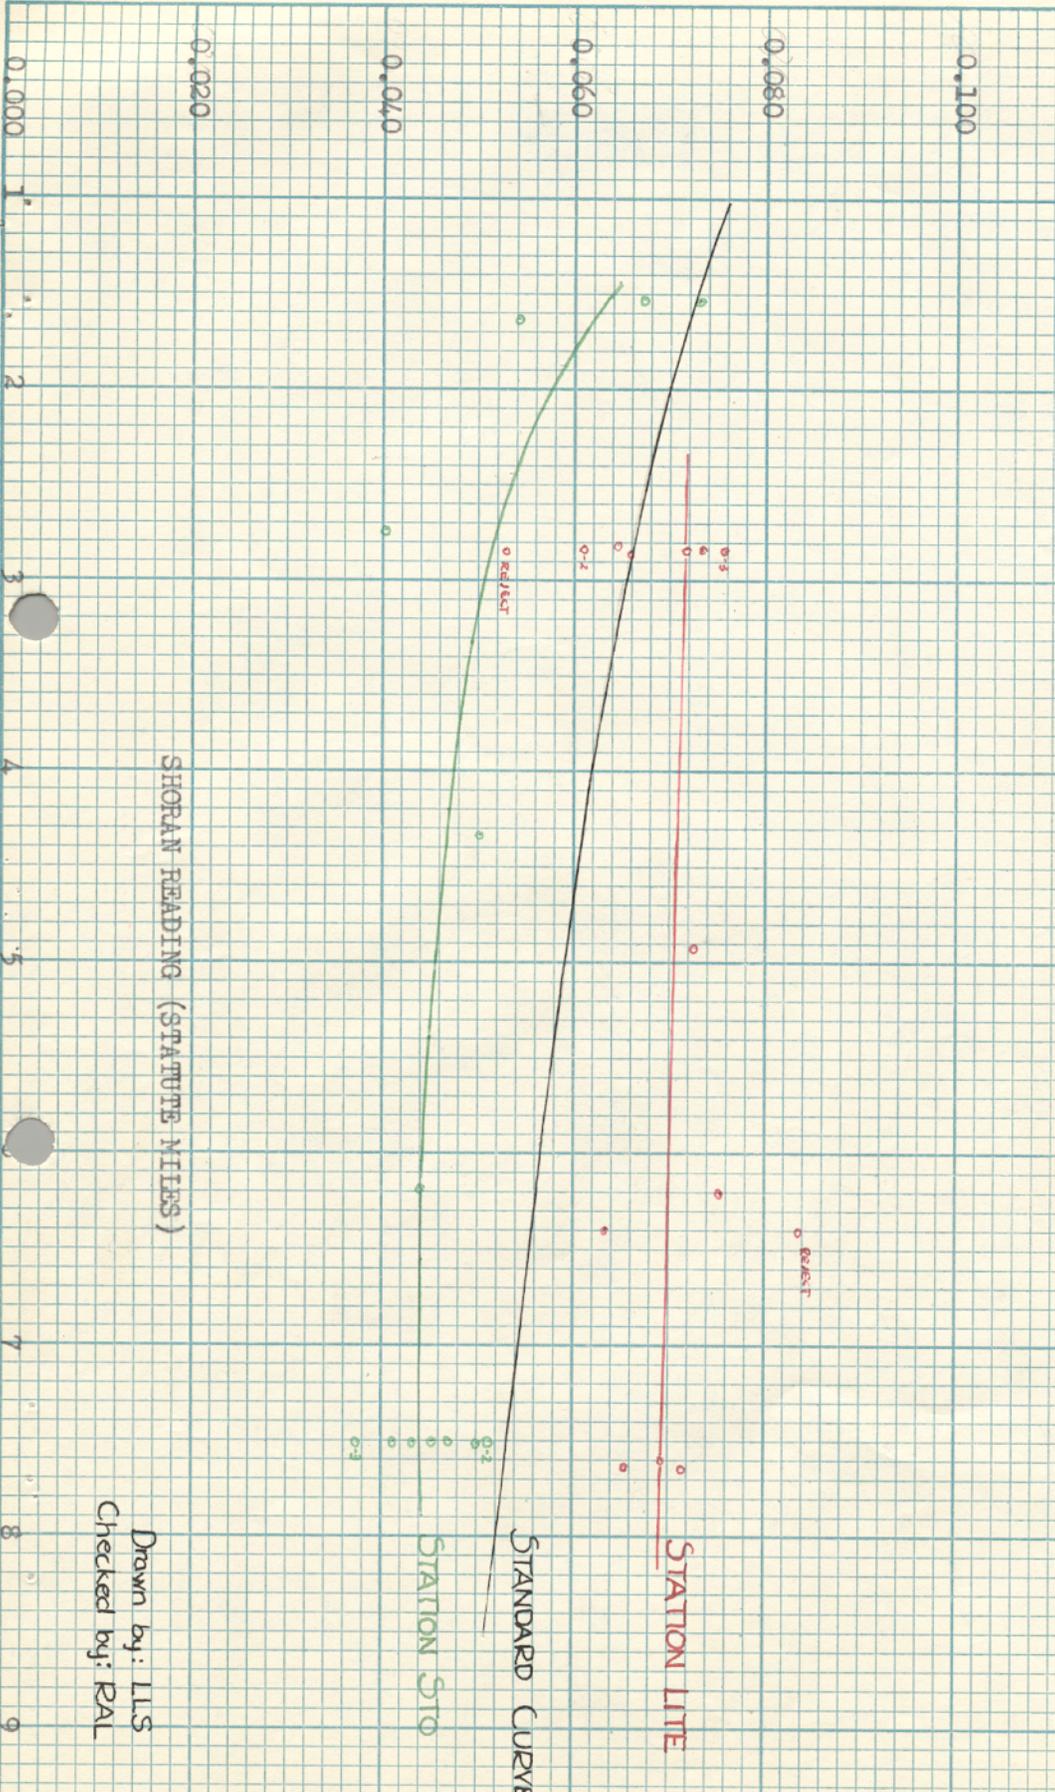
SHORAN CORRECTION CURVE  
 PROJECT 13850  
 SHEET (ECFP-1256)  
 LAUNCH 82

SHORAN READING (STATUTE MILES)

The <sup>Shoran</sup> shoran corrections appear to be based primarily <sup>be based primarily</sup> on <sup>values</sup> the values obtained from calibration <sup>calibration</sup> on special <sup>buoys</sup> buoys, set for that purpose. A <sup>cursor</sup> cursory inspection of the <sup>volumes</sup> volumes indicate that quite a few 3rd - <sup>simultaneous</sup> simultaneous Shoran readings were taken during hydro and these do not agree in many <sup>instances</sup> instances with the <sup>recorded</sup> recorded values. The <sup>verifier</sup> verifier should plot and <sup>compare</sup> compare these together with <sup>with</sup> the <sup>buoy</sup> buoy values for line, dist and area <sup>prior</sup> prior to <sup>inking</sup> inking <sup>sounding</sup> sounding at the present <sup>smooth</sup> smooth sheet position. The <sup>period of time elapsed</sup> period of ~~time~~ elapsed between these two sheets is not enough to <sup>account</sup> compensate for the large <sup>junctional</sup> junctional differences in depths.
