U. S. DEPARTMENT OF COMMERCE  
COAST AND GEODETIC SURVEY

DESCRIPTIVE REPORT

Type of Survey Hydrographic

General locality St. Johns River

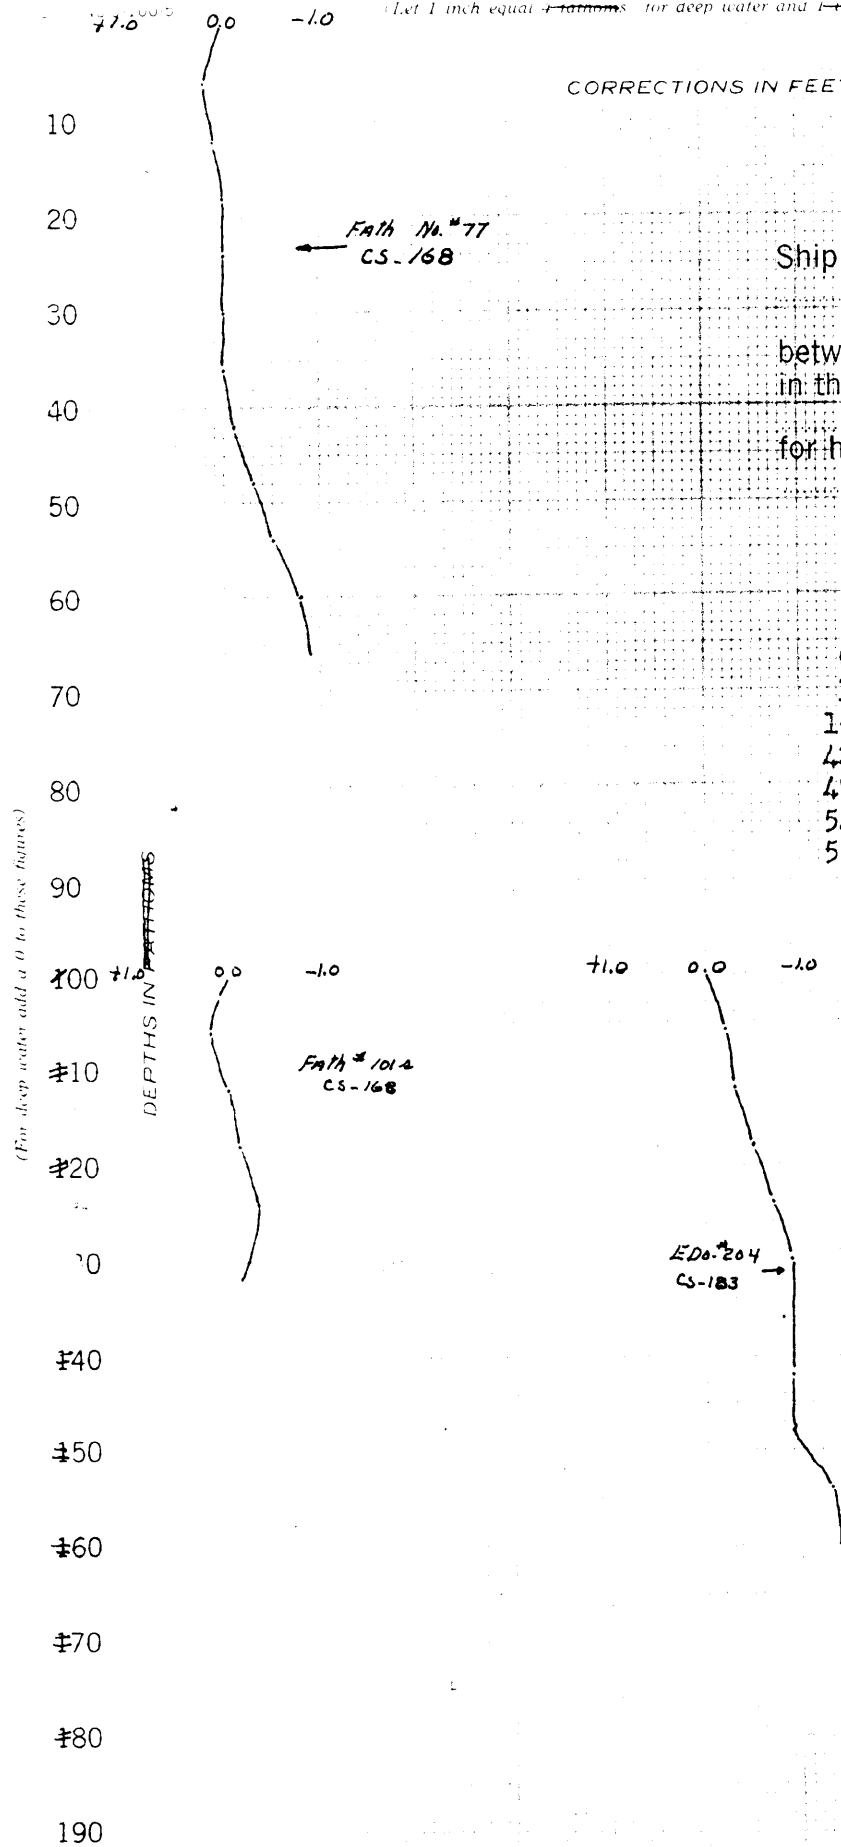
VELOCITY CORRECTIONS

DEPTHS (ft.)	CORRECTIONS
0.0 to 3.0	0.0
3.1 to 12.0	-0.2
12.1 to 19.0	-0.4
19.1 to 24.0	-0.6
24.1 to 48.0	-0.8
48.1 to 51.0	-1.0
51.1 to 54.0	-1.2
54.1 to 60.0	-1.4

CORRECTIONS IN FEET, ~~FATHOMS~~

Tabulations of Results
