## DESCRIPTIVE REPORT

Type of Survey Hydrographic

Field No. ECP 10-4-63 Office No. H-8634

Locality Bon Secour Bay

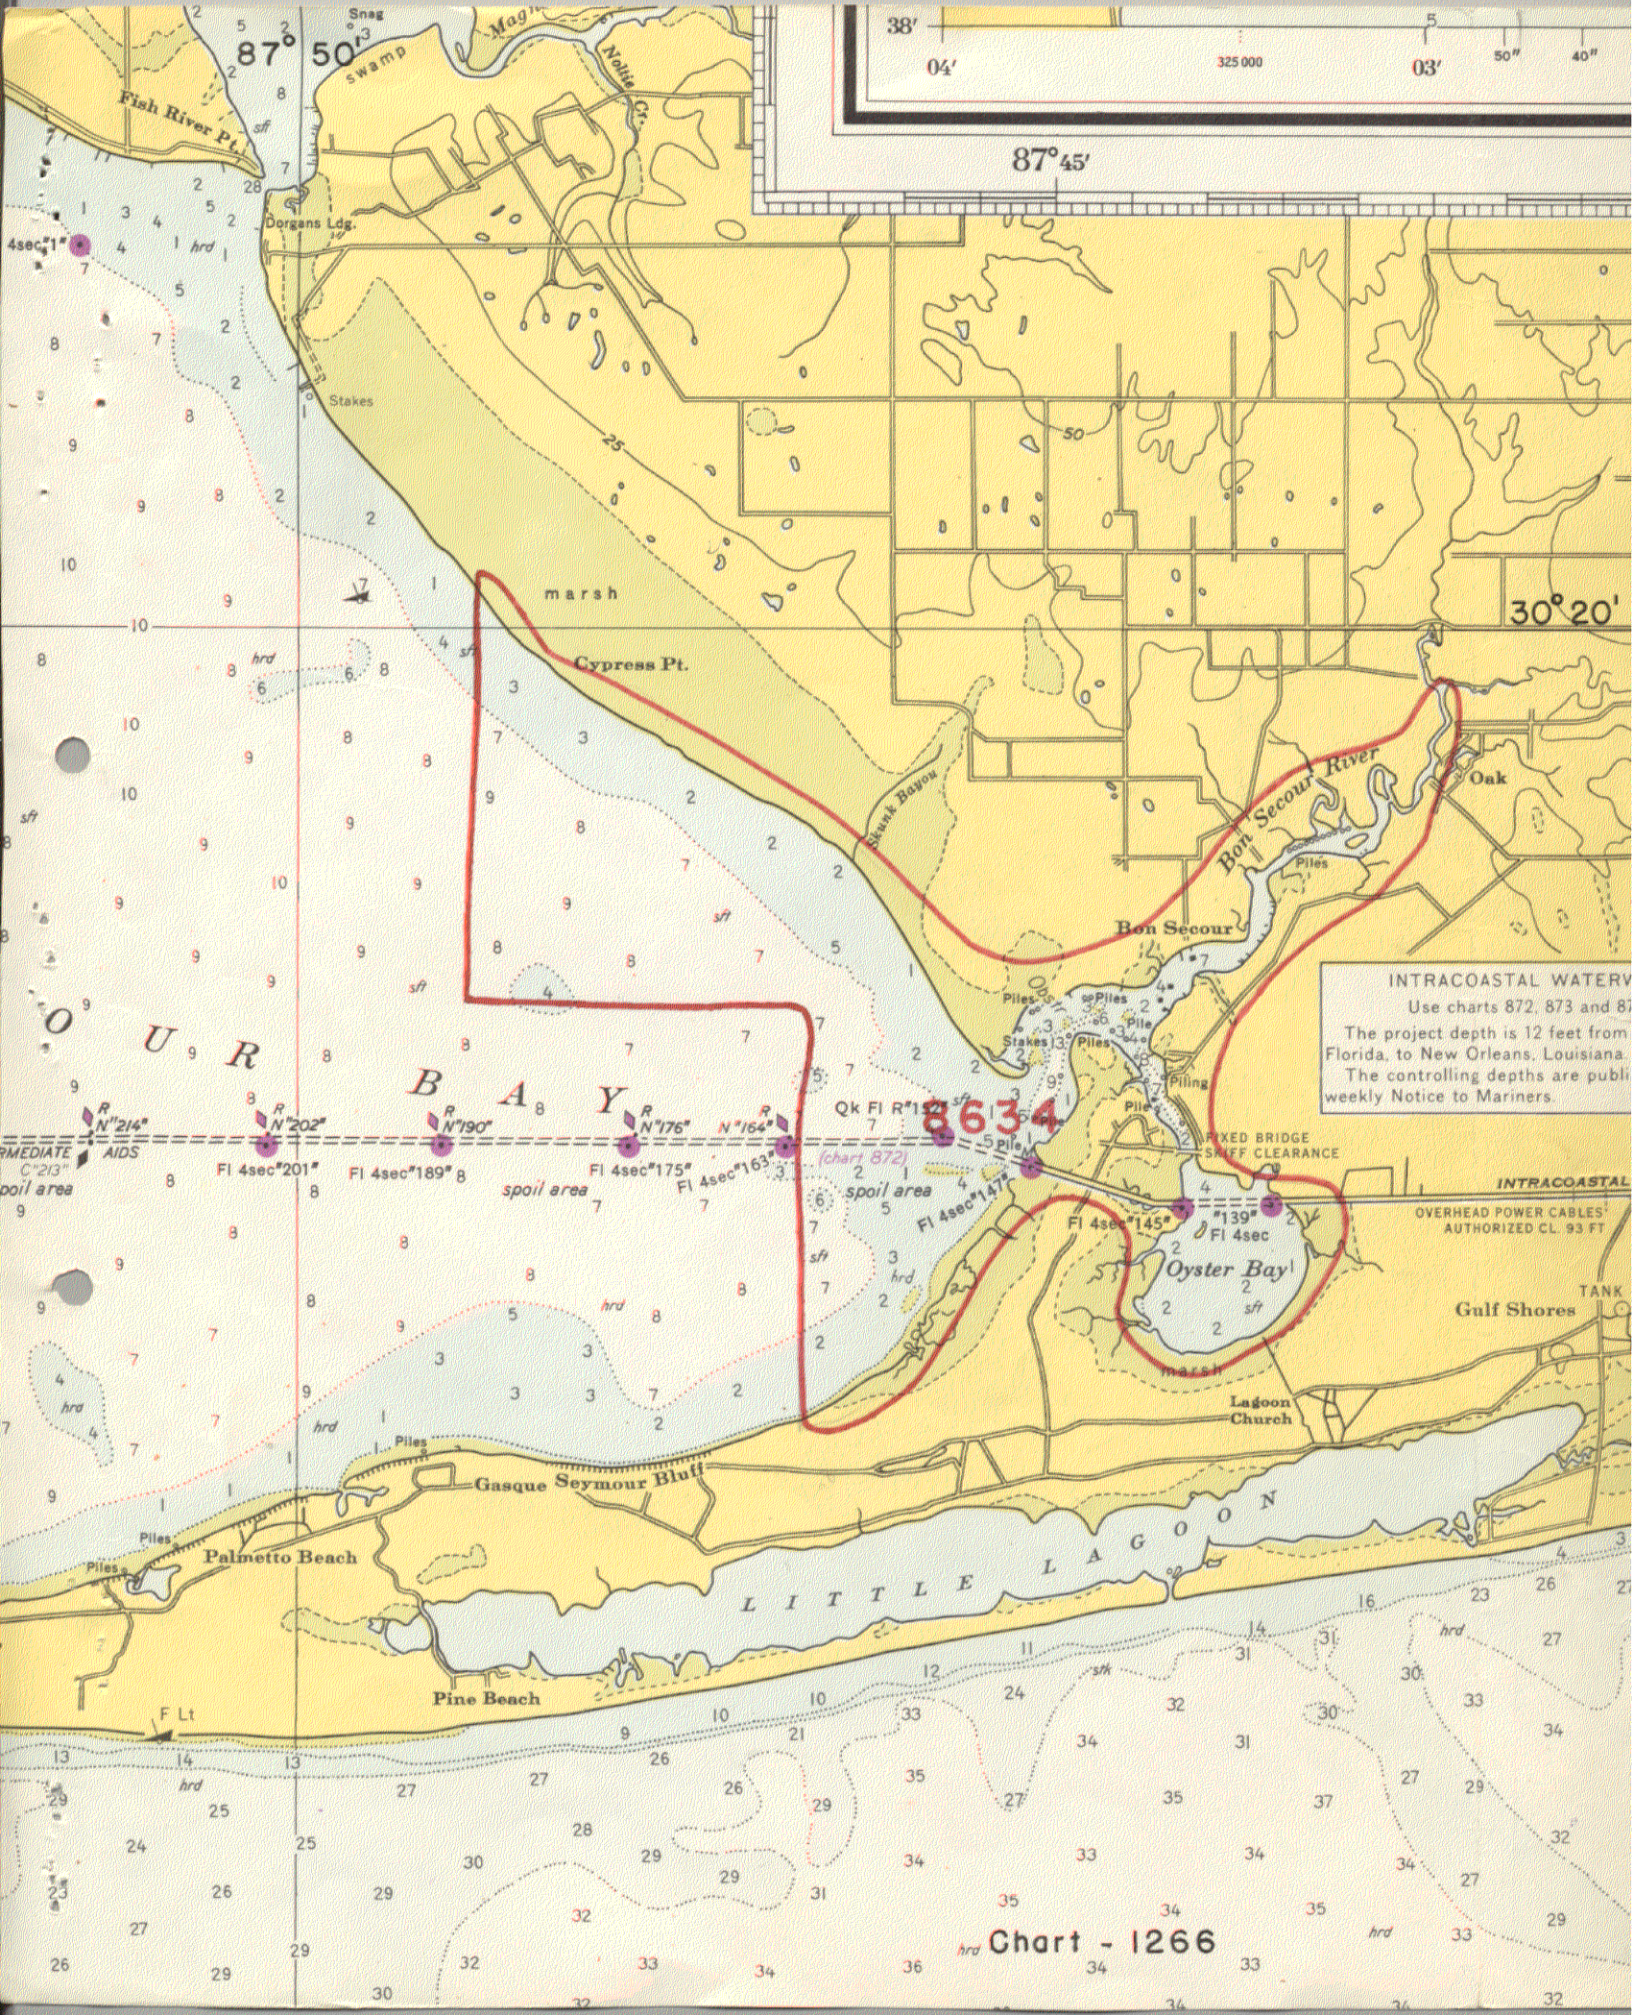
**INTRACOASTAL WATERWAY**  
 Use charts 872, 873 and 874  
 The project depth is 12 feet from  
 Florida, to New Orleans, Louisiana.  
 The controlling depths are published  
 weekly Notice to Mariners.

**INTRACOASTAL**  
 OVERHEAD POWER CABLES  
 AUTHORIZED CL. 93 FT.
