8707 WIRE DRAG

Form 504 U. S. DEPARTMENT OF COMMERCE COAST AND GEODETIC SURVEY DESCRIPTIVE REPORT	
Type of Survey <u>WIRE DRAG</u>	
Field No. <u>BO-10-1-62 WD</u> Office No. <u>H-8707 W.D.</u>	
LOCALITY	
State	<u>WASHINGTON</u>
General locality	<u>PUGET SOUND</u>
Locality	<u>PORT TOWNSEND</u>
<u>19 62</u>	
CHIEF OF PARTY <u>F. X. POPPER</u>	
LIBRARY & ARCHIVES	
DATE	<u>DEC 26 1962</u>

General locality PUGET SOUND

Locality PORT TOWNSEND

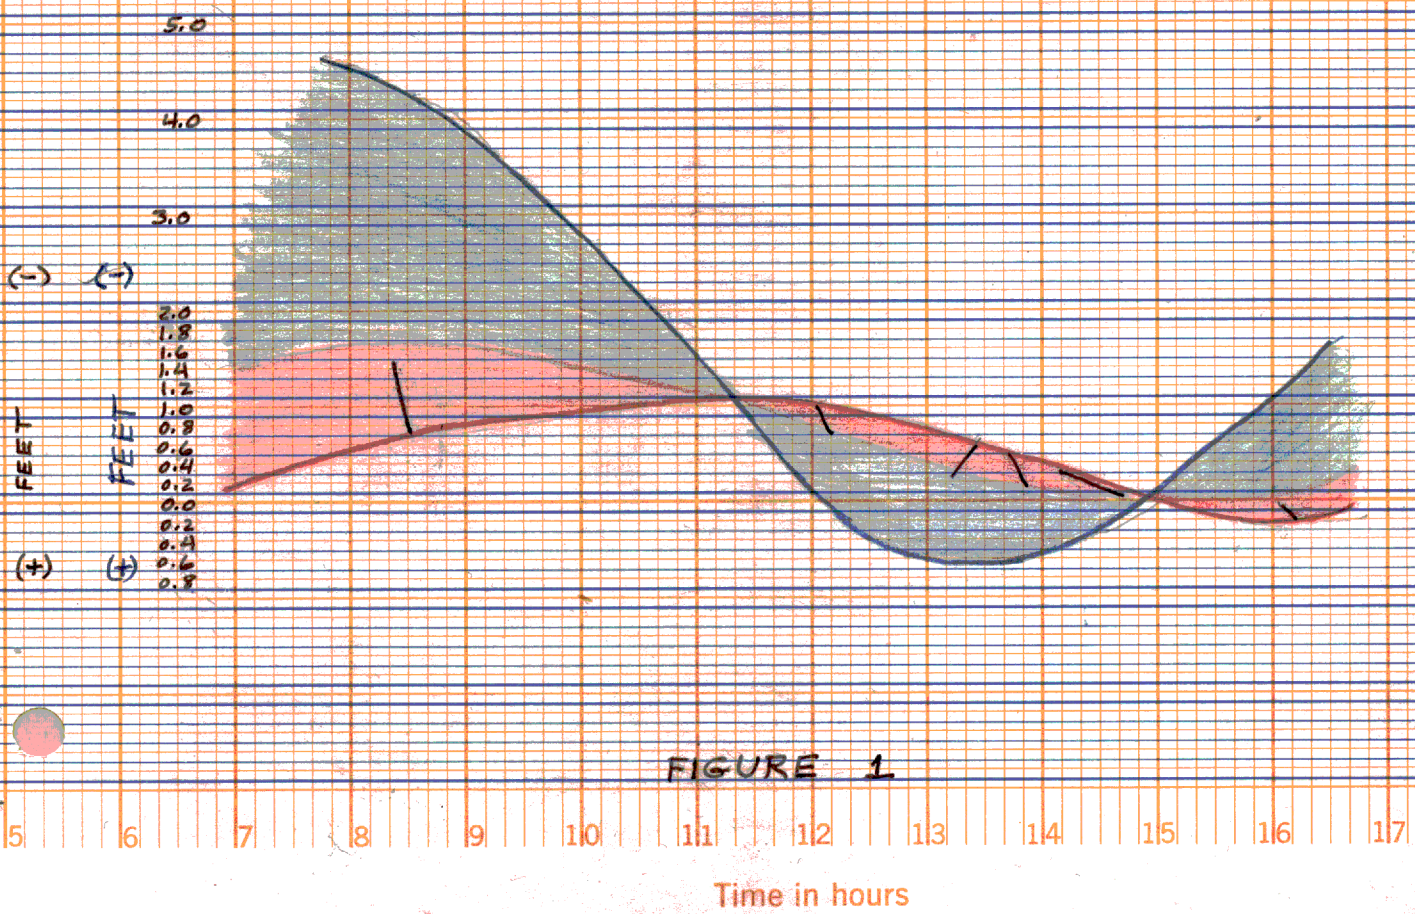
FIGURE 1

DISTRIBUTION OF TIDE CORRECTIONS INDIAN RIVER INLET, DELAWARE

- ZONE 1, OFFSHORE
- ZONE 2
- ZONE 3
- ZONE 4
- ACTUAL PATH OF LAUNCH IN ZONES, VERSUS TIME
