Form 504	
U. S. DEPARTMENT OF COMMERCE COAST AND GEODETIC SURVEY	
DESCRIPTIVE REPORT	
<i>Type of Survey</i> HYDROGRAPHIC	
<i>Field No.</i> PE-40-2-64	<i>Office No.</i> H-8797
LOCALITY	
<i>State</i> SOUTH CAROLINA	
<i>General locality</i> COAST OF SOUTH CAROLINA	
<i>Locality</i> VICINITY OF	
WINYAH BAY ENTRANCE	
1964	
CHIEF OF PARTY	
LCDR. RONALD M. BUFFINGTON	
LIBRARY & ARCHIVES	
DATE AUG 5 - 1965

HYDROGRAPHIC TITLE SHEET

Locality Vicinity of Winyah Bay Entrance

REMARKS: The survey was done as a smooth-boat sheet with Decca Range-Range HiFix as a control medium.

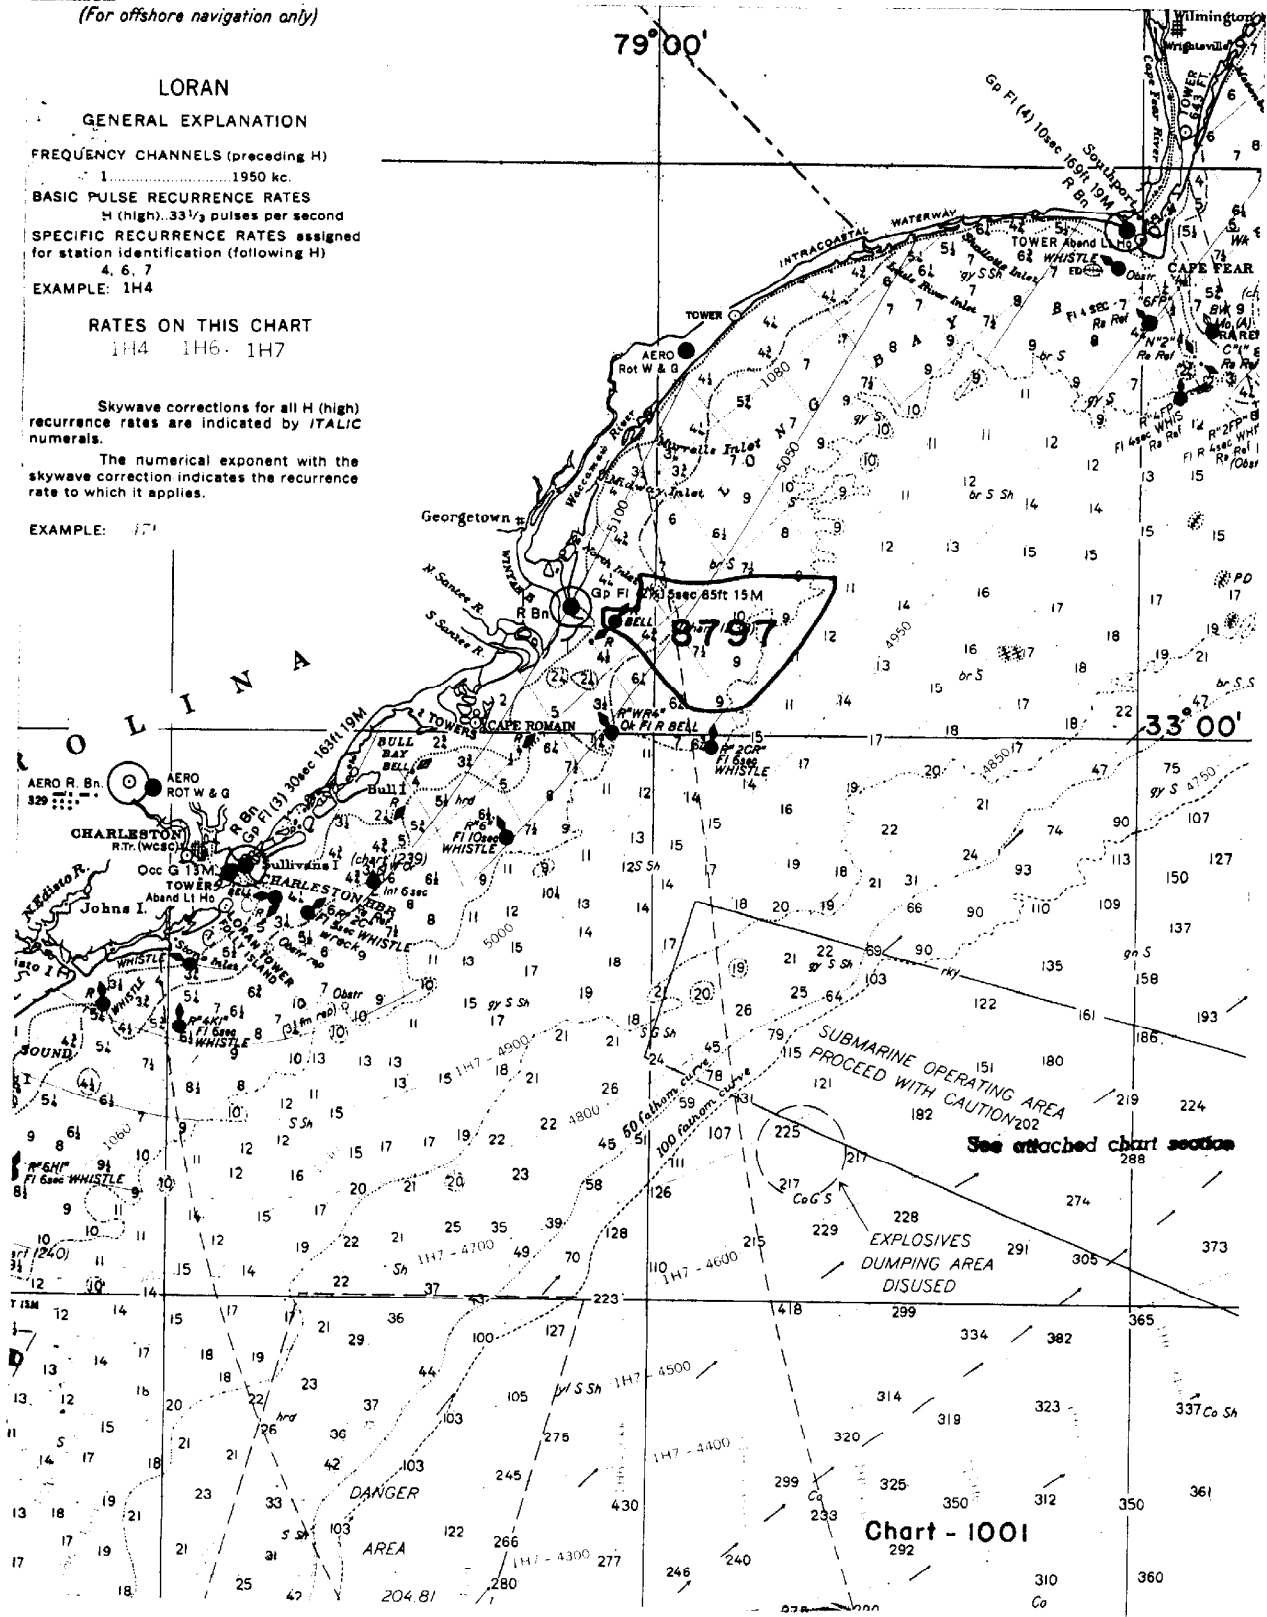
The numerical exponent with the skywave correction indicates the recurrence rate to which it applies.

EXAMPLE: 17¹
