| DESCRIPTIVE REPORT | |
| Type of Survey | Hydrographic |
| Office No. | H-8900 |
| Locality | Port Valdez |

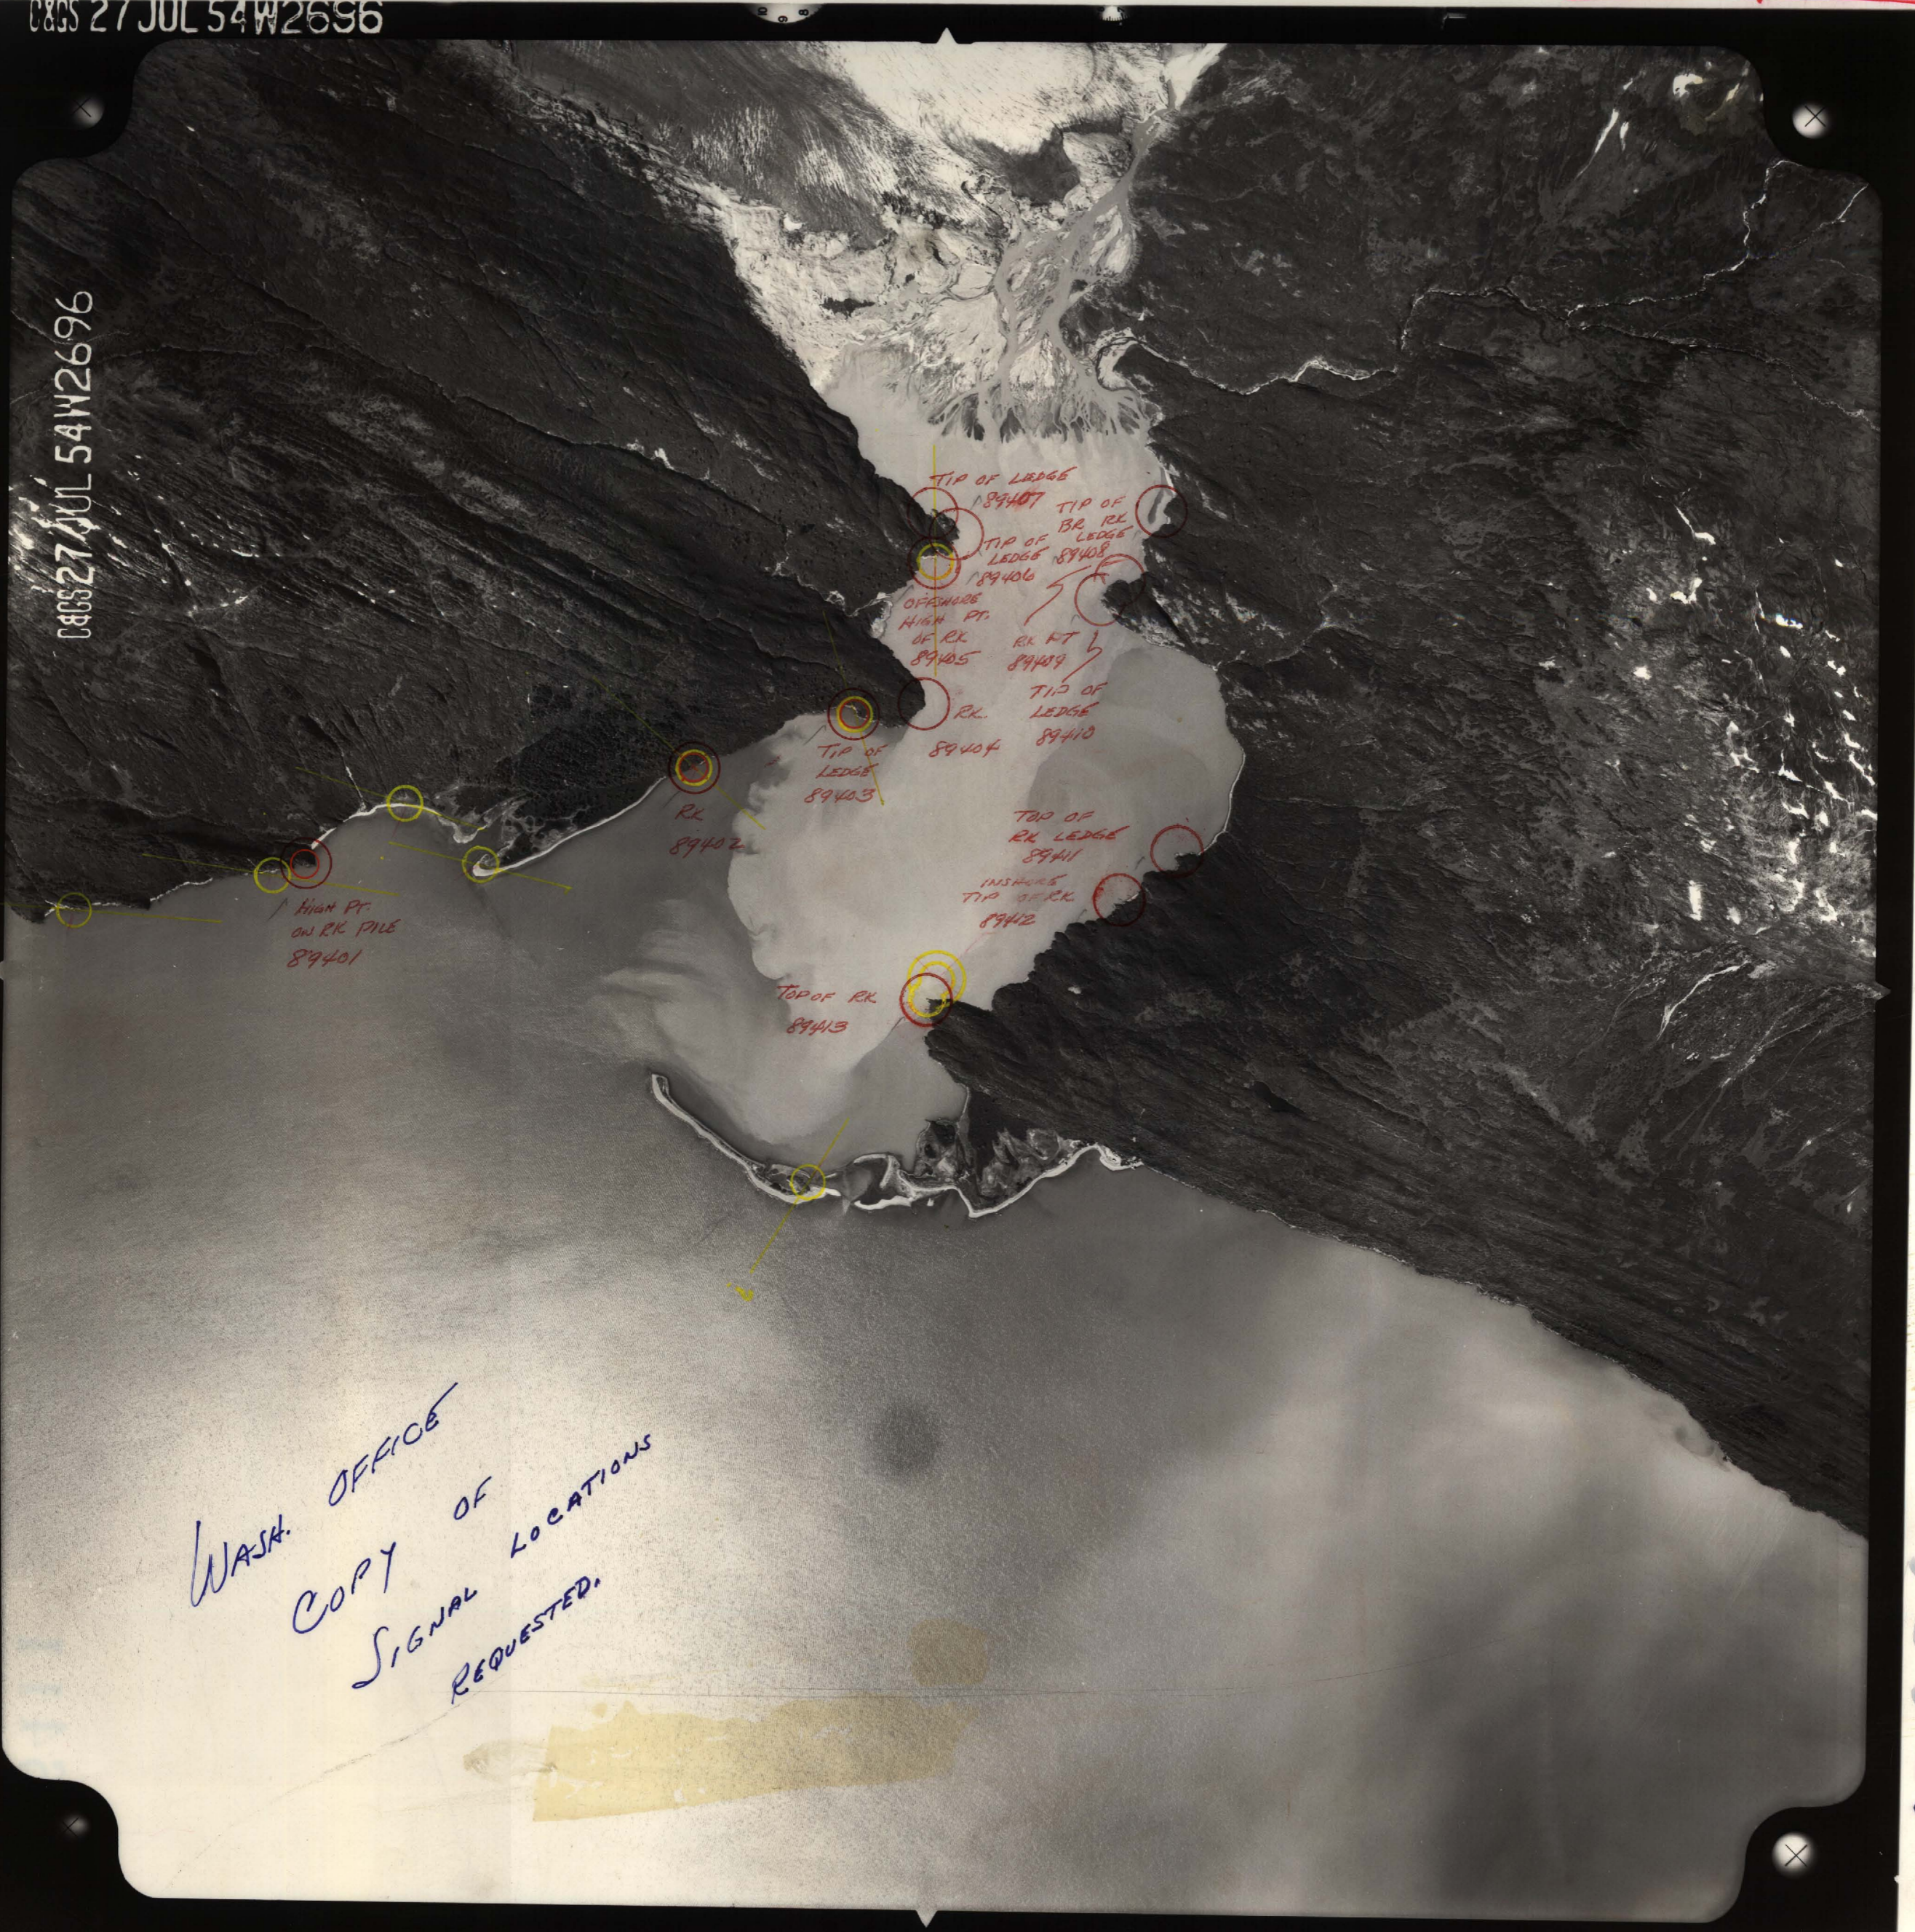
54W2696 H-8900 0068-H 1:20,000

WASH. OFFICE
COPY OF
SIGNAL LOCATIONS
REQUESTED.
