**DESCRIPTIVE REPORT**  
(HYDROGRAPHIC)

Type of Survey ..... HYDROGRAPHIC .....  
Field No. .... DA-20-1-74 .....  
Office No. .... H-9422 .....

State ..... ALASKA .....  
General Locality ..... PRINCE WILLIAM SOUND .....  
Locality ..... UPPER PORTION OF VALDEZ .....

HYDROGRAPHIC TITLE SHEET

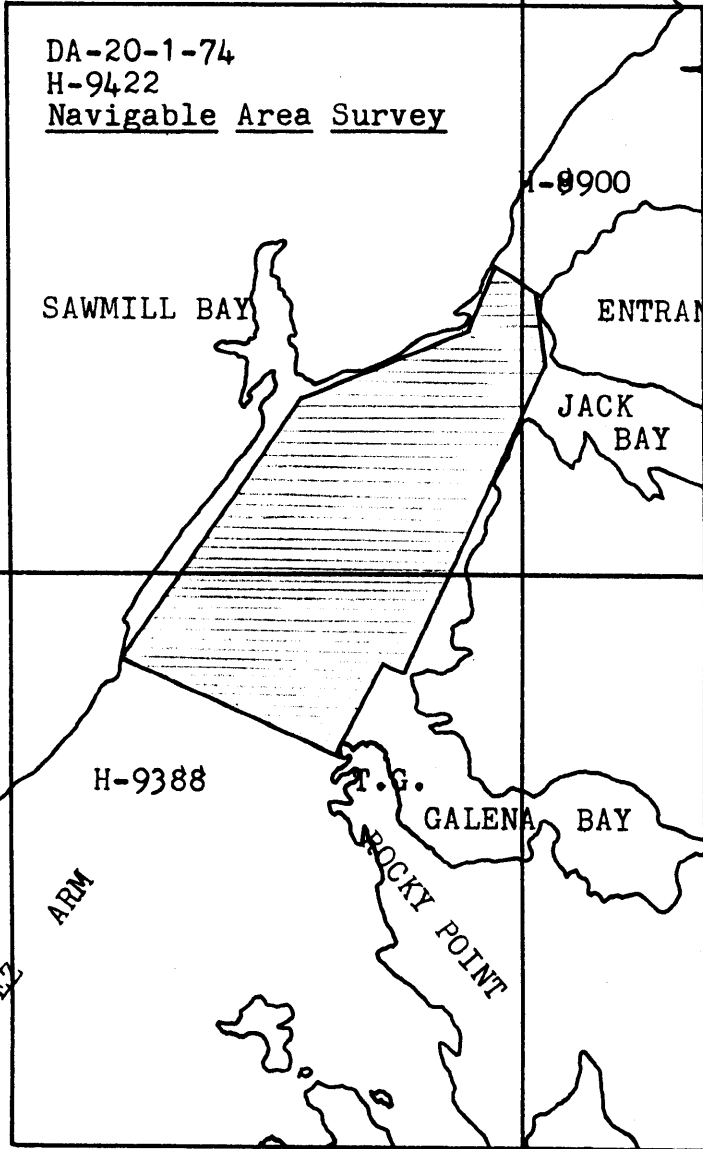
Valdez Arm, Alaska

NOAA SHIP DAVIDSON

PORT VALDEZ
