DESCRIPTIVE REPORT
(HYDROGRAPHIC)

Type of Survey ... HYDROGRAPHIC
Field No. ... RA-20-1-74
Office No. ... H-9443

State ... ALASKA
General Locality ... COOK INLET
Locality ... UPPER PORTION OF KNIK ARM

DESCRIPTIVE REPORT
TO ACCOMPANY HYDROGRAPHIC SURVEY

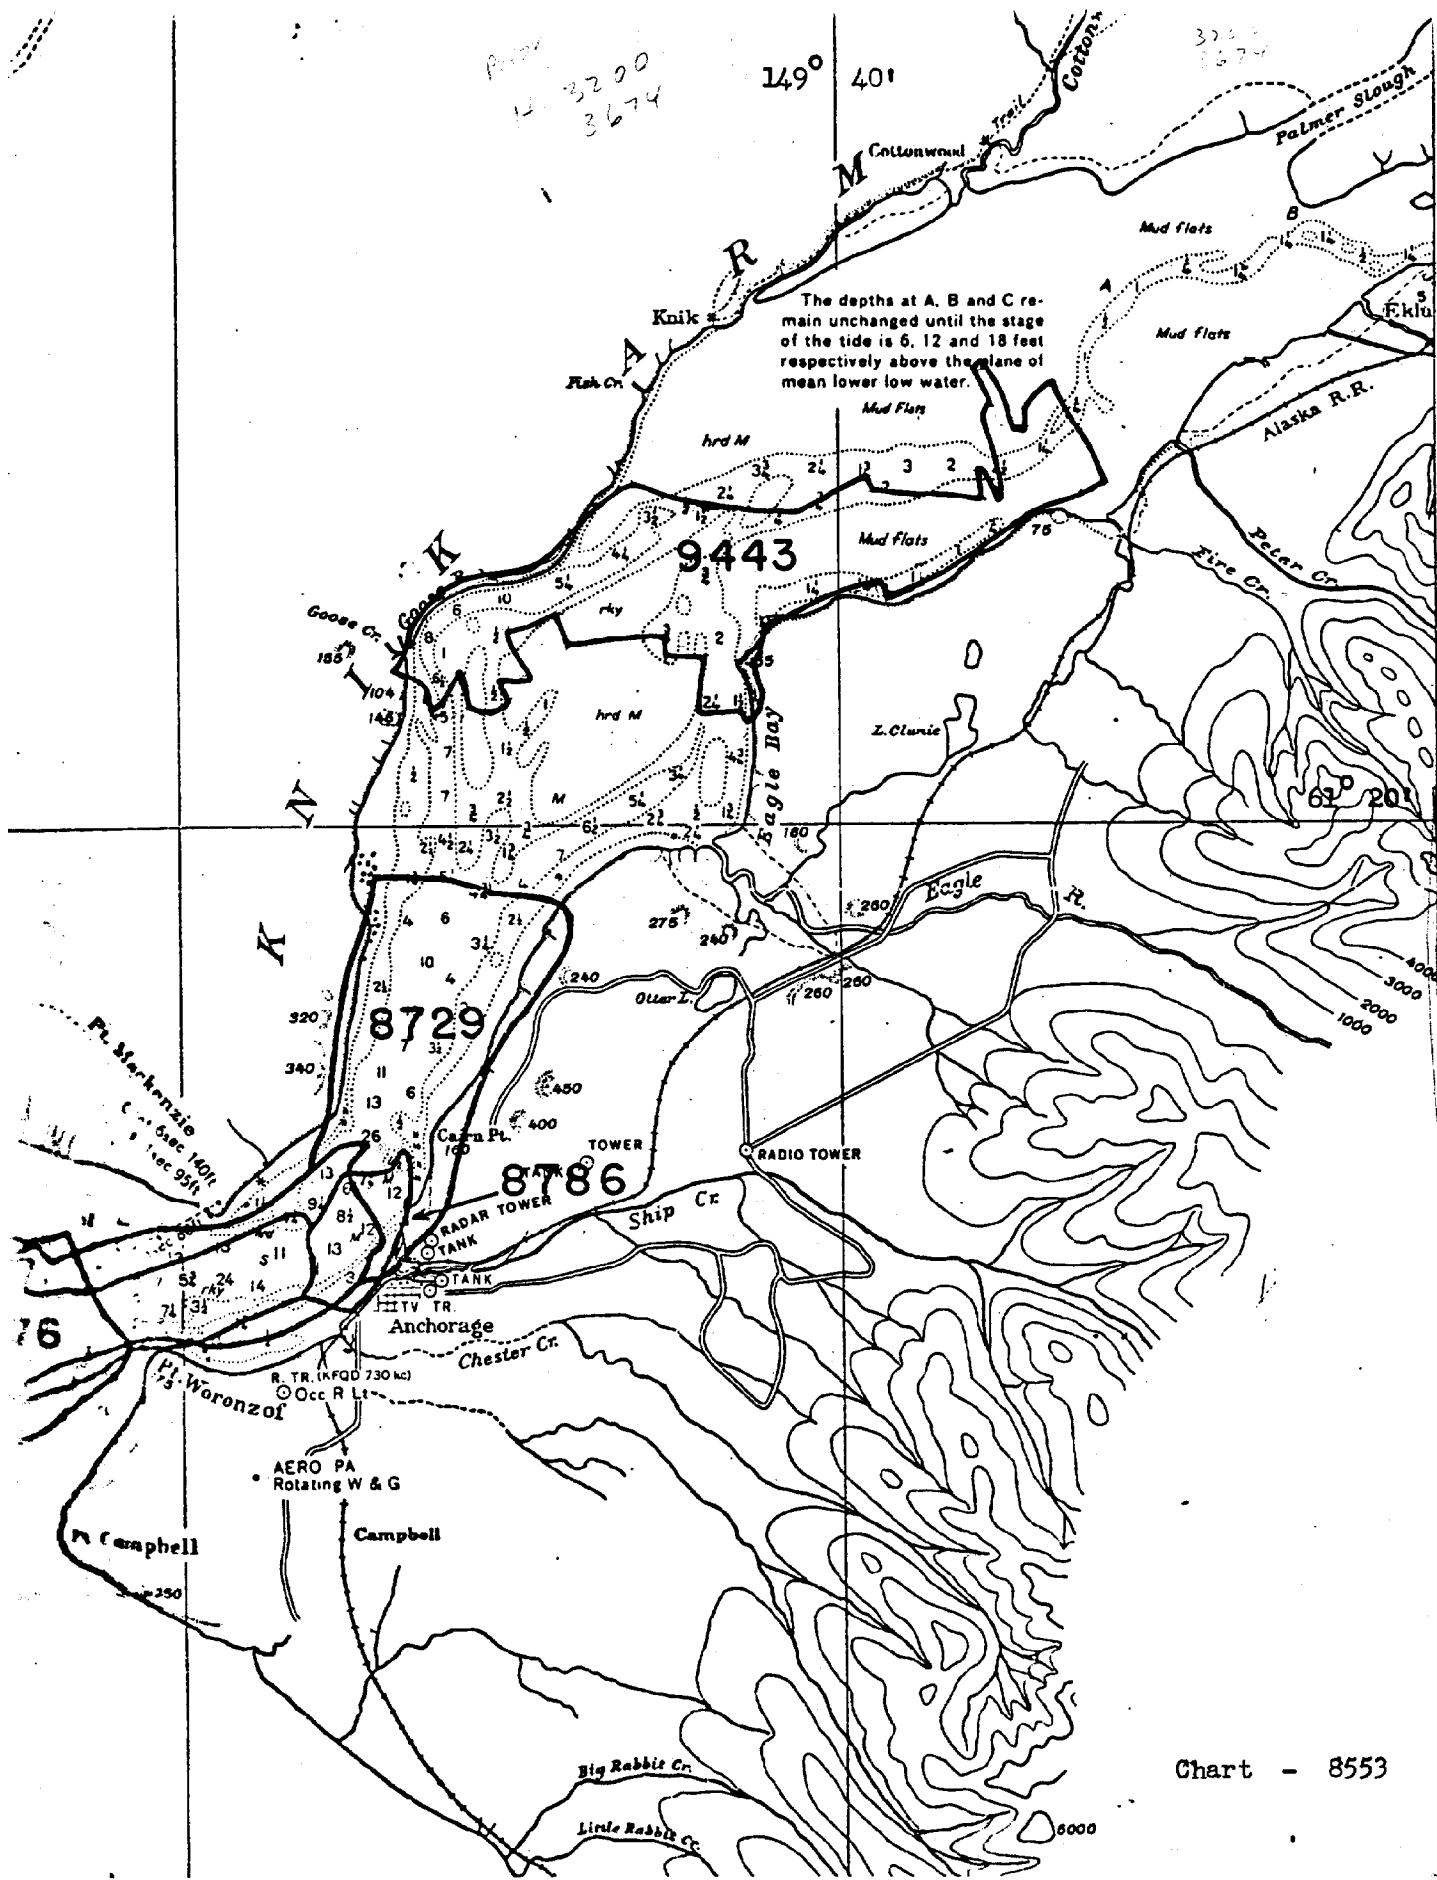
Chart - 8553

Prior
H 3290
3674

6. The verifier's report did not include a discussion of the comparison between the present survey and chart 8553, which alone covers the northeastern part of the survey area. This comparison is necessary to supersede the charted information. Comparison with chart 8553, 15th edition dated December 29, 1973, was accomplished during quality control inspection. The charted hydrography was determined to originate with the prior surveys discussed in the verifier's report, and is thereby superseded.

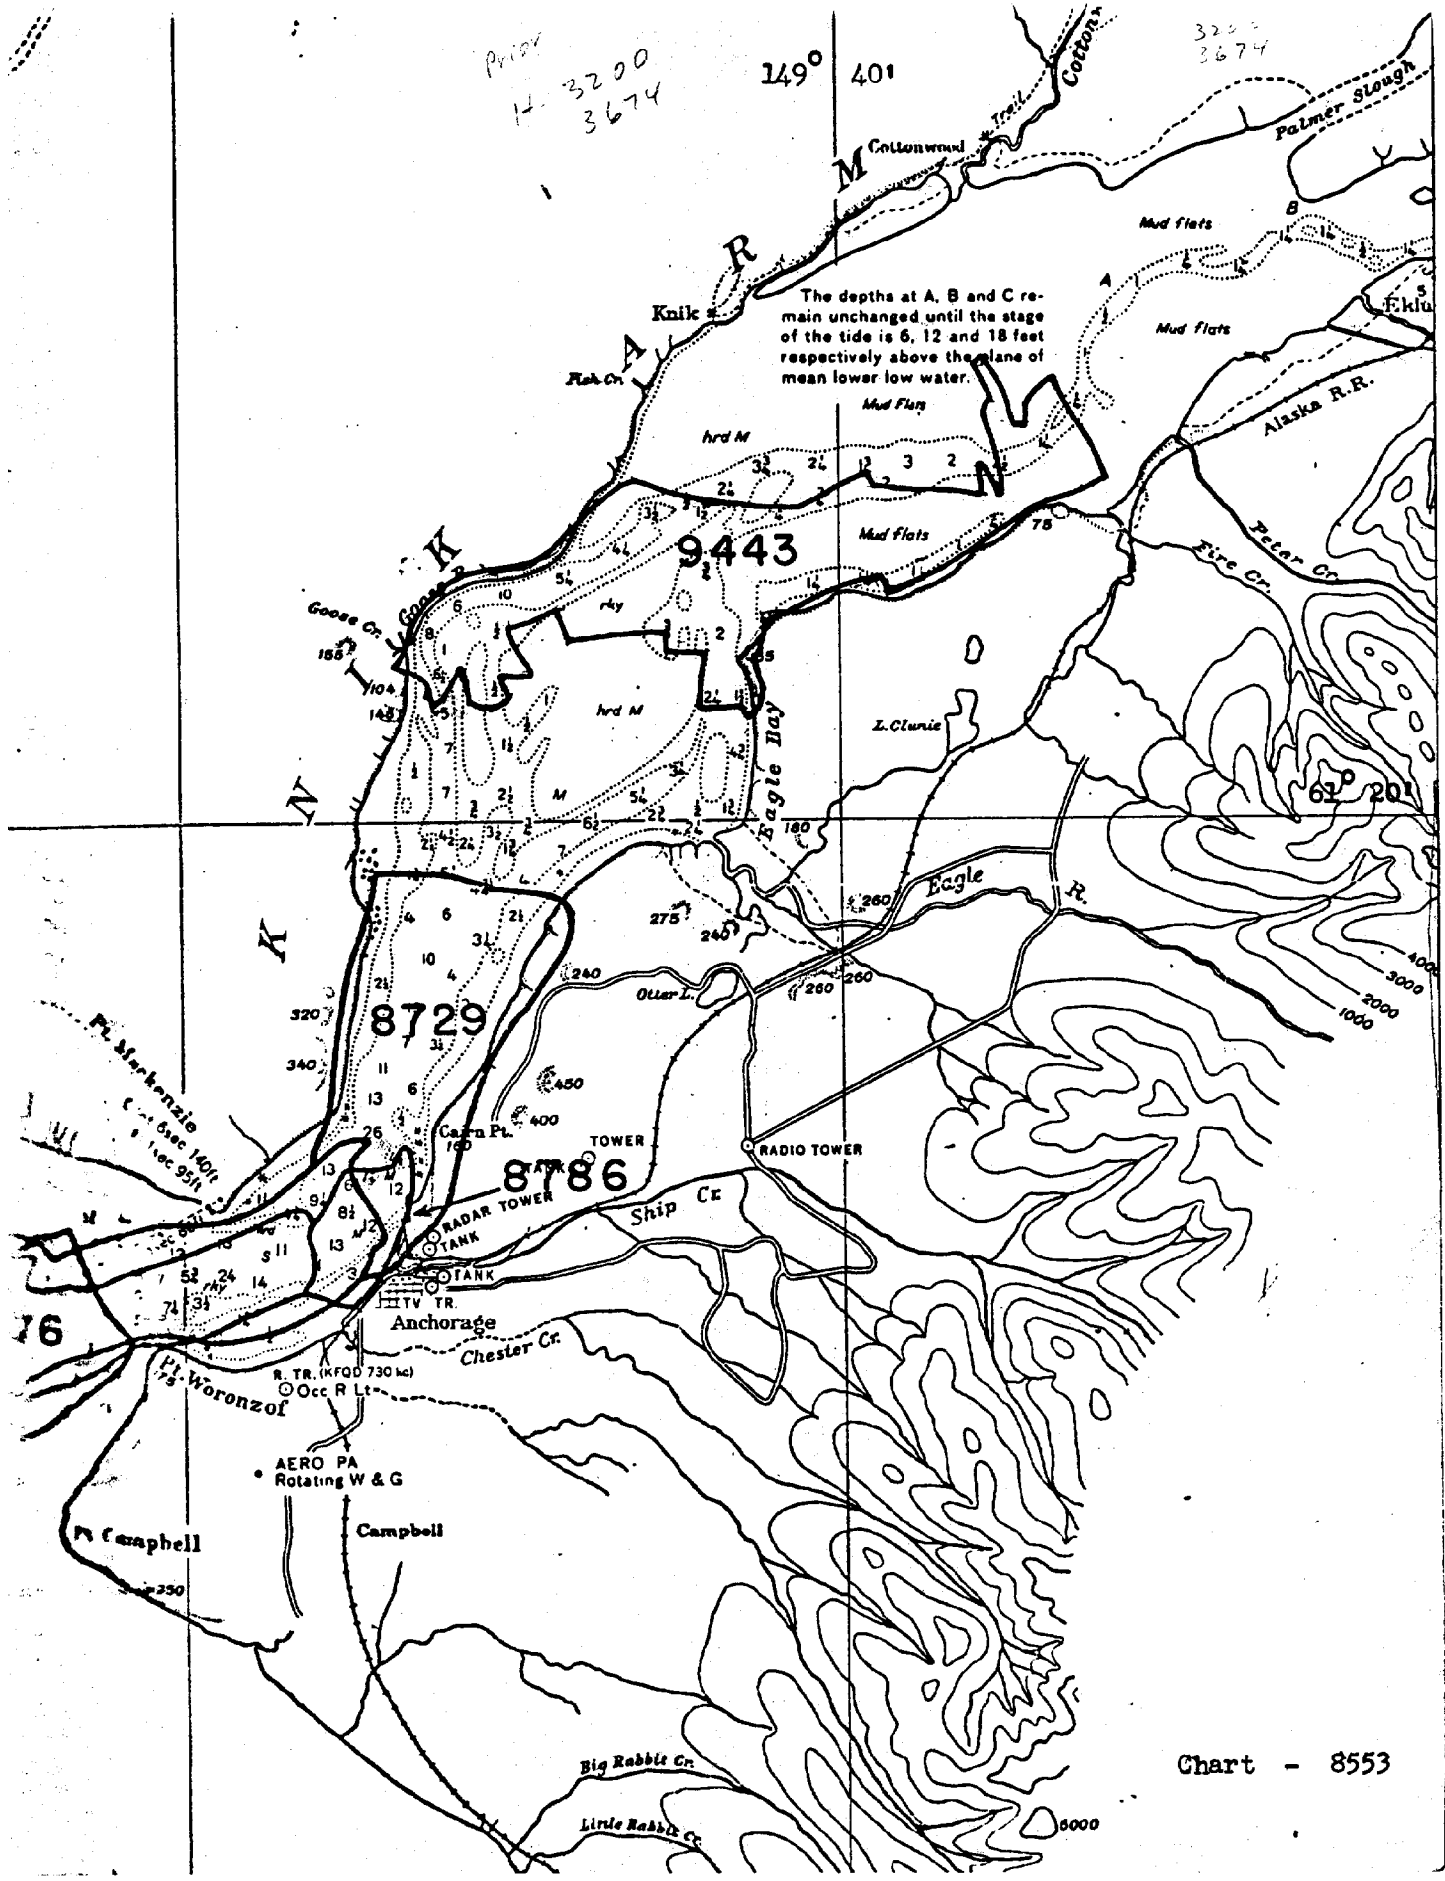
The depths at A, B and C remain unchanged until the stage of the tide is 6, 12 and 18 feet respectively above the plane of mean lower low water.
