DESCRIPTIVE REPORT (HYDROGRAPHIC)

Type of Survey HYDROGRAPHIC
Field No. AHP 10-7-74
Office No..... H-9489

State NORTH CAROLINA
General Locality CAPE FEAR RIVER
Locality FORT CASWELL TO ZEKES ISLAND

CHIEF OF PARTY
F. T. SMITH

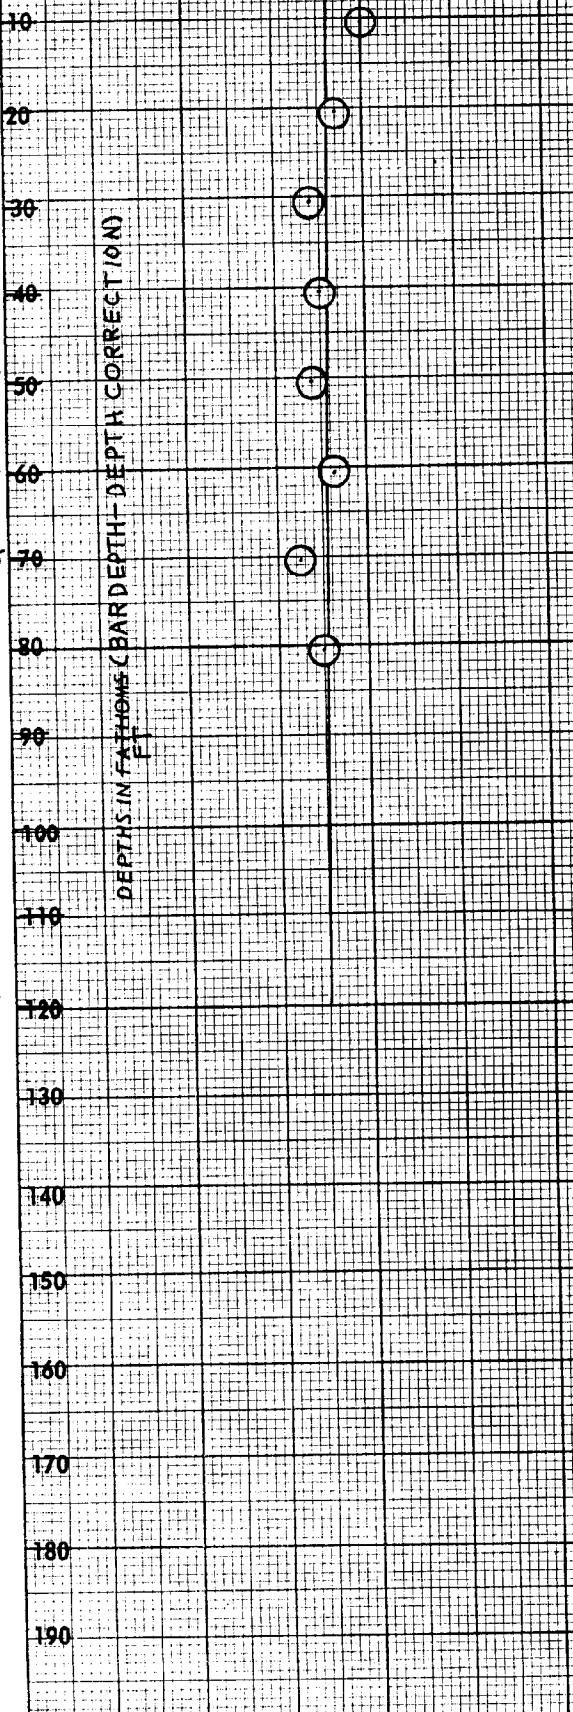
CORRECTIONS IN FEET, FATHOMS TABLE 2

5
10
15
20
25
30
35
40
45
50
55
60
