DESCRIPTIVE REPORT (HYDROGRAPHIC)

Type of Survey Hydrographic
Field No. AHP-10-5-75
Office No. H-9562

State Maryland
General Locality .. Lower Patapsco River
Locality Stony Creek to Bodkin Neck

Scale 1:10,000 Date of survey 11 Sept. 1975 - 12 Dec. 1975
18 Oct. 1976 - 9 Nov. 1976

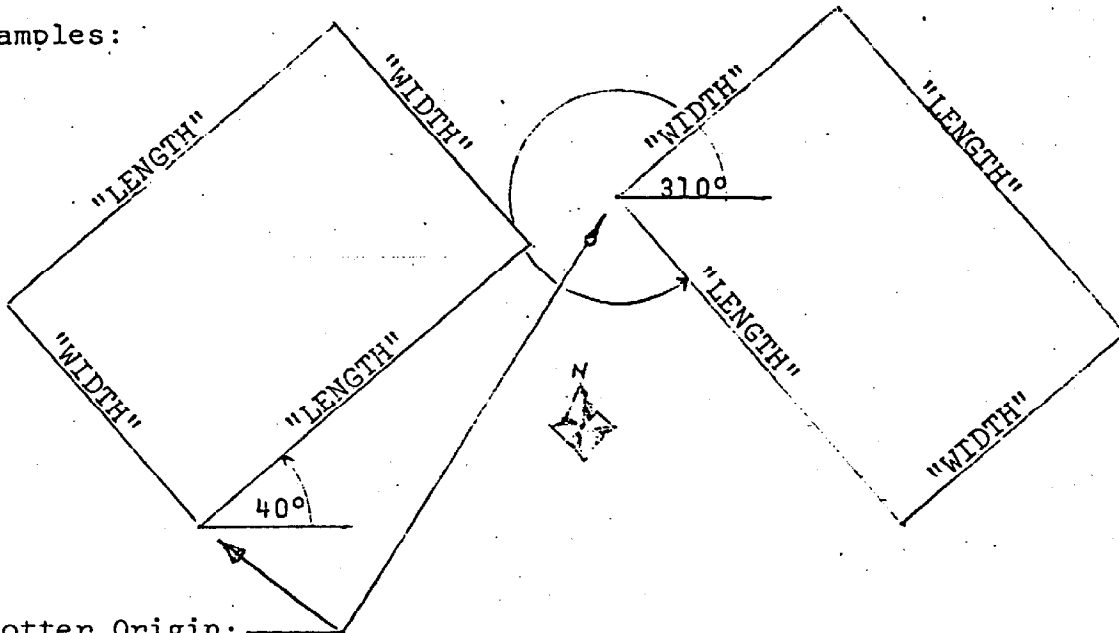
11. Examples:

1. Project No. OPR-514 4. Requested By J. S. Bradford
2. Reg. No. H-9562 5. Ship or Office Verification
3. Field No. AHP-10-5-75 6. Date Required ASAP
7. Polyconic Modified Transverse Mercator
8. Central Meridian of Projection 76 ° 28 ' 30 "
9. Survey Scale: 1: 10,000
10. Size of Sheet (check one - "width" x "length"):
36 x 54 36 x 60 Other Specify 152.4 x 104.6

12. Plotter Origin: _____
Latitude 39 ° 05 ' 53.0 "
Longitude 76 ° 24 ' 55.0 "
13. Skew Angle (measured counterclockwise at origin): 90 °
14. G.P.'s of Triangulation and/or Signals attached
15. G.P.'s and Frequencies for Electronic Control Arcs attached
16. Material Desired: Tracing Paper Mylar
Other Specify _____
17. Remarks: Smooth sheet
