DESCRIPTIVE REPORT
(HYDROGRAPHIC)

Type of Survey Hydrographic
Field No. AHP-10-1-76
Office No..... H-9606

State Florida
General Locality Banana and Indian Rivers
Locality Melbourne to Lotus

HYDROGRAPHIC TITLE SHEET

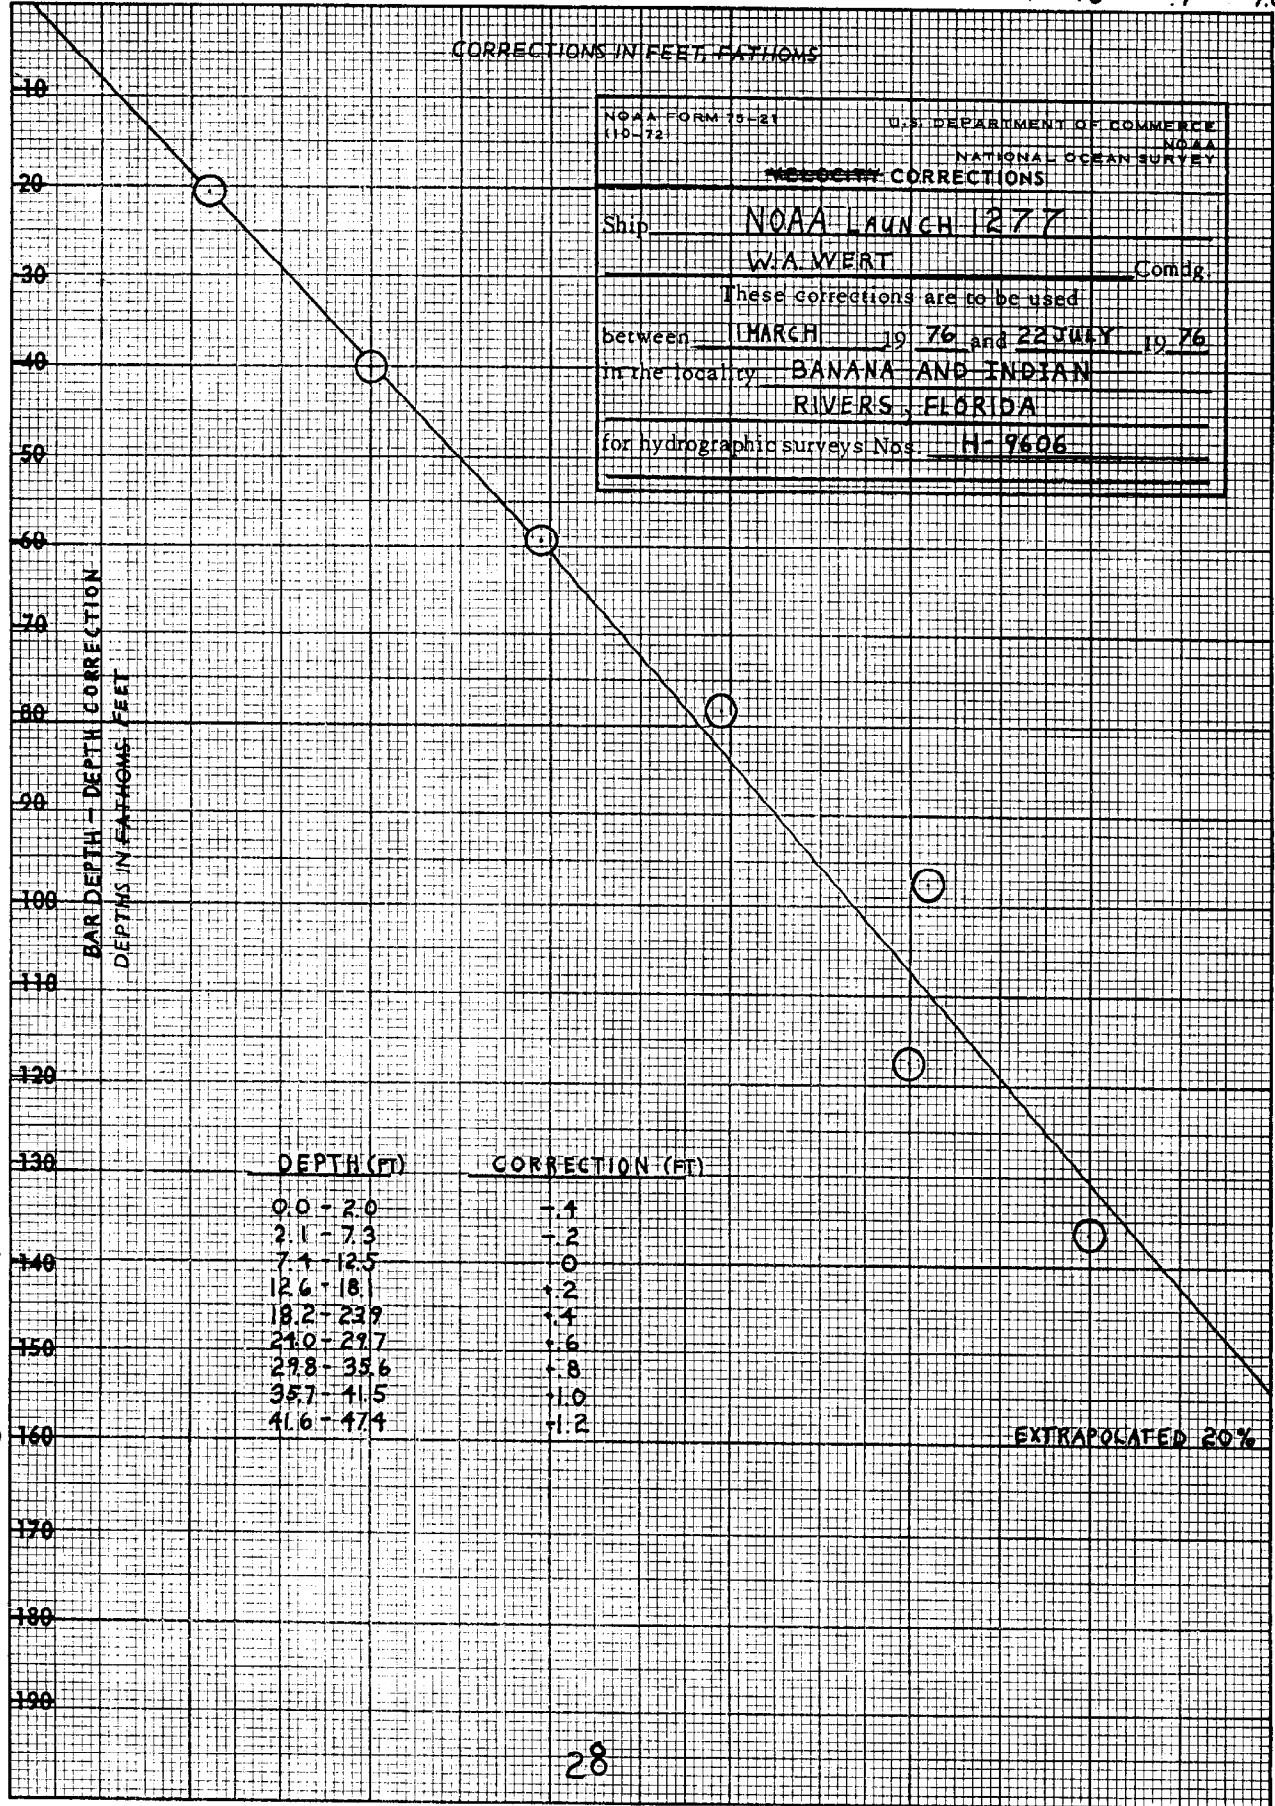
BAR DEPTH - DEPTH CORRECTION
 DEPTHS IN FATHOMS FEET

EXTRAPOLATED 20%

RPM	CORRECTION (FT)
0-1200	0.0
1201-1825	+0.2
1826-2475	+0.4
2476-2550	+0.6
