HYDROGRAPHIC TITLE SHEET

H-9624

Locality Southwest Approach to Hinchinbrook Entrance

PROGRESS SKETCH
OPR-999-DA-76
NAVIGABLE AREA SURVEY
 Hinchnbrook Entrance to Middleton Island,
 Gulf of Alaska

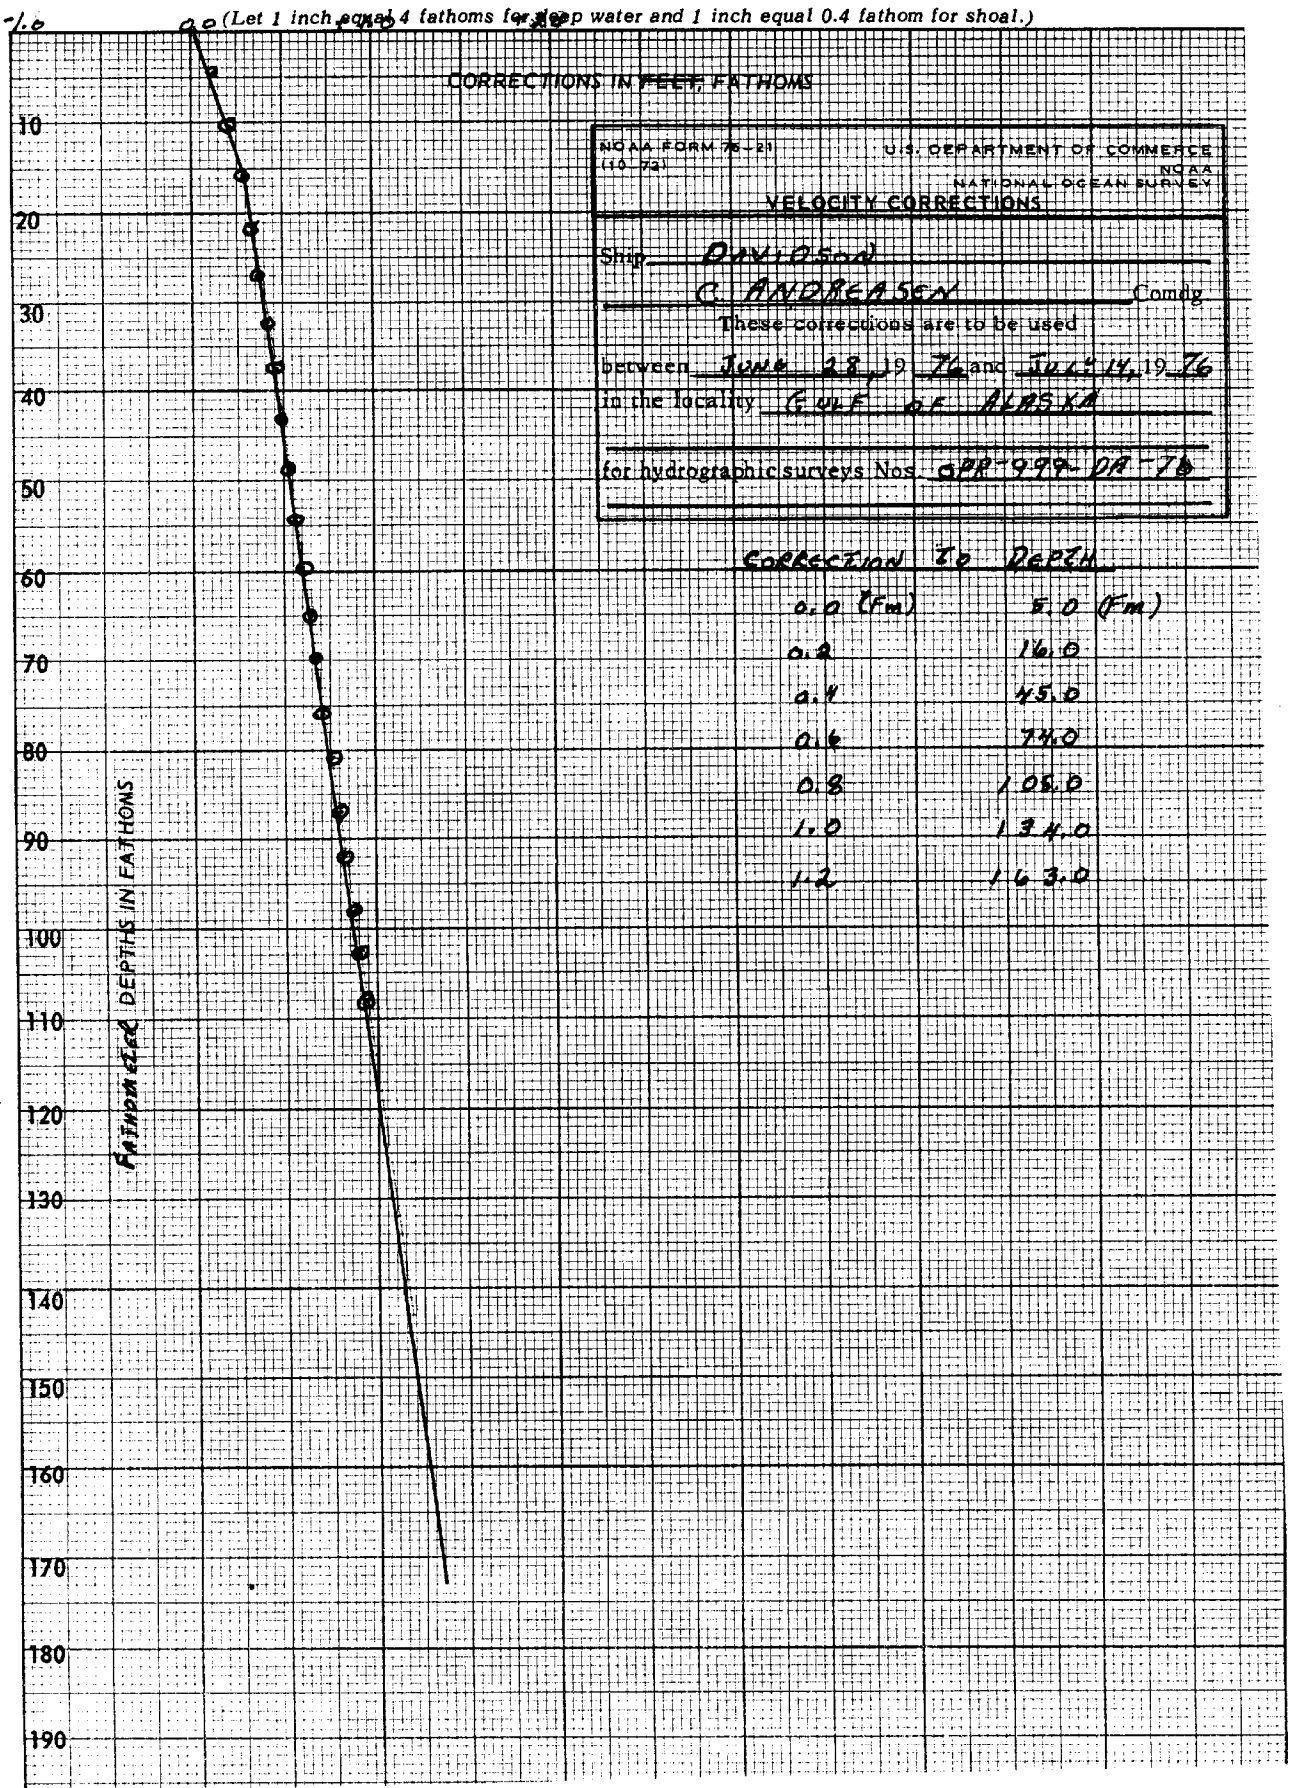
<u>Correction (fm)</u>
1.8

(For deep water add a 0 to these figures)

7.0 (Let 1 inch equal 4 fathoms for deep water and 1 inch equal 0.4 fathom for shoal.)

CORRECTIONS IN FEET, FATHOMS

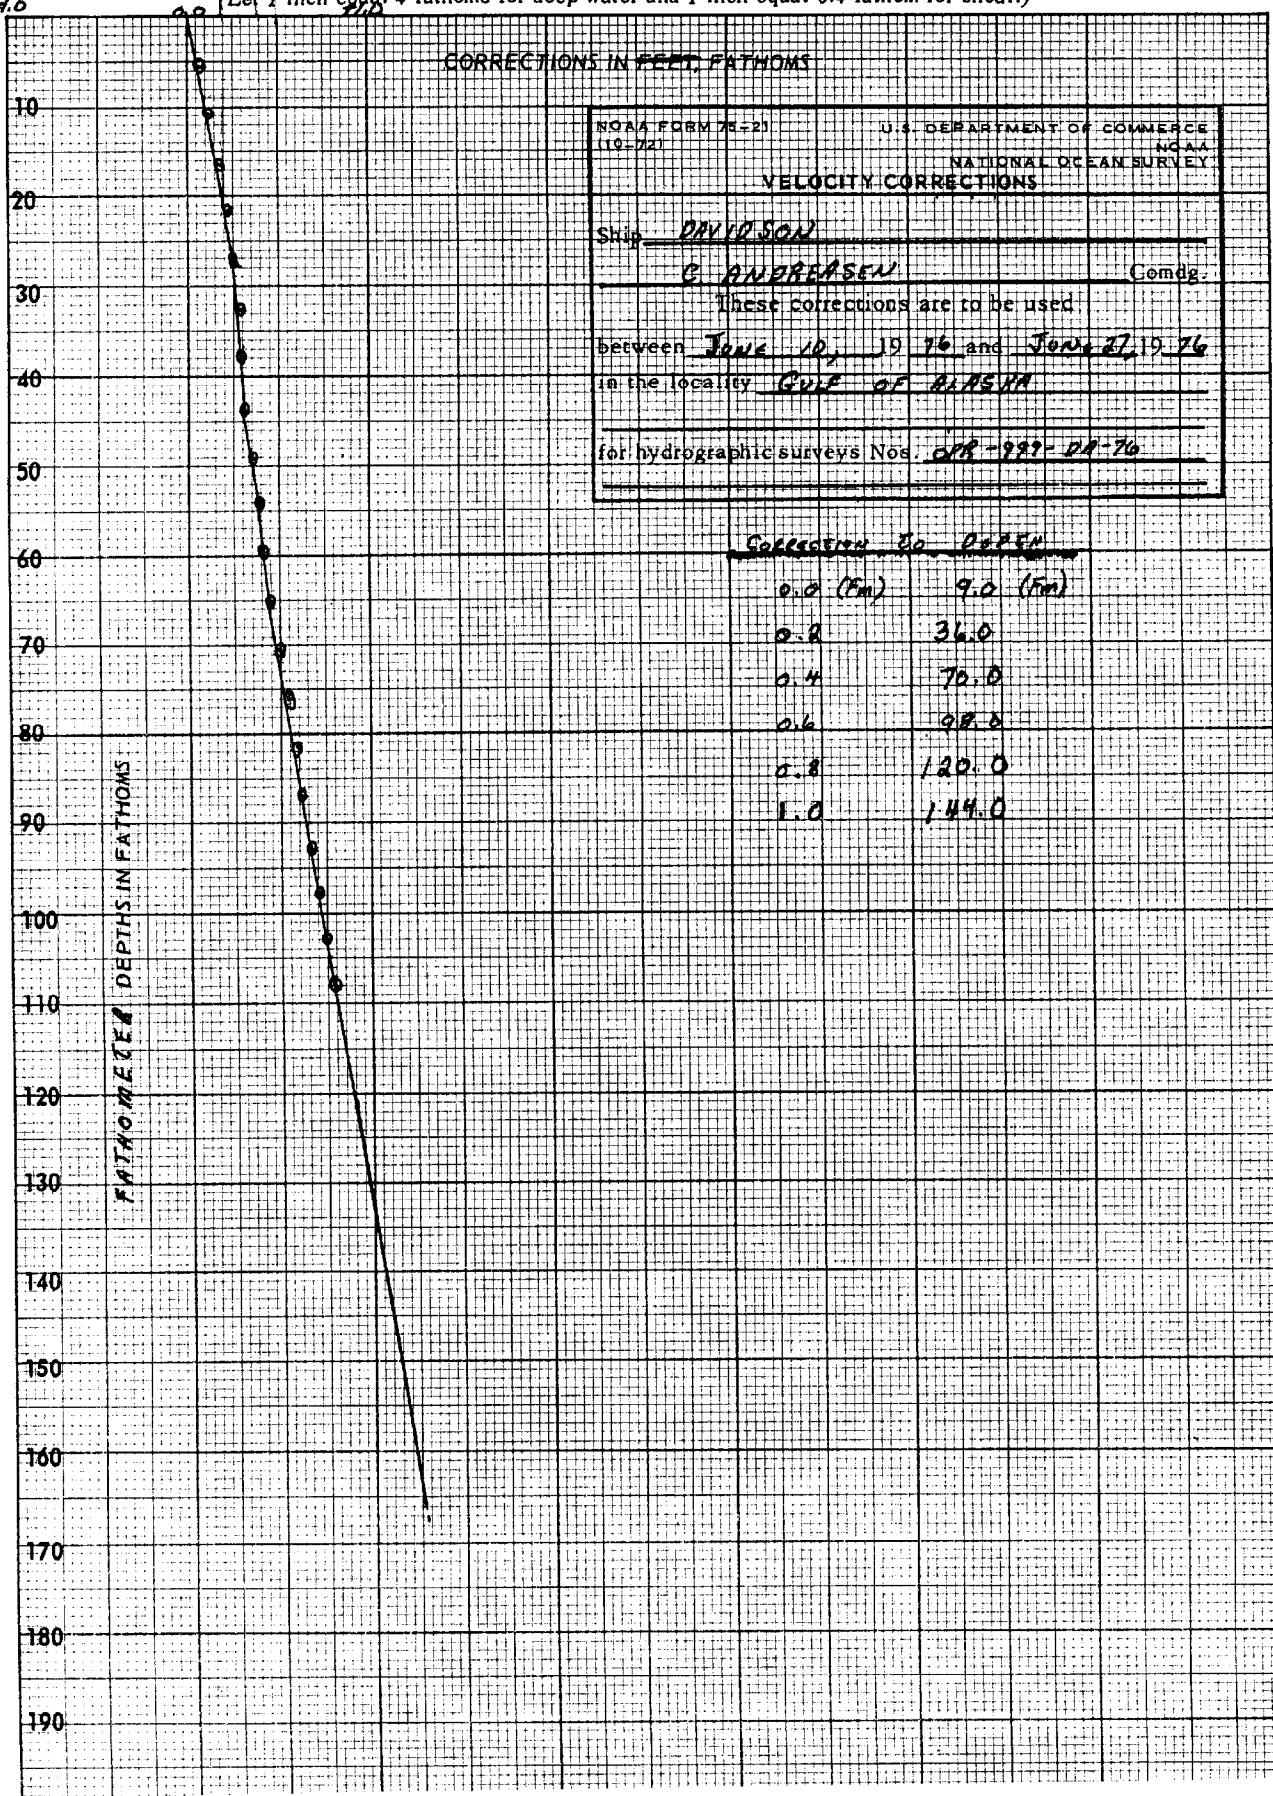
CORRECTION TO DEPTH	DEPTH
0.0 (Fm)	9.0 (Fm)
0.2	36.0
0.4	72.0
0.6	108.0
0.8	144.0
1.0	180.0

(For deep water add a 0 to these figures)
