NOAA FORM 76-35A	
U.S. DEPARTMENT OF COMMERCE NATIONAL OCEANIC AND ATMOSPHERIC ADMINISTRATION NATIONAL OCEAN SURVEY	
DESCRIPTIVE REPORT (HYDROGRAPHIC)	
Type of Survey	HYDROGRAPHIC
Field No.	HSB-5-1-77
Office No.	H-9676
LOCALITY	
State	SOUTH CAROLINA
General Locality	COOPER RIVER
Locality	GOOSE CREEK TO SNOW POINT
19 77	
CHIEF OF PARTY J.O. Rolland & W.R. Daniels	
LIBRARY & ARCHIVES	
DATE	June 20, 1978

HYDROGRAPHIC TITLE SHEET

General locality Cooper River

Locality Goose Creek to Snow Point

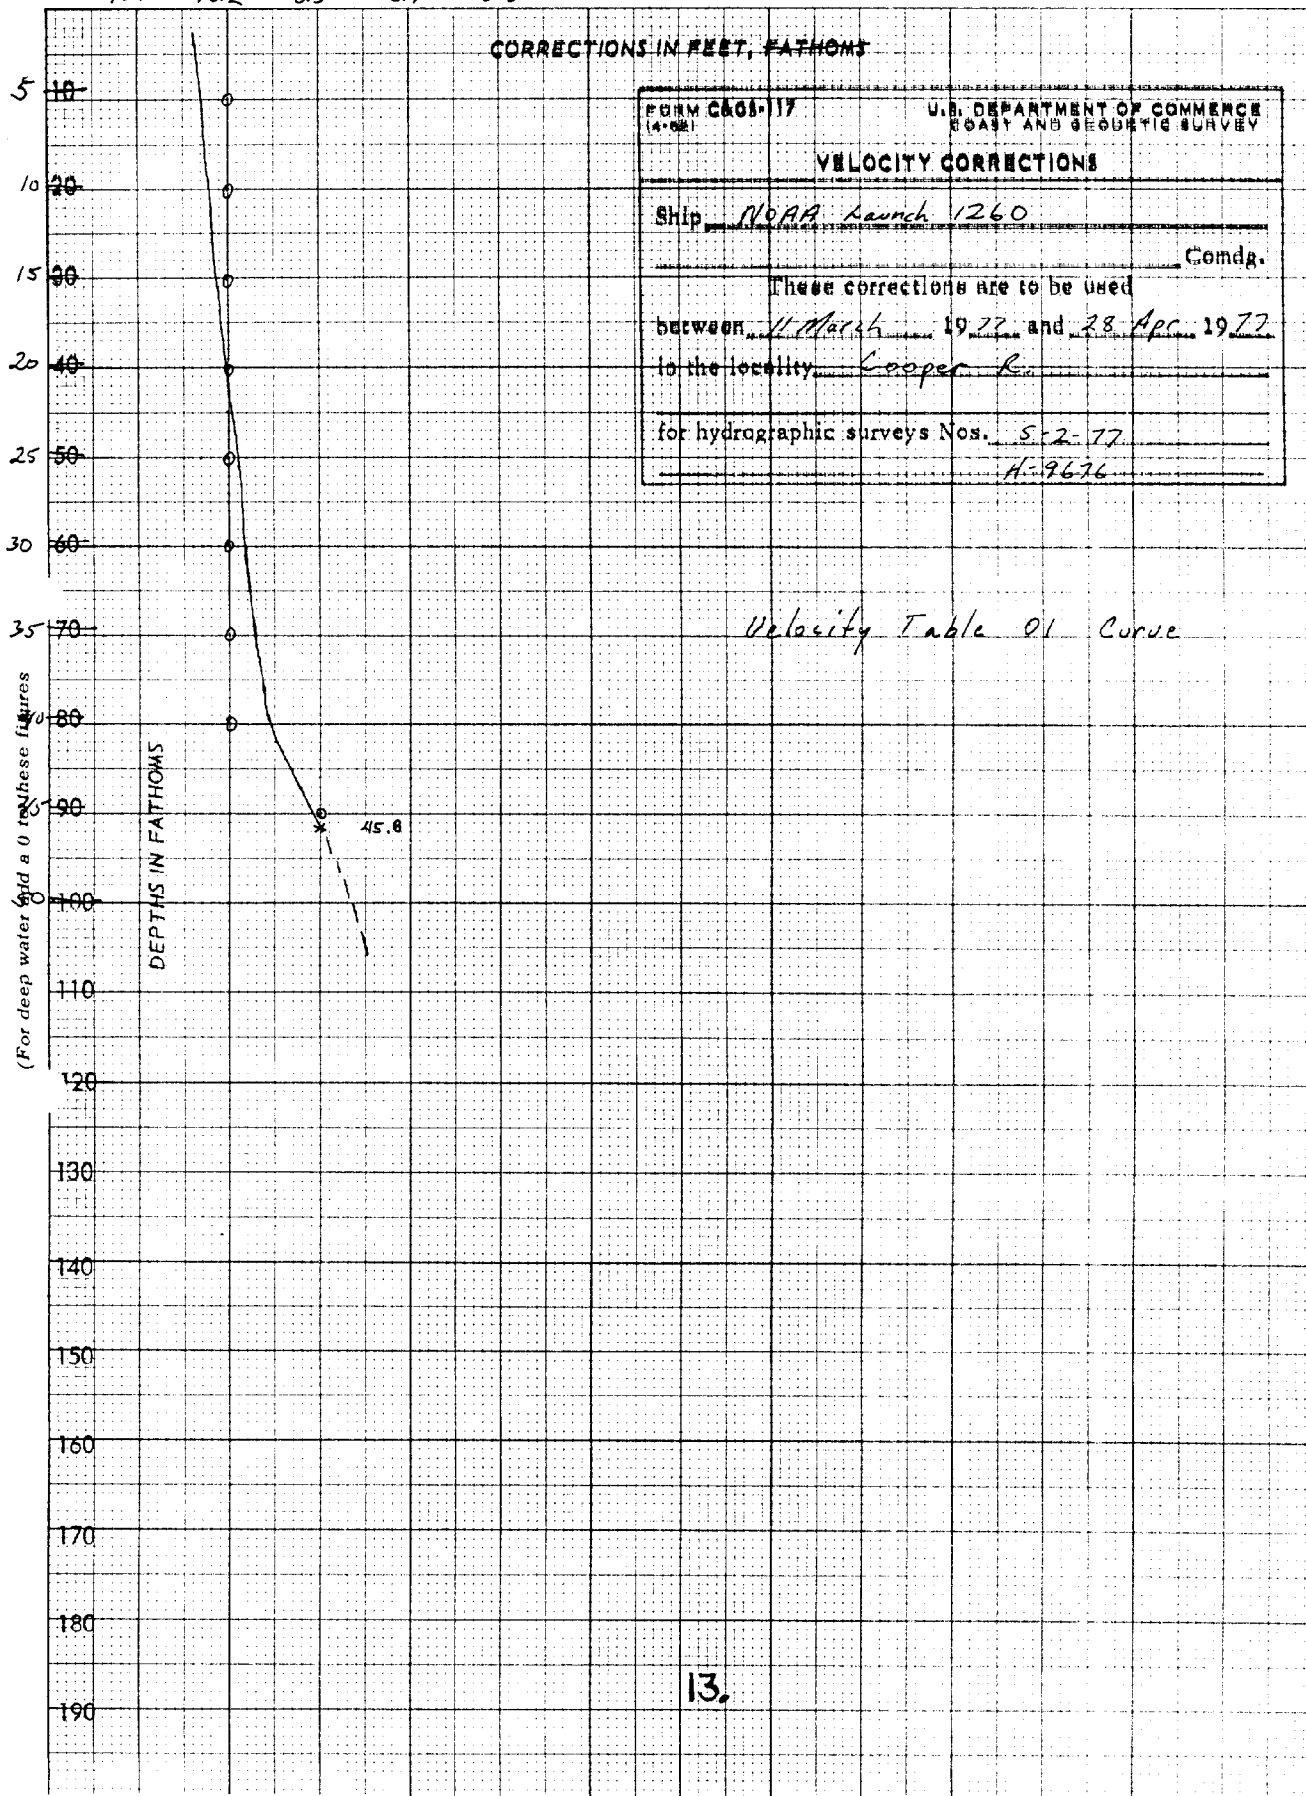
FORM CGO 17 (4-62)	U.S. DEPARTMENT OF COMMERCE COAST AND GEODETIC SURVEY
VELOCITY CORRECTIONS	
Ship <u>NOAA Launch 1260</u>	Comdg. _____
These corrections are to be used between <u>11 March 1977</u> and <u>28 Apr 1977</u> to the locality <u>Cooper R.</u> for hydrographic surveys Nos. <u>S-2-77</u> <u>H-9676</u>
