DESCRIPTIVE REPORT
(HYDROGRAPHIC)

Type of Survey Hydrographic.....
Field No. HSB-10-1-77.....
Office No. H-9705.....

State New York.....
General Locality Lake Erie.....
Locality Buffalo Harbor.....

SHEET
LAYOUT
H-9705
HSB 10-1-77

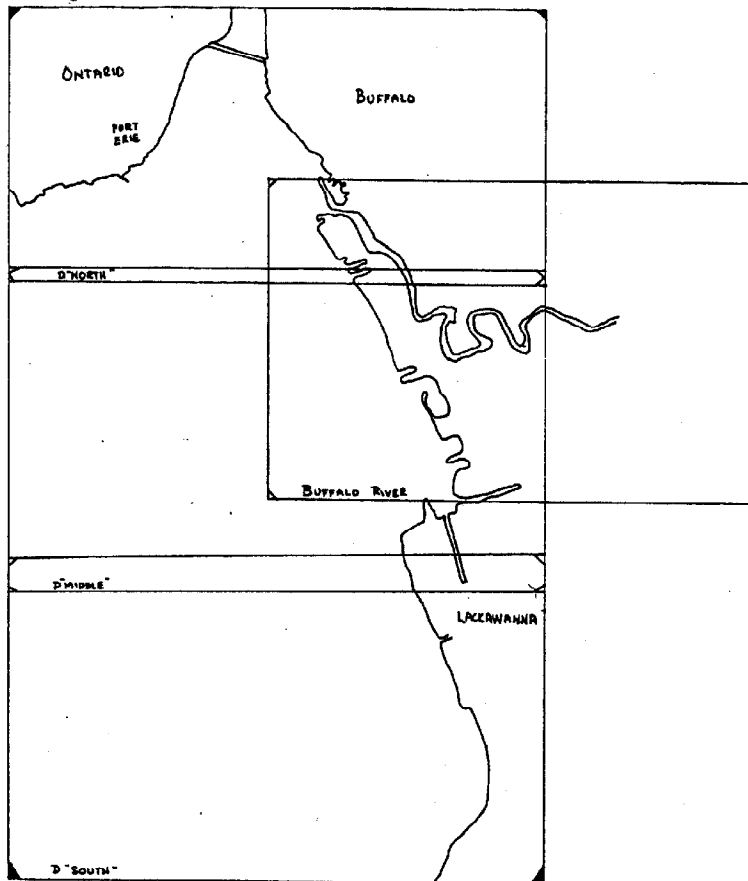
Chart: 14822
(formerly LS31)
1:80000
"NIAGARA RIVER AND 22ED.
WELLAND CANAL" Nov 9/79

SURVEY AREA : H-9705

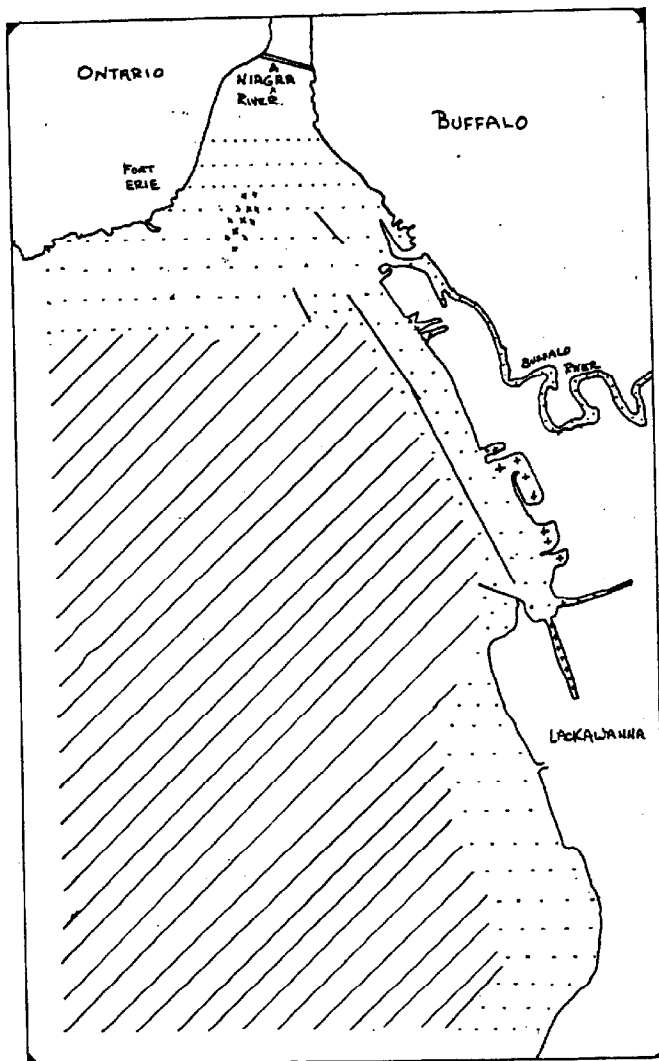
CHART: 14822
(FORMERLY LS31)

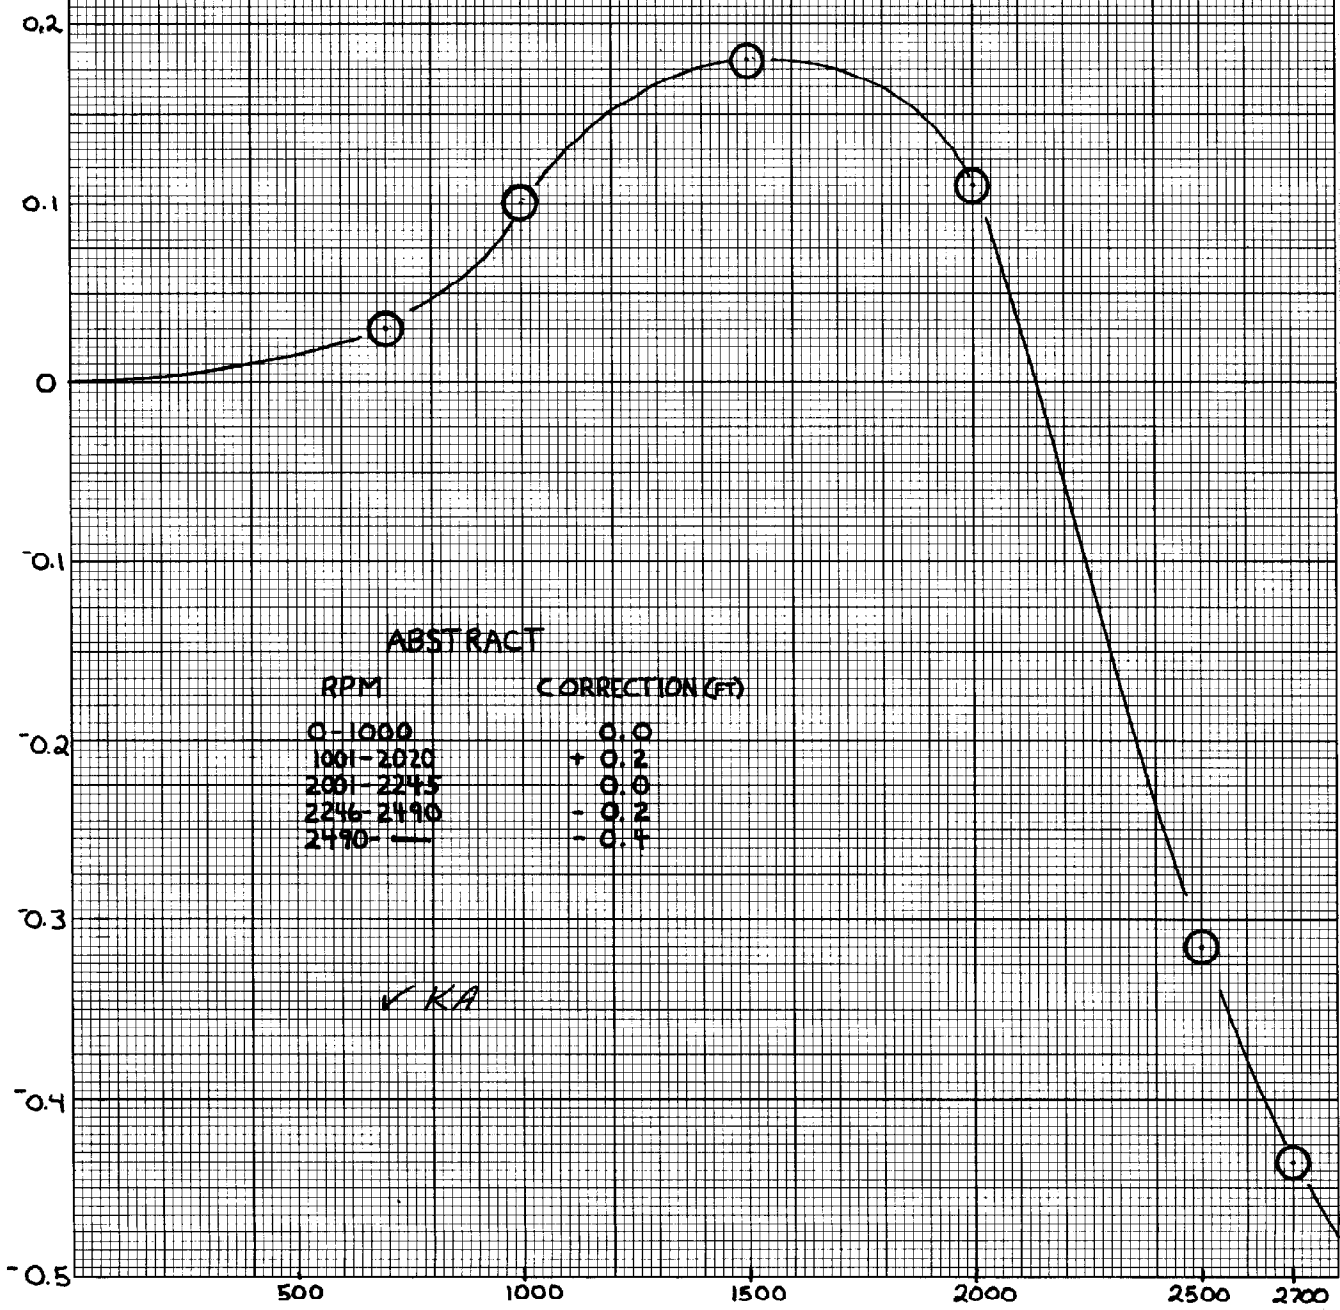
RPM	CORRECTION (ft)
0-1000	0.0
1001-2020	+ 0.2
2001-2245	0.0
2246-2490	- 0.2
2490-	- 0.4

SETTLEMENT & SQUAT
 NOAA LAUNCH 1255
 MAY 26, 1977 - JD 146
 BUFFALO HARBOUR - BUFFALO, N.Y.

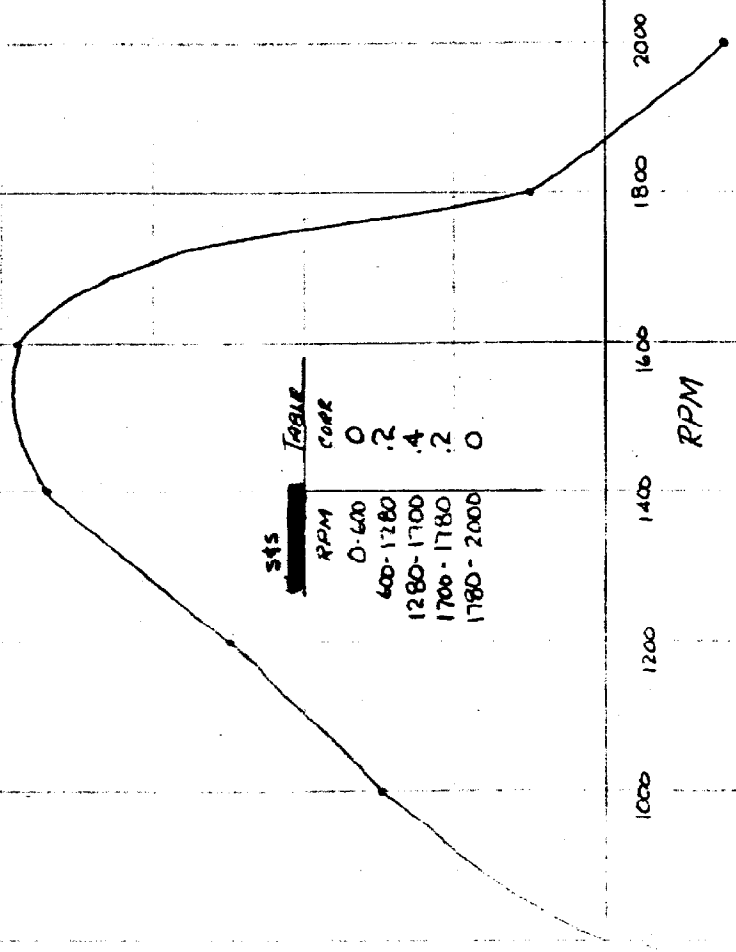
RPM	CORRECTION (FE)	(ACTUAL VALUES USED TO PLOT CURVE)
000	0	
1000	.15	
1200	.25	
1400	.37	
1600	.39	
1800	.05	
2000	-.08

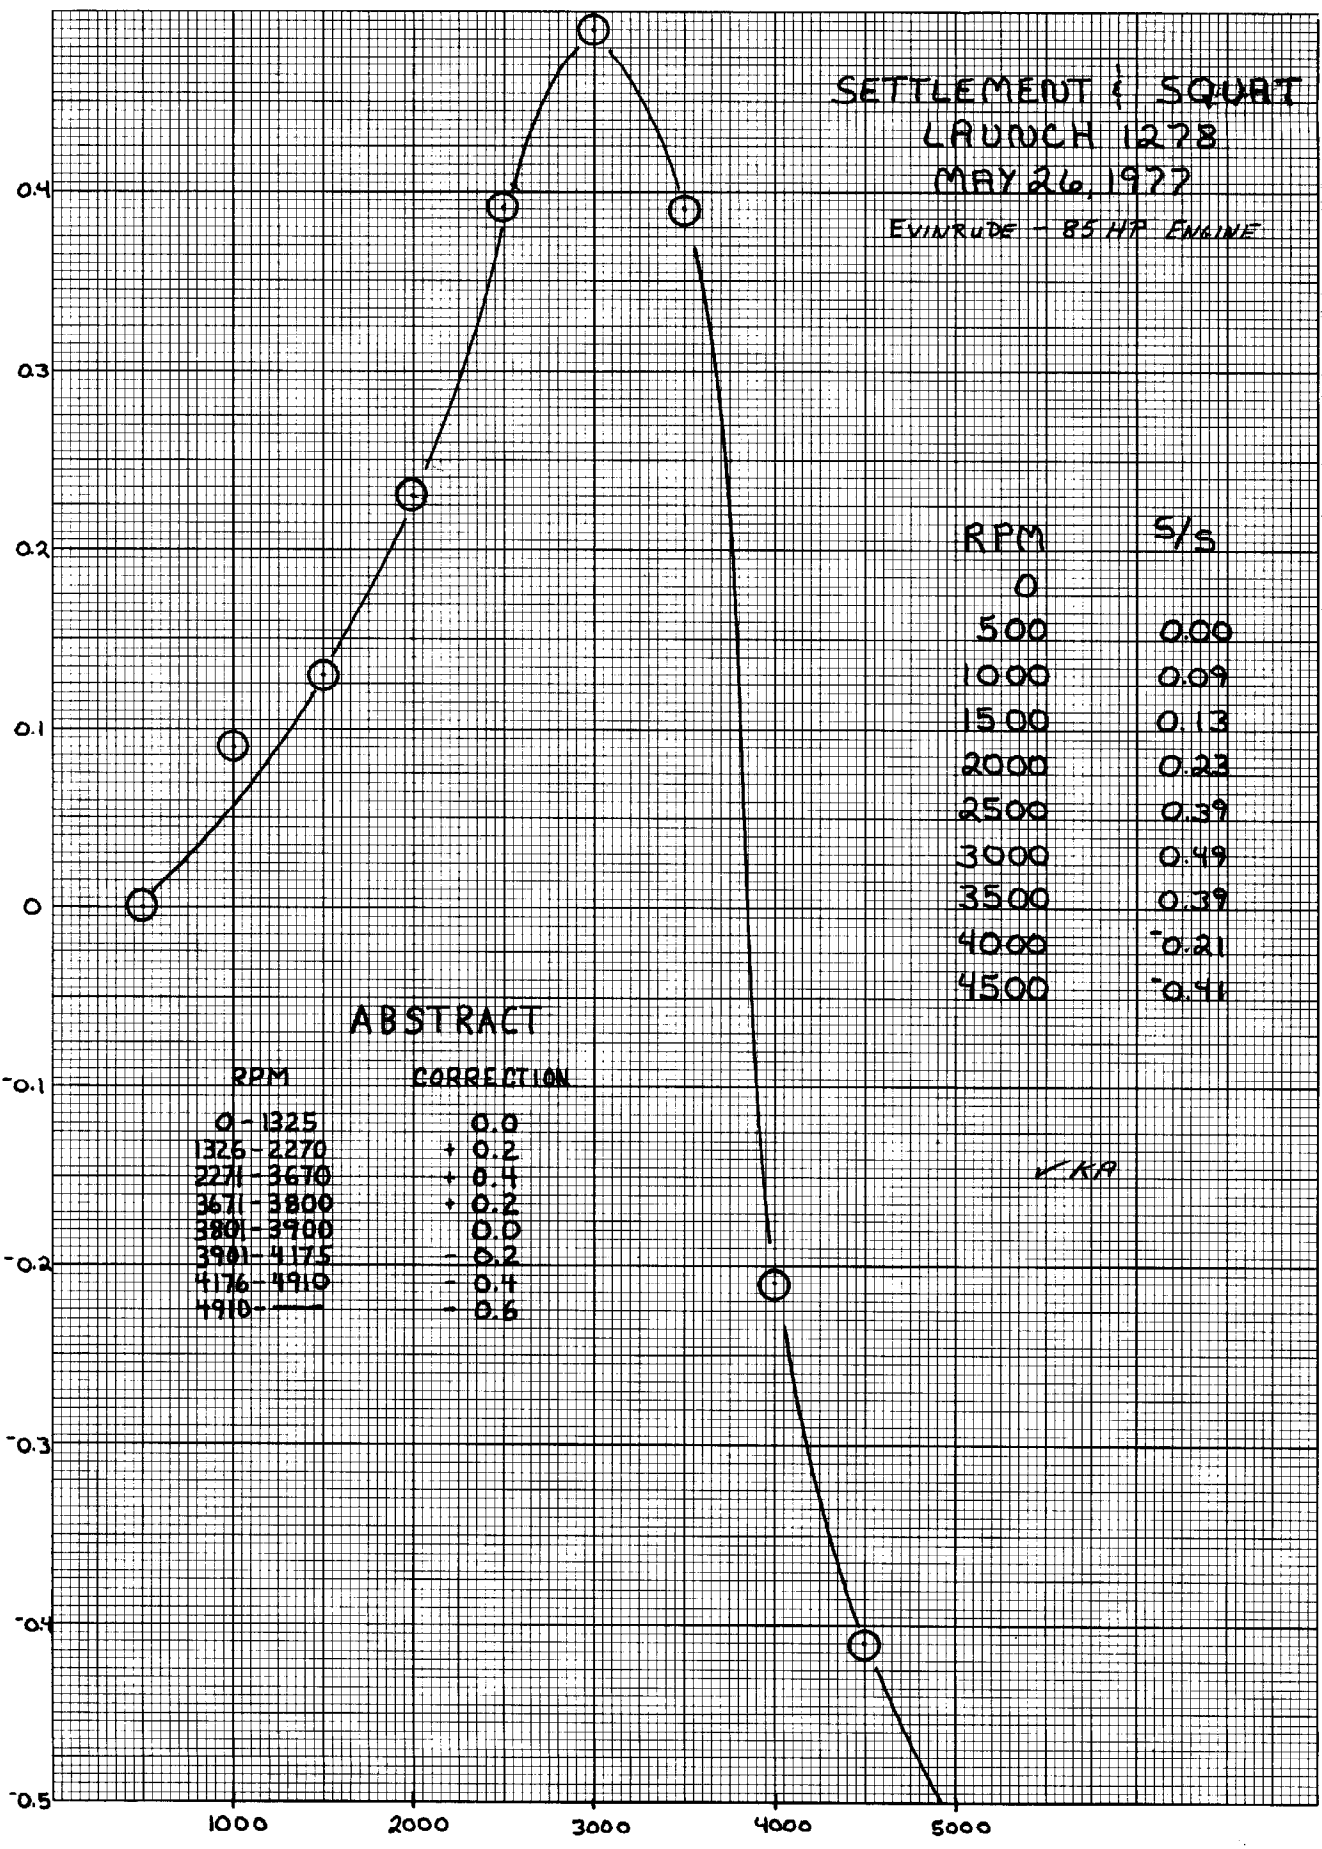
SETTLEMENT / SQUAT
LAUNCH 1278
MAY 26, 1977
EVINRUDE - 85 HP ENGINE

RPM	S/S
0	0.00
500	0.00
1000	0.09
1500	0.13
2000	0.23
2500	0.39
3000	0.49
3500	0.39
4000	0.21
4500	0.11
