DESCRIPTIVE REPORT (HYDROGRAPHIC)

Type of Survey Hydrographic
Field No. FA-5-2-78
Office No..... H-9740

State California
General Locality .. Pierpont Bay
Locality Ventura Harbor

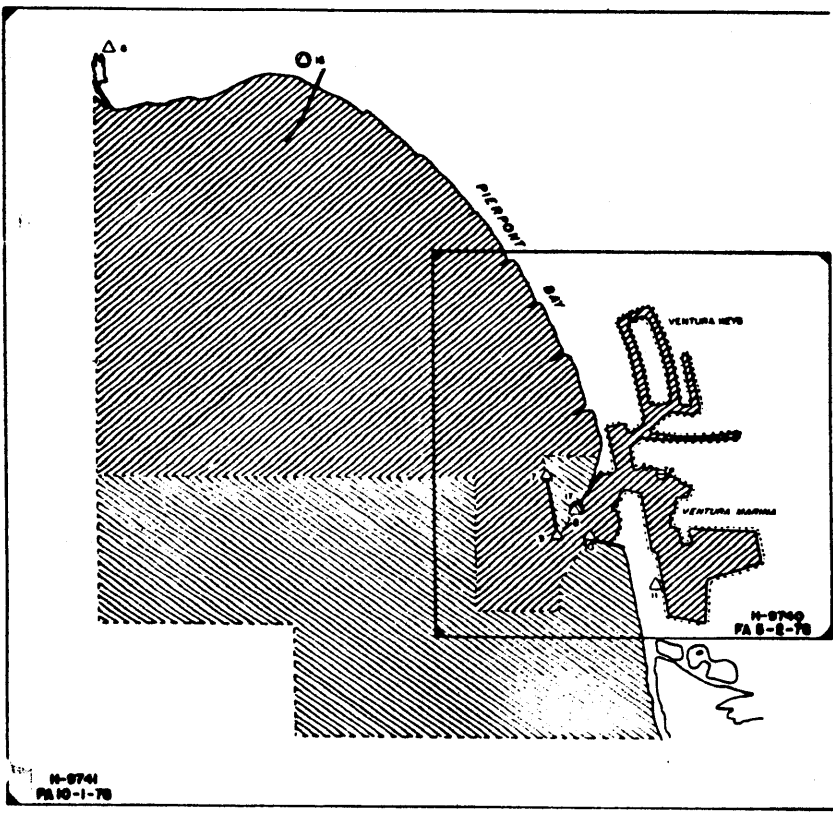
OPR-L100 (411)-FA-78
 PROGRESS SKETCH
 VENTURA CALIFORNIA
 NOAA SHIP FAIRWEATHER S-220
 CDR BRUCE I. WILLIAMS, CMDG
 SCALE OF NOS CHART 18725
 1978

FEB	MARCH
LNM SOUNDING LINE	105.0	51.2
30 NM SOUNDING LINE	3.08	1.58
STD CAST (MARTEK)	0	1
BOTTOM SAMPLE	0	25
