DESCRIPTIVE REPORT
(HYDROGRAPHIC)

Type of Survey Hydrographic.....
Field No. HSB-5-2-79.....
Office No..... H-9826.....

State Maryland.....
General Locality Chesapeake Bay.....
Locality Approach to Patuxent River.....

T.W. Richards.....

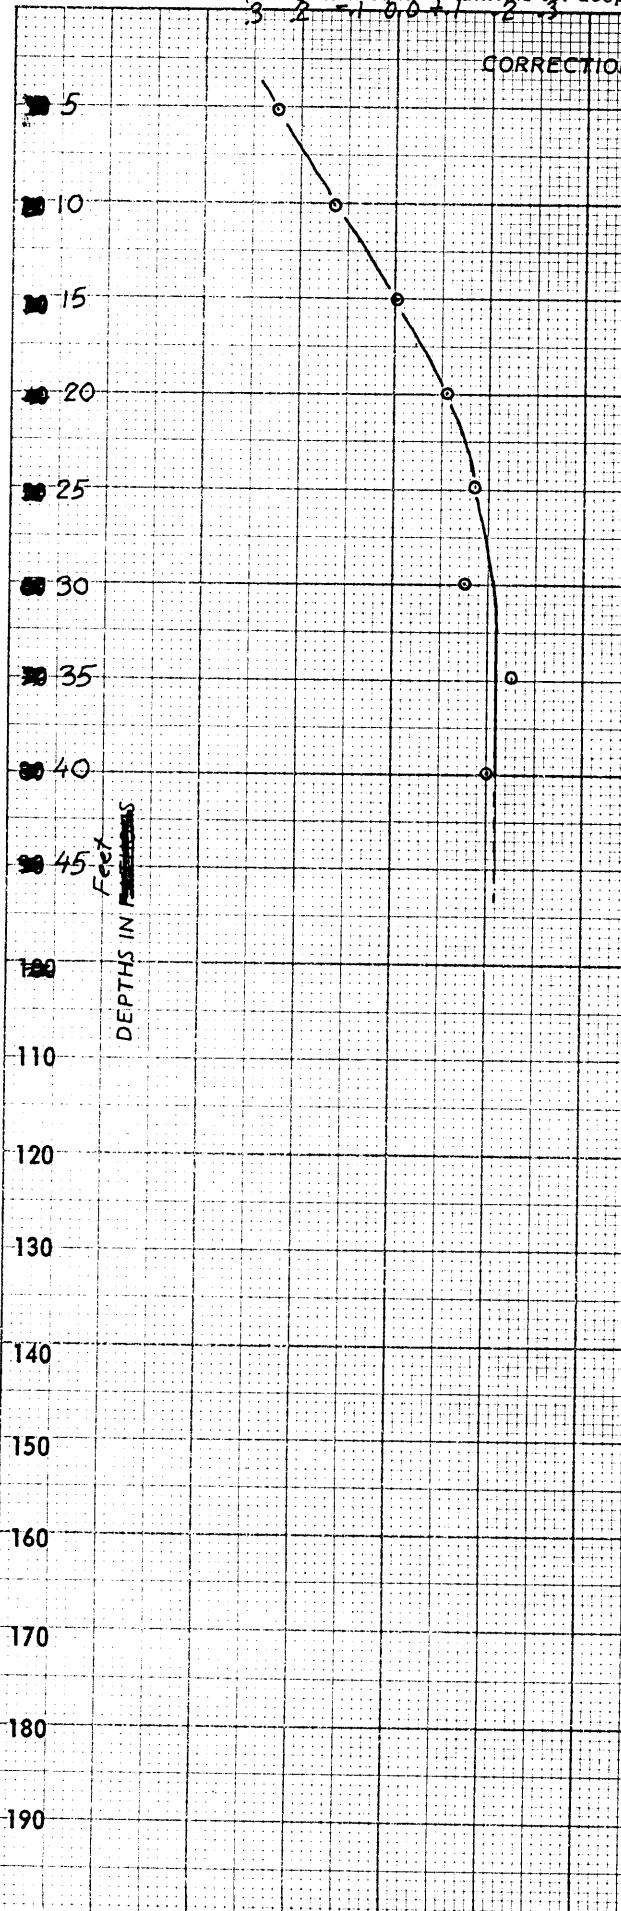
NOAA FORM 75-21 (10-72)	U.S. DEPARTMENT OF COMMERCE NOAA NATIONAL OCEAN SURVEY
VELOCITY CORRECTIONS	
Ship <u>Launch 1283</u>	
Comd. <u>T.W. Richards, LCDR, NOAA</u>	
These corrections are to be used	
between <u>21 May</u> 19 <u>79</u> and <u>7 June</u> 19 <u>79</u>	
in the locality <u>Patuxent River</u> <u>Maryland</u>	
for hydrographic surveys Nos. <u>H-9826</u>

(For deep water add a 0 to these figures)

depth (ft.)	Corr. (ft.)
to 11.0	-0.2
19.4	0.0
100.0	+0.2

Velocity corrections and any residual instrument corrections were determined from standard direct comparison bar checks taken daily. Weather and sea conditions encountered routinely each afternoon made bar checks impractical in the

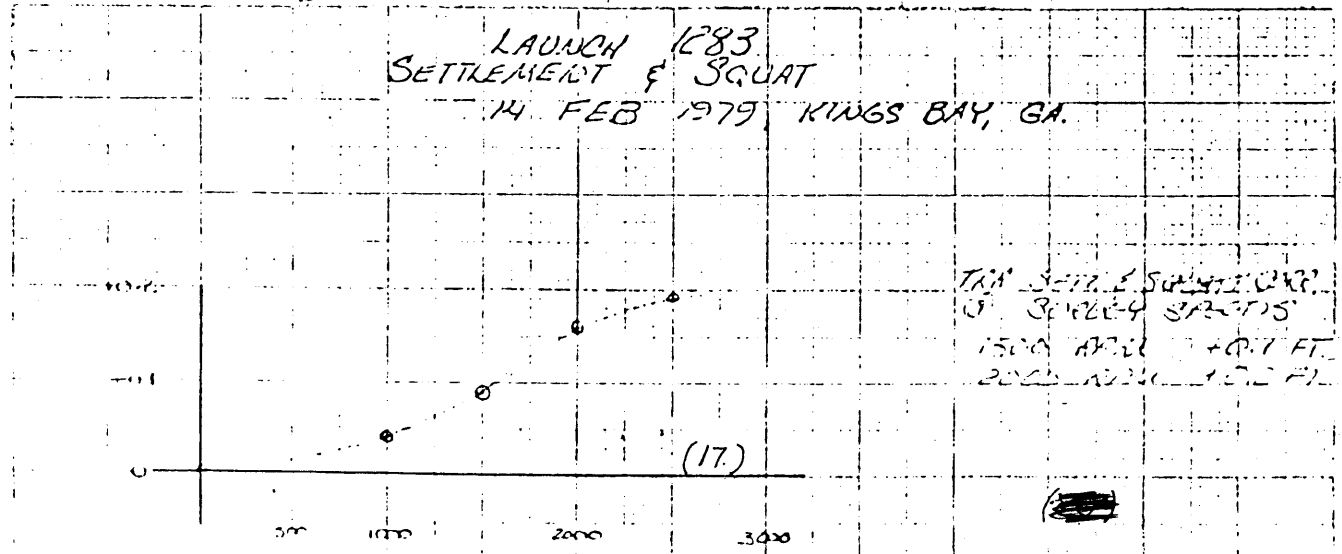
LAUNCH 1283
SETTLEMENT & SQUAT
14 FEB 1979, KINGS BAY, GA.
