DESCRIPTIVE REPORT

Type of Survey Hydrographic
Field No. RA-20-3-79
Office No. H-9840

State Alaska
General Locality Cook Inlet
Locality Vicinity of Cape Starichkof

PROGRESS SKETCH
OPR-PII4-RA-79
SOUTHERN COOK INLET, ALASKA
JUNE 1-AUGUST 15, 1979
NOAA SHIP RAINIER
WAYNE L. MOBLEY, CAPT., NOAA
COMD G
 FROM CHART 16640

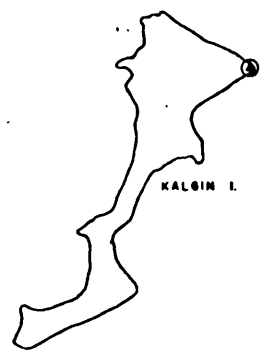
PROGRESS SKETCH
 OPR-P114-RA-79
 SOUTHERN COOK INLET, ALASKA
 JUNE 1-AUGUST 15, 1979
 NOAA SHIP RAINIER
 WAYNE L. MOBLEY, CAPT., NOAA
 COMD G
 FROM CHART 16640

PREDICTED TIDE
 ZONING USED FOR OPR-P114-RA-79
 FIELD SHEETS:

1. HW (in minutes)
 2. LW (in minutes)
 3. Ratio (HT of tide)
- w/respect to
 Seldovia.
