## DESCRIPTIVE REPORT

Type of Survey Hydrographic	
Field No. FA-5-1-80	
Office NoH-9862	
	**************************************
LOCALITY	`
State Washington	•••••
General Locality Puget Sound	
Locality Sinclair Inlet	
1979-80	
CHIEF OF PARTY CAPT A.J. Patrick	
LIBRARY & ARCHIVES	
DATE December 8, 1981	J

NOAA SHIP FAIRWEATHER (S-220) CAPT. ARCHIBALD J. PATRICK, CMDG

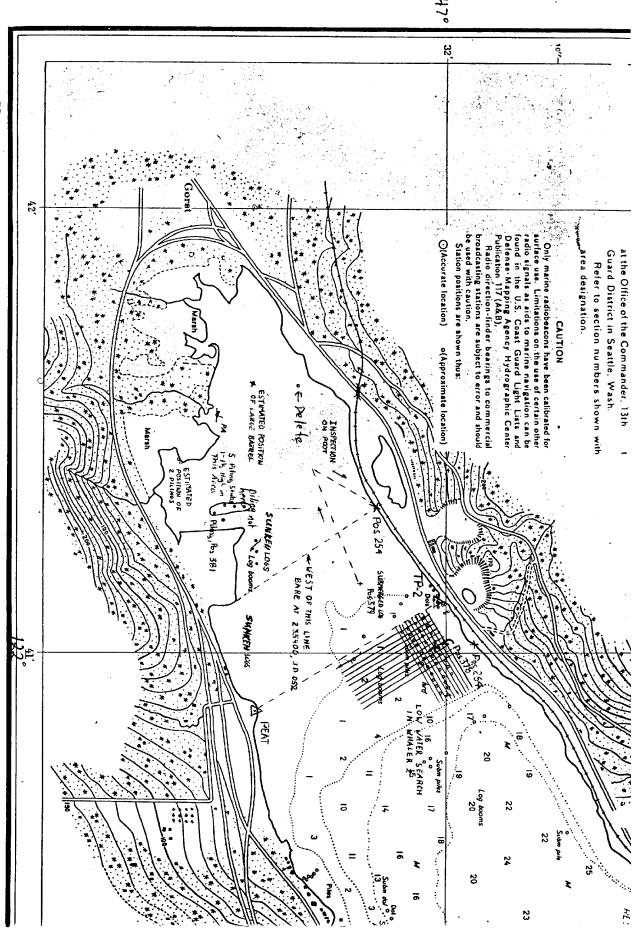
Ten lines were run parallel to the shore at ten meter spacing, (see chartlet on the following page). The end points for these lines were the line between
