DESCRIPTIVE REPORT

Type of Survey WIRE DRAG
Field No. R/H-20-1-76
Office No. H-9871 W.D

State Virginia
General Locality Atlantic Ocean
Locality Chesapeake Bay Entrance

HYDROGRAPHIC TITLE SHEET

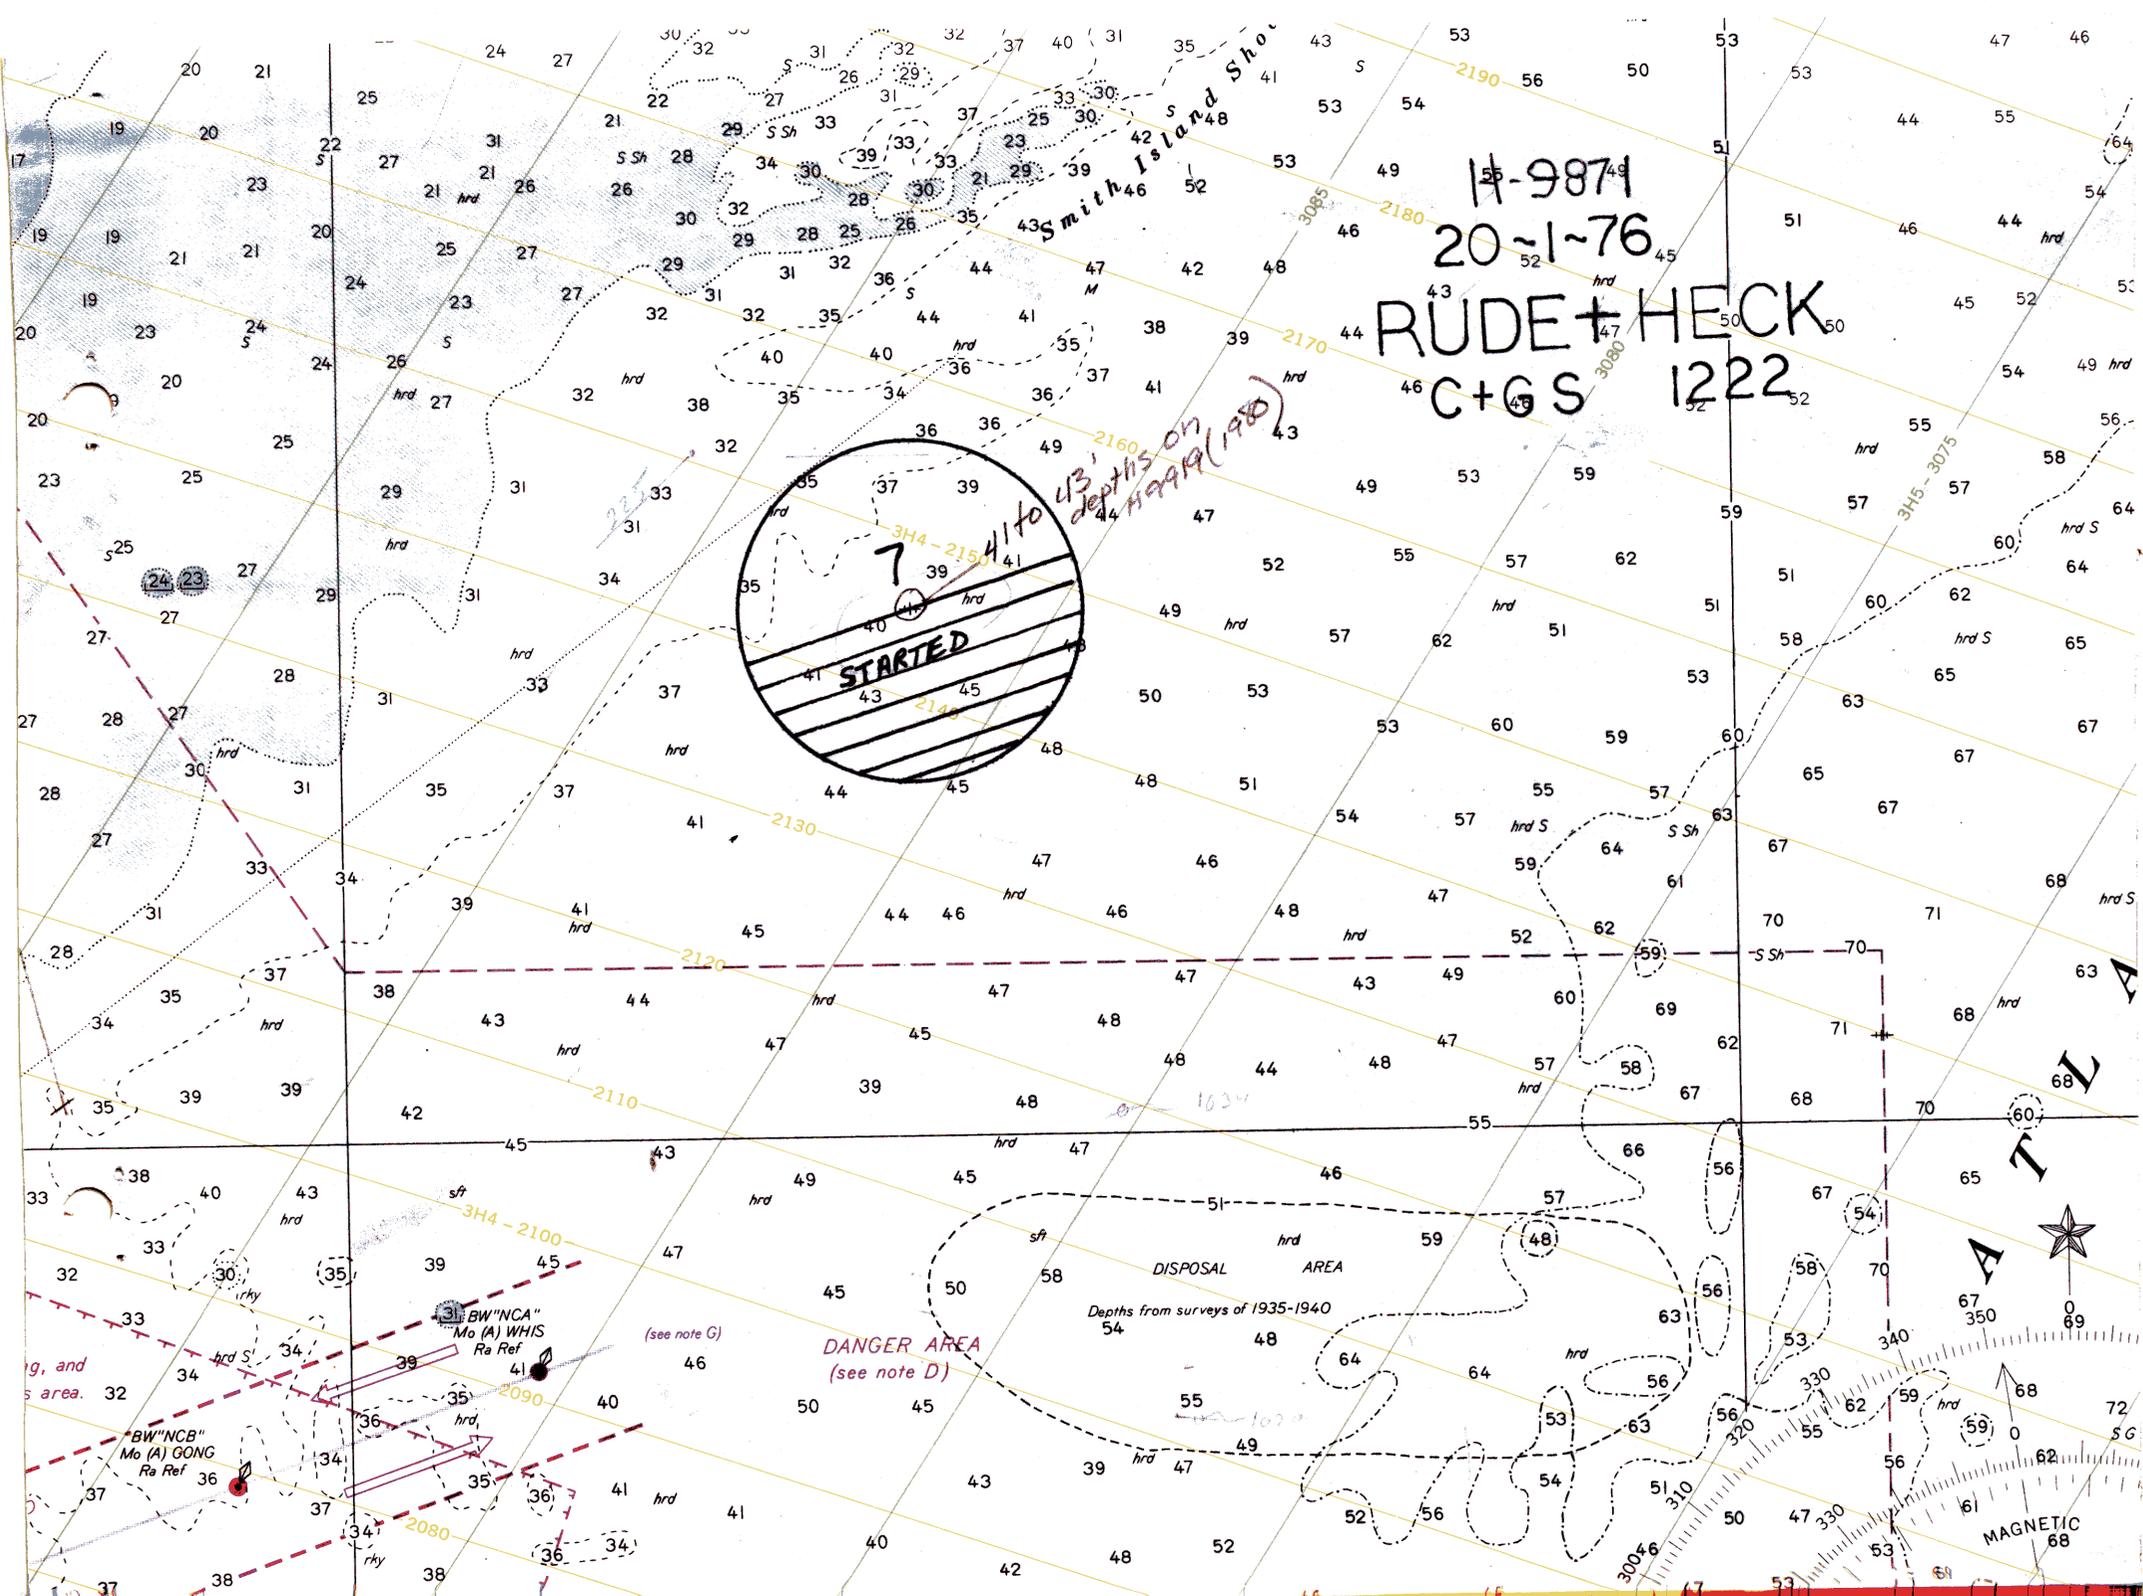
11-9871
20-1-76
RUDE + HECK
C+GS 1222

STARTED
7
3H4-2150
43 depths on
44 H999 (1980)

DISPOSAL AREA
Depths from surveys of 1935-1940
