DESCRIPTIVE REPORT

Type of Survey	<u>Hydrographic</u>
Field No.	WH-20-2-80
Office No	H-9898
×**	
	LOCALITY
State	Michigan
	-ake Huron
	Port Sanilac to
	exington Heights
t en	19 80
	CHIEF OF PARTY
<u></u>	DR.F.P.Rossi
	RARY & ARCHIVES
DATE	ovember 16, 1981

HYDROGRAPHIC TITLE SHEET

State MICHIGAN	
General locality LAKE HURON	
Locality SOUTH WEST COAST PORT SANILAC TO LEXINGTON HEIGH	<u>TS</u>
Scale 1:20,000 Date of survey 23 JULY - 9 OCTOBER	L980
Instructions dated 31 MARCH 1980 Project No. OPR-X115-WH-80	
essel NOAA SHIP WHITING Launchs 1014, 1015, and Monark 1288	<u></u>
Chief of party CDR Frank P. Rossi	
Surveyed by J.C. Gardner, R.G. Mann, D.A. Bland, J.B. Grant	·
Soundings taken by echo sounder, 根格数据根据表 ROSS Model 5000 RATTHEON DE 719 E	<u> </u>
Graphic record scaled by WHITING personnel	·
Graphic record checked by JCG, RGM, DAB, JBG, RWB	
Protracted by Automated plot by HYDROPLOT	
Soundings penciled by	
Oundings in ###### feet at MEW LWD (IGLD 1955:576.8 FT)	
REMARKS: All times are Coordinated Universal Time	
Notes in red made during verification.	
<u> </u>	_
SIANDARDS CHECKED 11-8-82.	
Clon

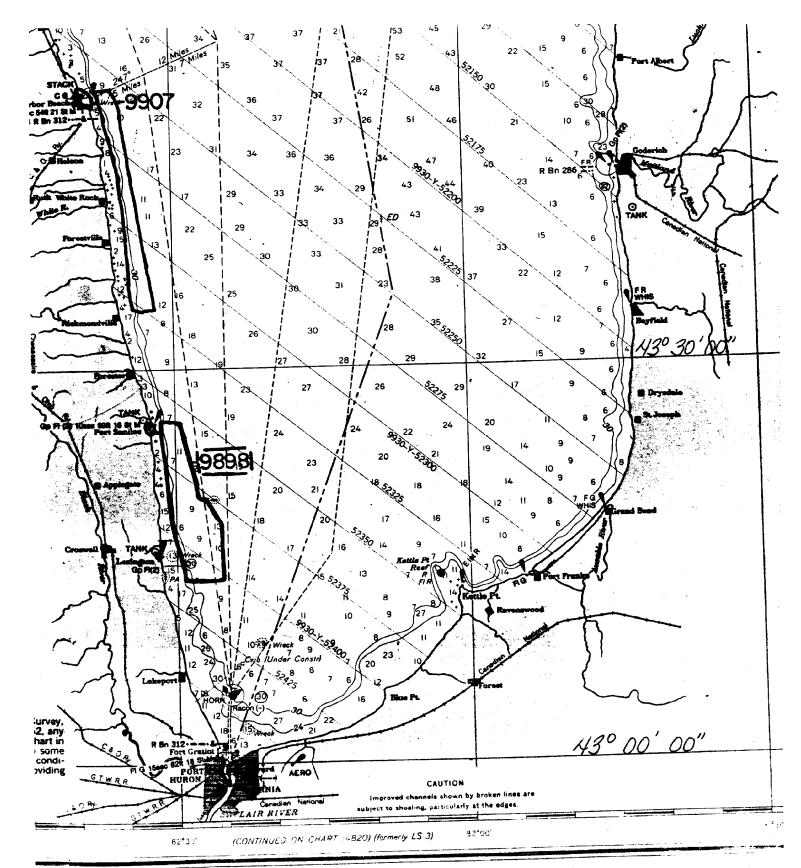
Diagramo Ro. 13-5

Published at Washington, D. C.
U.S. DEPARTMENT OF COMMERCE
MATIONAL OCEANIC AND ATMOSPHERIC ADMINISTRATION
NATIONAL OCEAN SURVEY
