HYDROGRAPHIC TITLE SHEET

H-9952

General locality San Francisco Bay

Locality Vicinity of San Francisco Airport

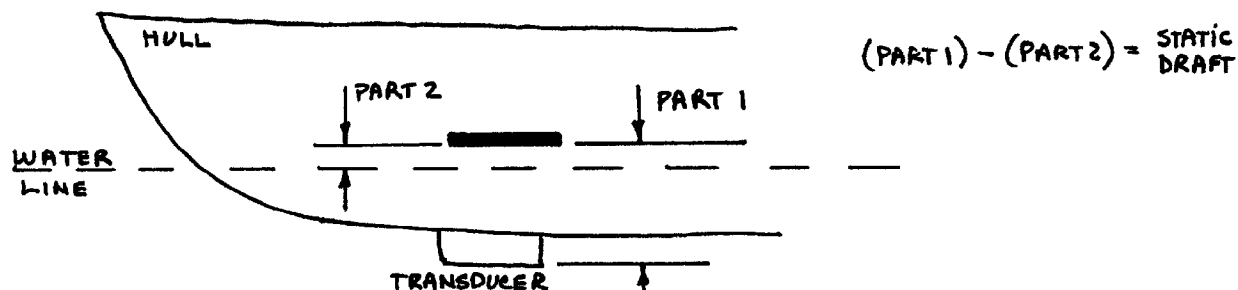
The static transducer depth of launch 1101 (EDP 0651) was physically measured in two parts. The first part was done while the launch was out of the water. The distance between the transducer face and the bottom of a black line painted on the hull above the water line was accurately measured using a surveying level (Lietz B-1, S/N 214303) and rod. The second part was done with the launch in the water with a normal crew and fuel load. The distance between the bottom of the painted black line and the actual water line was measured with a steel tape.

The actual static transducer depth is the distance obtained in part 1 minus the distance measured in part 2.

The Actual static draft was measured at 1.63 feet.

The static draft corrector of 1.6 feet is on the TC/TI tape, and applied to the field sheet. The value of 1.6 feet for static draft was altered as settlement and squat became significant. ✓

The instrument/draft corrector for launch 1101 corrects soundings for errors caused by the difference in the pre-survey estimated static draft of 1.6 feet (used on all data tapes) and the actual static draft of 1.63 feet. It also corrects any instrument errors caused by the Ross sounding system or its transducer. ✓
