DESCRIPTIVE REPORT

Type of Survey Hydrographic
Field No. FA-20-1-82
Office No. H-10040

State Alaska
General Locality Shelikof Strait
Locality Wide Bay to Imuya Bay

Scale 1:20,000 Date of survey Aug. 7 to Aug. 20, 1982
February 23, 1982 June 11 to Aug. 4, 1983

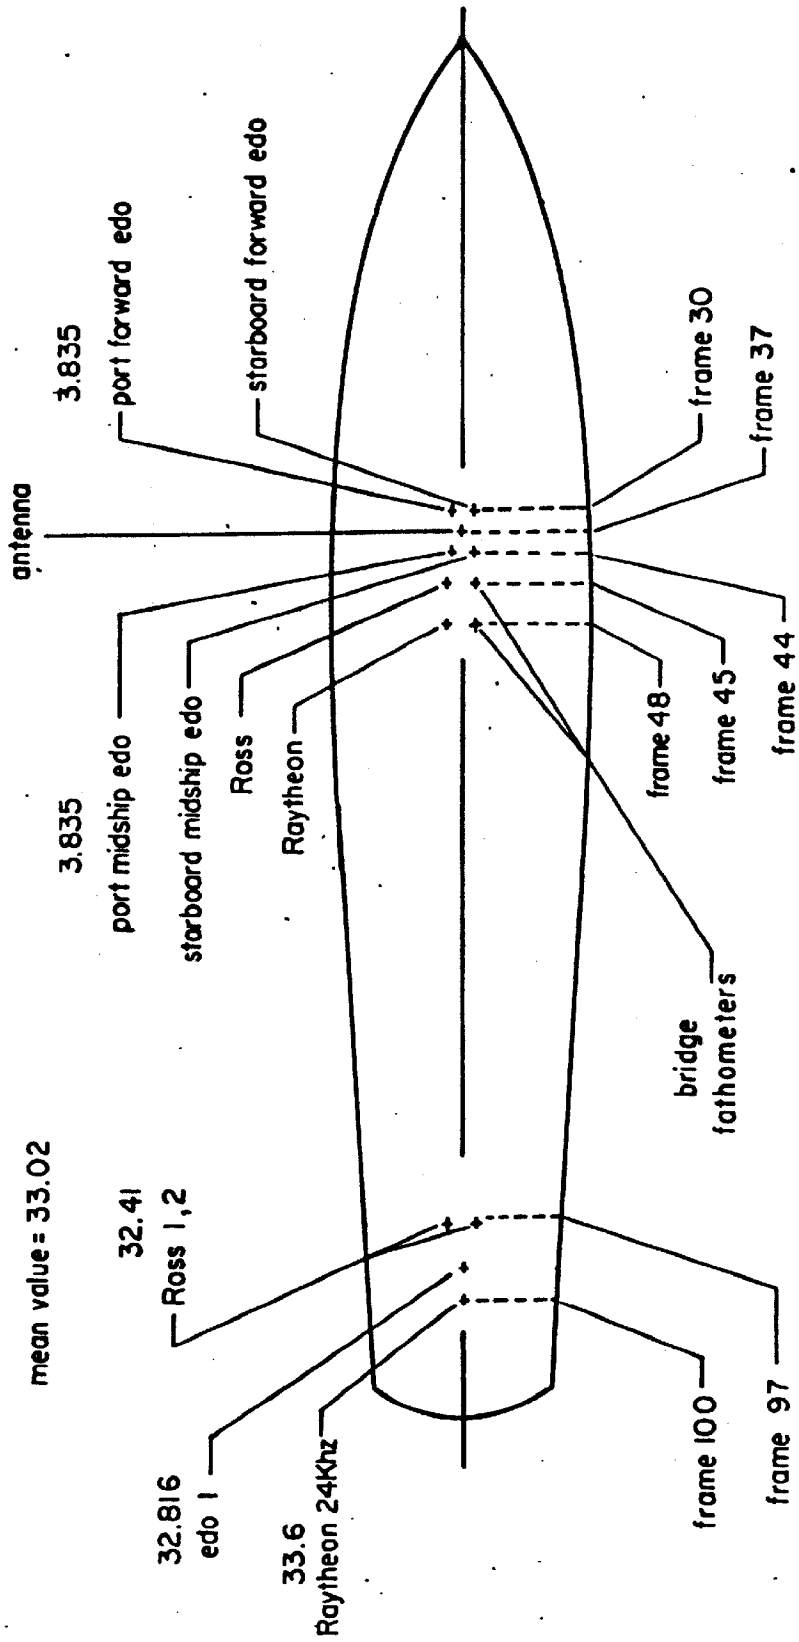
Figure 1

FAIRWEATHER TRANSDUCER LOCATION DIAGRAM, APRIL 1982

numerical values are distance in meters forward or aft of antenna

Ross skag (1,2) and midship transducers were used on FAIRWEATHER for all hydrography run by the ship. See Figure 1, FAIRWEATHER Transducer Location Diagram, for details. No unusual sounding vessel configurations were used on this survey. ✓
