DESCRIPTIVE REPORT

Type of Survey .. Hydrographic ..
Field No. PE-20-2-83 ..
Office No..... H-10084 ..

State Delaware—New Jersey ..
General Locality .. Delaware Bay ..
Locality Fourteen Foot Bank to ..
..... Cross Ledge ..
..... 1983 ..
CHIEF OF PARTY
CDR W.S. Simmons ..

HYDROGRAPHIC TITLE SHEET

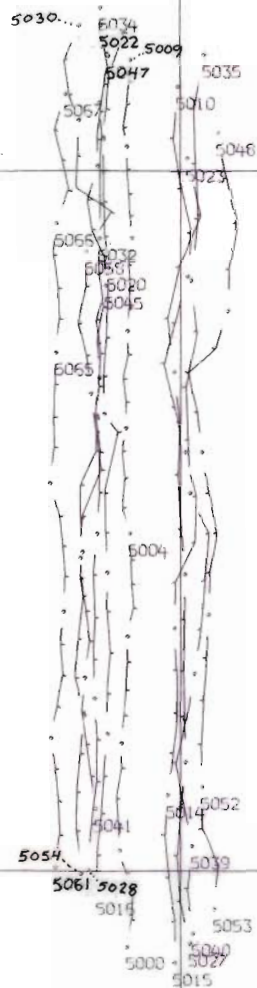
charted submarine wreck

The dangerous submerged wreck (AWOIS 02946) at latitude $38^{\circ}08'47''$ ⁹N, longitude $75^{\circ}15'32''$ W from Notice to Mariners 28 of 1962 was not fully investigated. Additional work was recommended for this item and it was reassigned to Project Instructions OPR-D219-PE-84. The wreck should be retained on the chart. ✓HR
