DESCRIPTIVE REPORT

Type of Survey .. Hydrographic

Registry No. H-10116

General Locality .. Chesapeake Bay

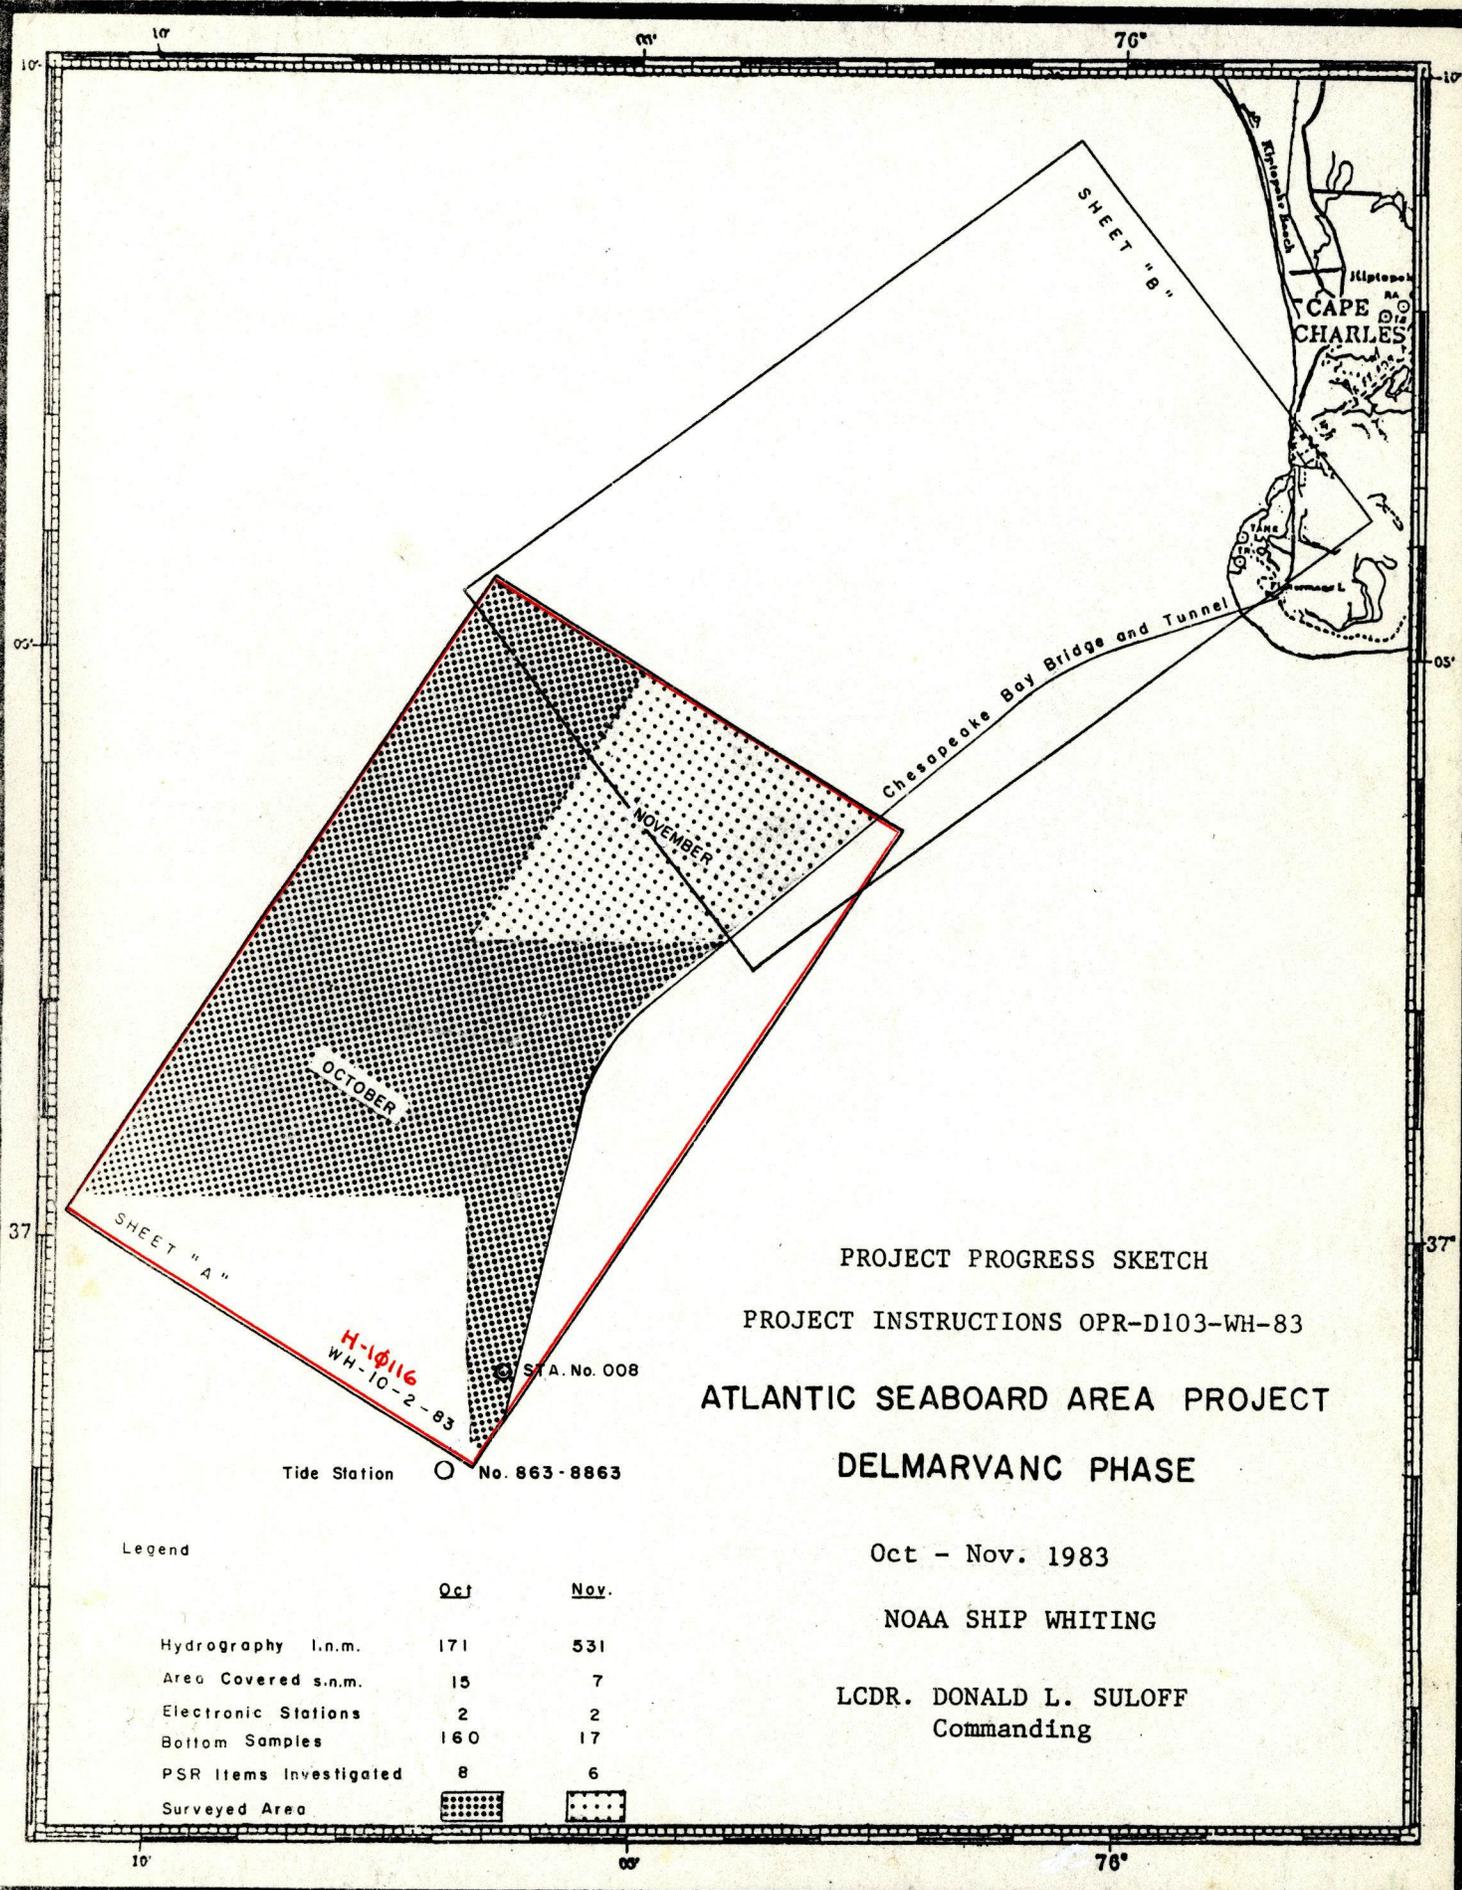
PROJECT PROGRESS SKETCH
 PROJECT INSTRUCTIONS OPR-D103-WH-83
 ATLANTIC SEABOARD AREA PROJECT
 DELMARVANC PHASE

Oct - Nov. 1983
