## DESCRIPTIVE REPORT

Type of Survey Hydrographic

Registery No. H-10229

General Locality Kelp Bay

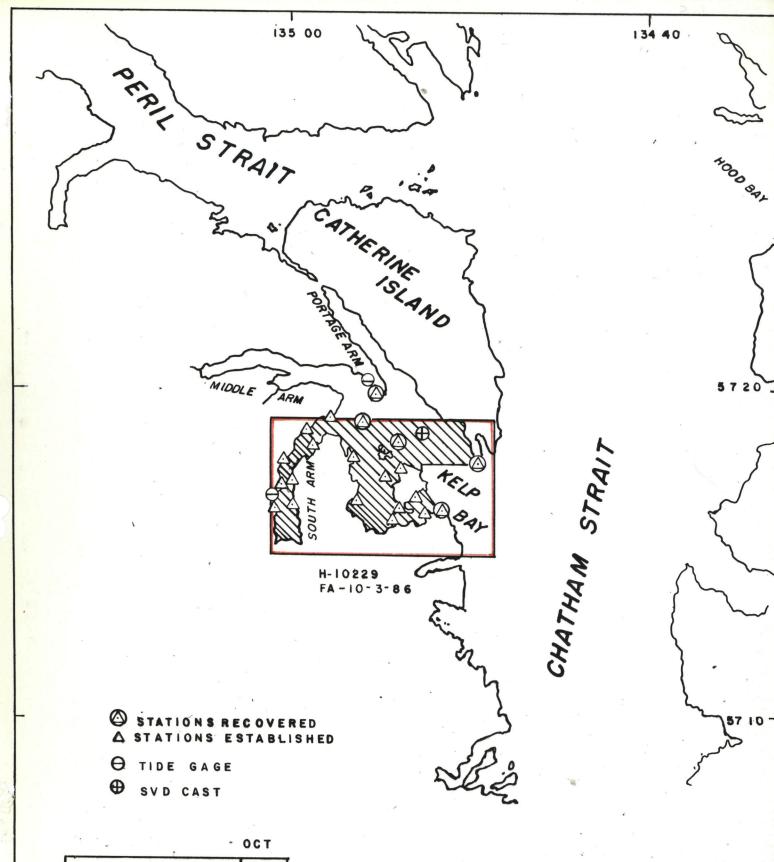
MONTHLY PROGRESS SKETCH OPR-0183-FA-86 -KELP BAY, ALASKA-

SQ NM SOUNDING LINE	10
LNM SOUNDING LINE	323
BOTTOM SAMPLES	51
HYDRO CONTROL STATIONS	21
SV/D CAST	2
TIDE GAGE INSTALLATION	2
LNM SL VERIFICATION	15
HYDROGRAPHY	IIIII
